RADON REDUCTION SYSTEMS IN SCHOOLS

## ABSTRACT

Successful radon reduction techniques applied in houses have been modified and installed in a limited number of schools to reduce elevated radon levels. These mitigation techniques include subslab ventilation and to a lesser extent sealing and pressure control through the heating, ventilating, and air-conditioning (HVAC) systems.

Premitigation diagnostic data were collected and mitigation systems designed and installed in several schools in Prince Georges County and Washington County, Maryland, and Fairfax County, Virginia. The schools exhibited premitigation radon levels as high as 80 picocuries per liter (pCi/L\*) and represent a range of air-handling systems and substructures. Case studies of five of these schools are presented.

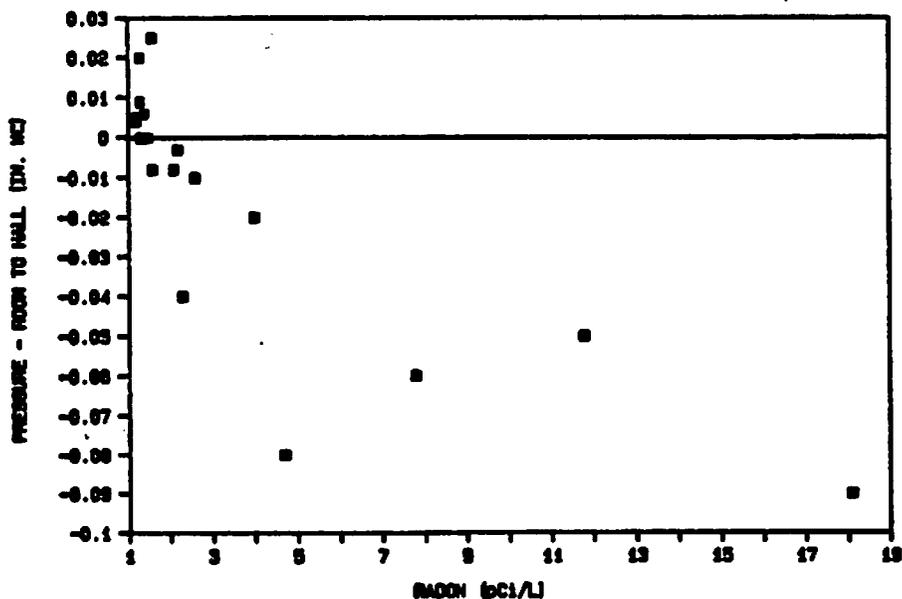
pressure in all rooms if the system were properly balanced. However, continuous radon and pressure measurements with the data logger indicated that many of the rooms were under negative pressure when both the supply and return fans were in operation. The room with the highest radon level measured 15 Pa negative pressure. As seen in Figure 1, there was a good correlation between negative pressure and radon levels in all rooms, with the highest radon levels in the rooms with the most negative pressures. When the return air fan was turned off the pressure in all rooms became positive, and radon levels decreased to less than 2 pCi/L. Examination of the air-handling system showed that the air distribution fan had been damaged and part of the housing cut away resulting in a great loss in capacity. It is believed that the distribution fan was actually supplying less air than the return air fan was removing, resulting in a negative pressure in many rooms.

Figure 1. Correlation Between Radon Levels and Pressure (Case Study A)

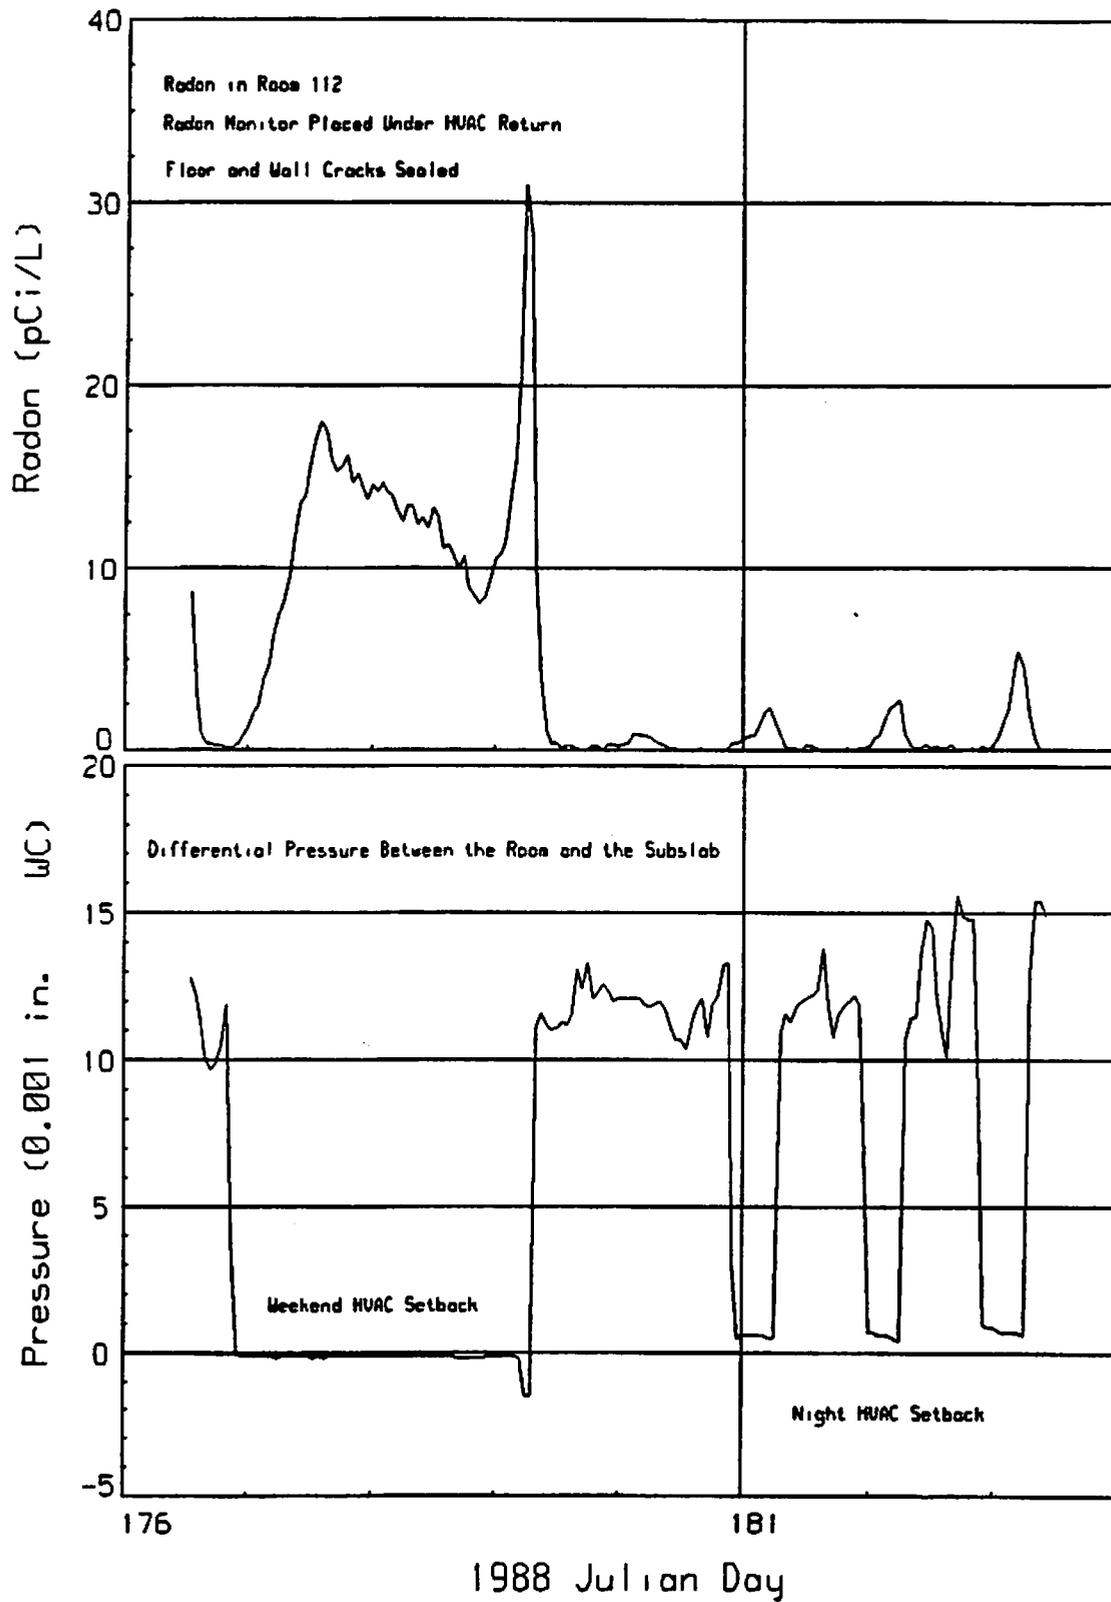
The impact of HVAC operation on radon levels in this room is displayed in Figure 2 for a 7 day period. (The return air louvers were closed during these measurements.) While the HVAC system is operating, the room is at a higher pressure than the subslab area and, consequently, radon entry is reduced. However, when the HVAC system is turned off during night and weekend setback, pressure in the room drops and radon levels increase.

Figure 2. Influence of HVAC Operation on Radon Levels (Case Study A).

As a temporary solution to reduce radon levels, the return air fan was left off and the HVAC system operated with only the air distribution fan. Under these conditions, all rooms showed positive pressure and had radon levels below 2 pCi/L. The damaged supply fan has now been replaced and the air distribution and air return systems are being balanced.

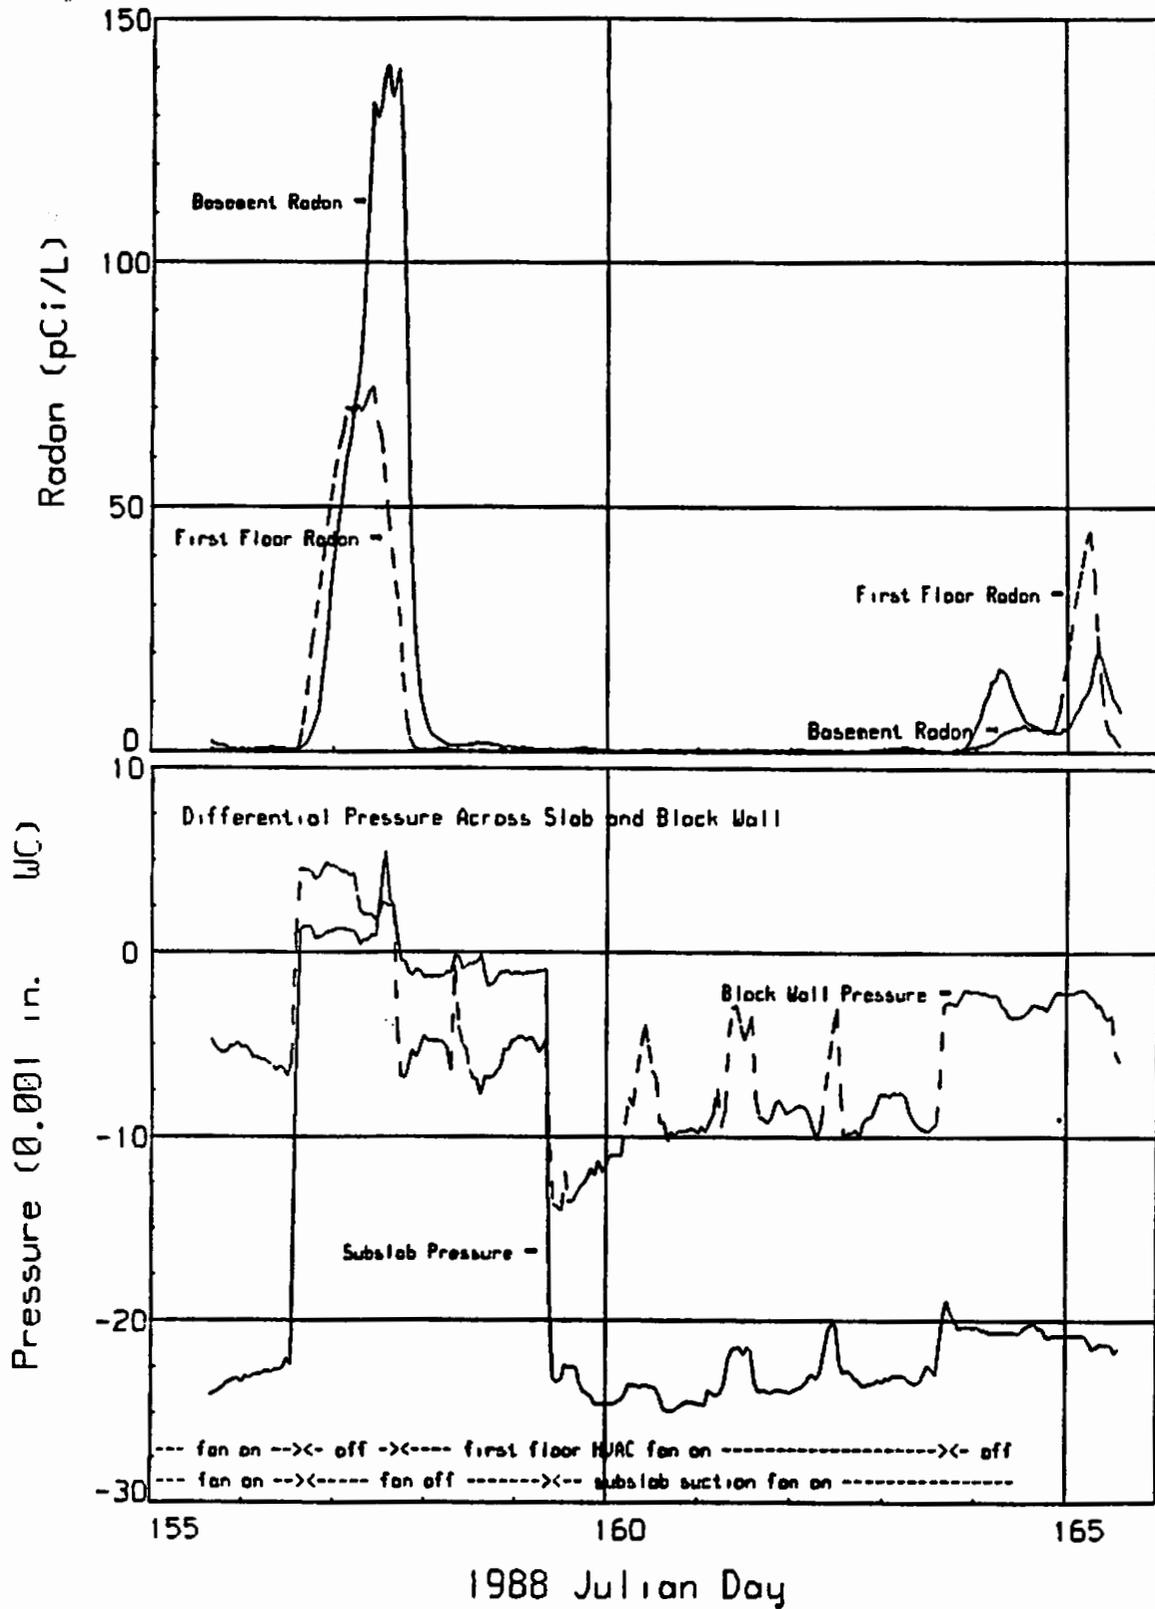
To evaluate the performance of a single-point subslab suction system and to investigate the effects of a single-fan HVAC system on mitigation performance, Figure 3 shows radon and pressure measurements in the school over a 10 day period. The first floor single fan HVAC system was operated continuously during the week to provide mitigation while the school was in session on the first floor. Since the basement was unoccupied during the monitoring period the basement HVAC system was not operated. Over the weekend (day 156), the HVAC system and the single point subslab suction system were turned off, and the radon levels rose quickly on both floors. On day 157 the subslab suction system remained off, but the first floor HVAC system was turned on. Radon levels on both floors dropped, and the differential pressure across the slab and block wall became slightly negative. During the school week (days 158-163), both the HVAC system and subslab suction system were operating, and radon levels remained low. During the following weekend (days 164 and 165), the subslab suction system was operated and the first floor HVAC system was off, resulting in an increase in radon levels. As seen in Figure 3, radon levels on the first floor reached 40 pCi/L under these conditions, so another suction point was installed on the first floor using a Kanaflakt T-3B fan (rated at 310 cfm at 0.75 in. static pressure) and a 3 ft diameter suction hole. The first floor suction point was located on the west end of the building because radon levels were always higher there than on the east end. Subslab radon measurements also showed greater source strength on the west end. Addition of this suction point reduced levels on the first floor although radon levels on both floors still rose above 10 pCi/L at night with the air handlers off.

Figure 3. Influence of HVAC Operation and Single Point Subslab Depressurization on Radon Levels and Pressure (Case Study B).

Pressure field extension measurements indicated incomplete coverage of both floors. Consequently, two additional suction holes were installed in the basement, each with a T-2 fan and a 1 ft diameter suction hole. A 1 ft diameter suction point was also installed on the first floor and manifolded to the existing suction point.

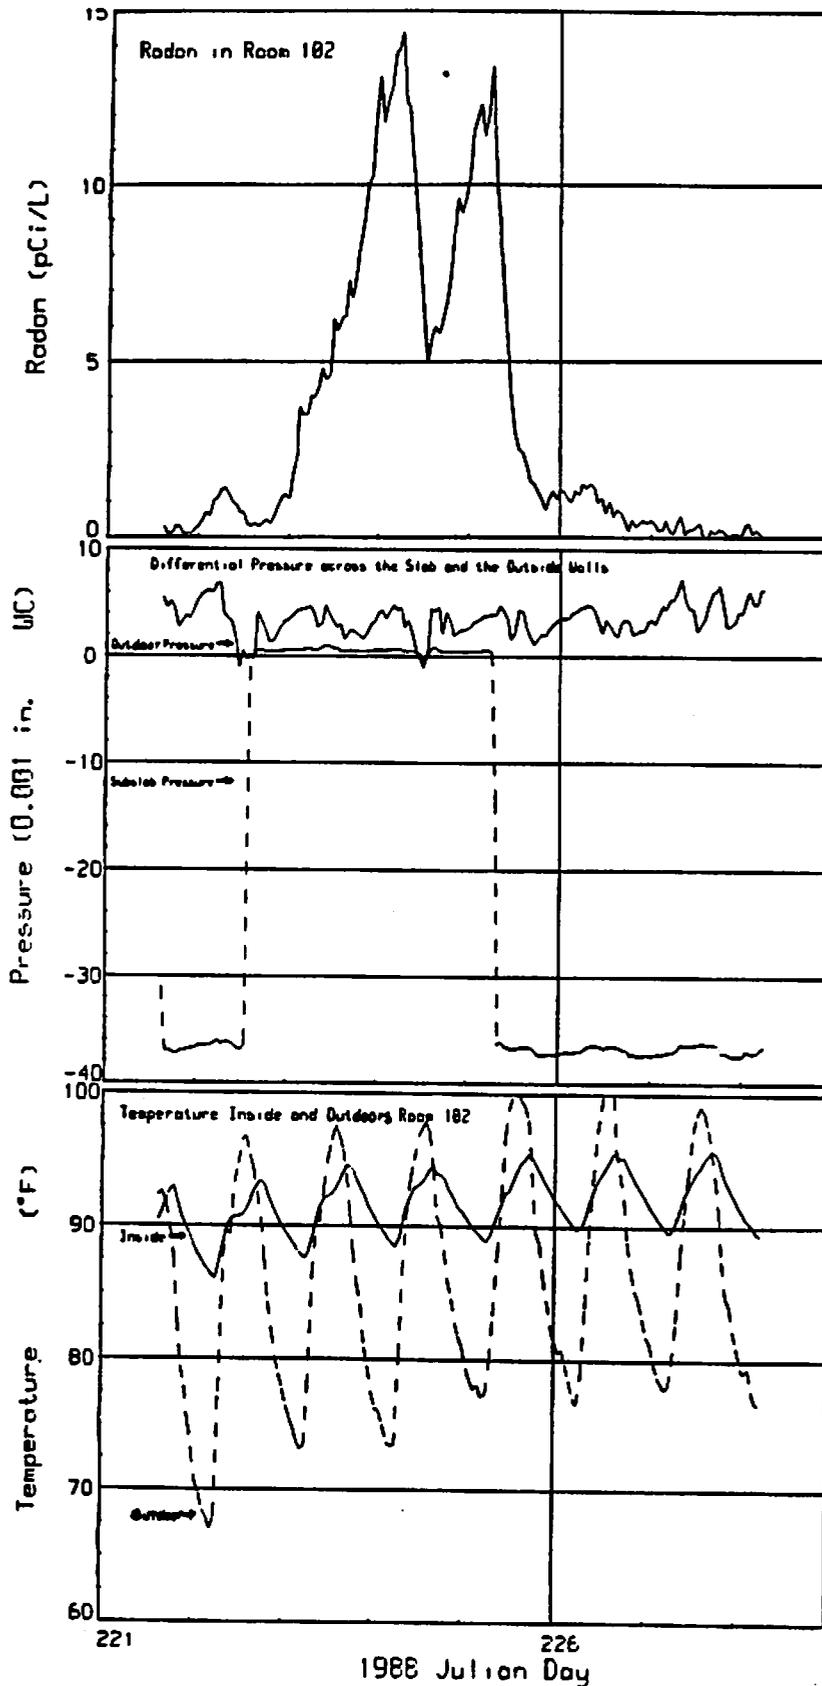
To analyze the effectiveness of a single point subslab suction system and to investigate the pressures that control radon levels in schools during hot weather, radon, pressure, and temperature were monitored continuously in one classroom, as seen in Figure 4. The classrooms were kept closed during this period of very hot weather, and there is no ventilation system in this building. When the subslab ventilation system was turned off from day 222 through day 225, the radon levels quickly rose and followed a diurnal cycle that seems to match the temperature cycle. When the outdoor temperature is coolest relative to indoor temperature, the radon levels are highest. This can be expected from the stack effect, as discussed in Case Study B. Although a small positive pressure was measured across the slab during this period, it does not show significant diurnal variation. The differential pressure across an outside classroom wall does not show much correlation with the radon levels, except for a sharp dip in the middle of day 224 that may be due to wind.

Figure 4. Effect of Single Point Subslab Depressurization on Radon Levels (Case Study D).
