PRESSURE FIELD EXTENSION USING A PRESSURE WASHER**NEW JERSEY DEPE SPONSORED PROJECT
INNOVATIVE MITIGATION RESEARCH AWARDS**

Bill Brodhead
WPB Enterprises, Inc.
Riegelsville, PA

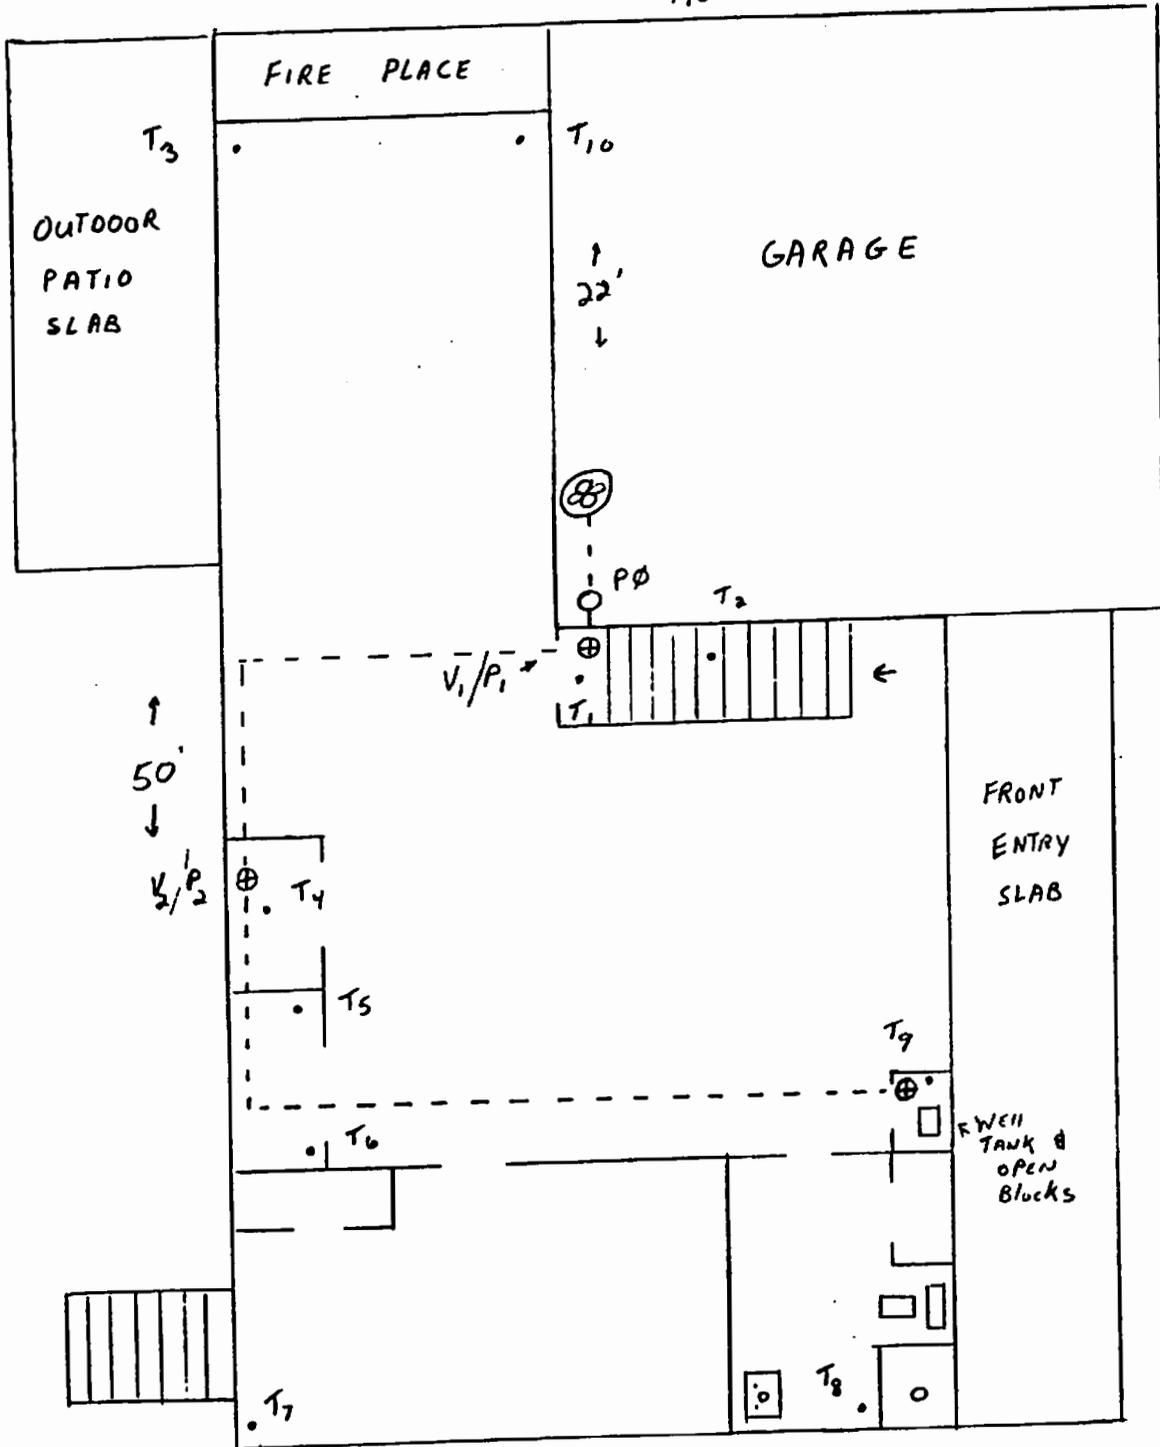
HOUSE - WT3

Ten new test holes, 5/16" in diameter, were drilled around the perimeter of the basement. The slab was approximately six inches thick. After all test holes were drilled they were vacuumed to remove concrete dust. No sub-floor radon measurements were made. Refer to accompanying drawing for test hole locations.
