## WASHINGTON STATE PASSIVE STACK STUDY

Jan E. Fay and Ray Tekverk  
Faytek Incorporated  
Coeur d'Alene, ID

Thomas J. Gerard  
Thomas J. Gerard & Associates, Inc.  
Spokane, WA

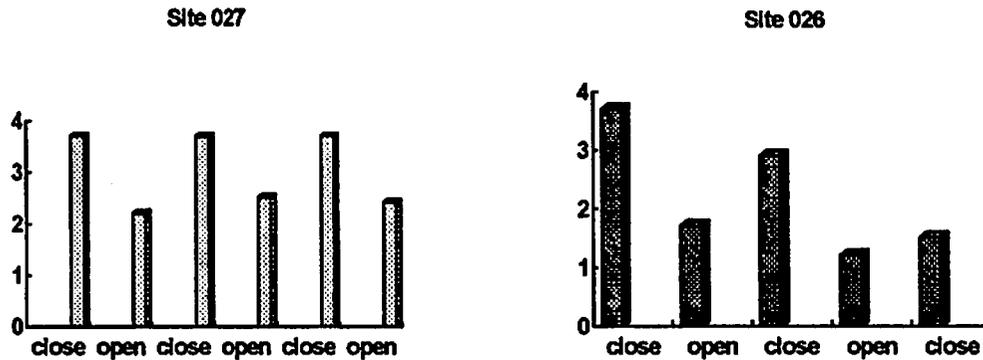
Below are two examples of houses where the variations in radon levels under alternating stack conditions appear to be significant. Radon levels are graphed in picoCuries/Liter, and the stack condition (opened or closed) is noted on each measurement.

While lower radon levels under open stack conditions were observed in quite a few of the early test houses, in many of the cases the fluctuations were either so small that they are not conclusive, or the number of test rounds to date is small enough that statements on performance would be premature.
