COMPLEX RADON MITIGATION OF A LARGE BUILDING

David Wilson, Oak Ridge National Laboratory, Oak Ridge, Tennessee, USA

Stanley Ng, Pacific Division, Naval Facilities Engineering Command, Pearl Harbor, Hawaii, USA

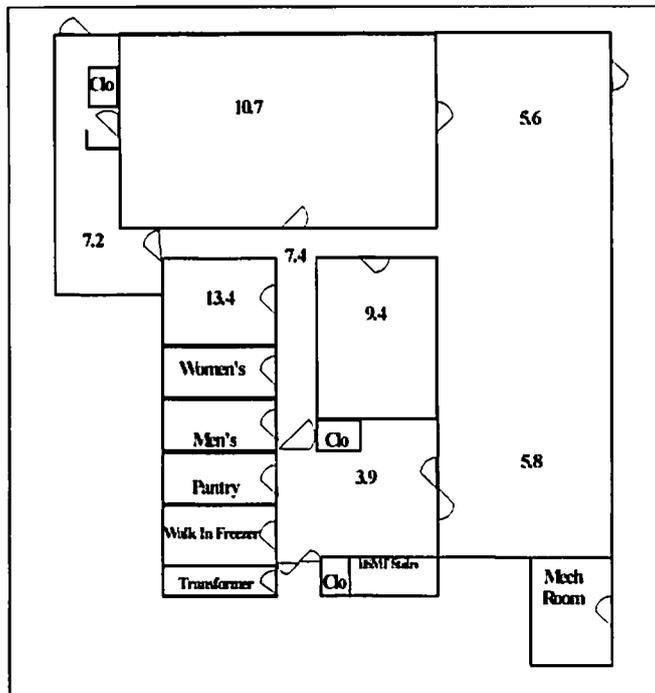
Figure 2. Long-term radon results in pCi/L

During 1997 to 1998, long-term radon testing using alpha-track detectors was performed within all routinely occupied rooms. Of the seven rooms tested, six were determined to have elevated radon levels, ranging from 5.6 pCi/L to 13.4 pCi/L (Figure 2). In 1999, short-term follow-up testing (electret) was repeated in the seven rooms, the basement, and both bathrooms. These

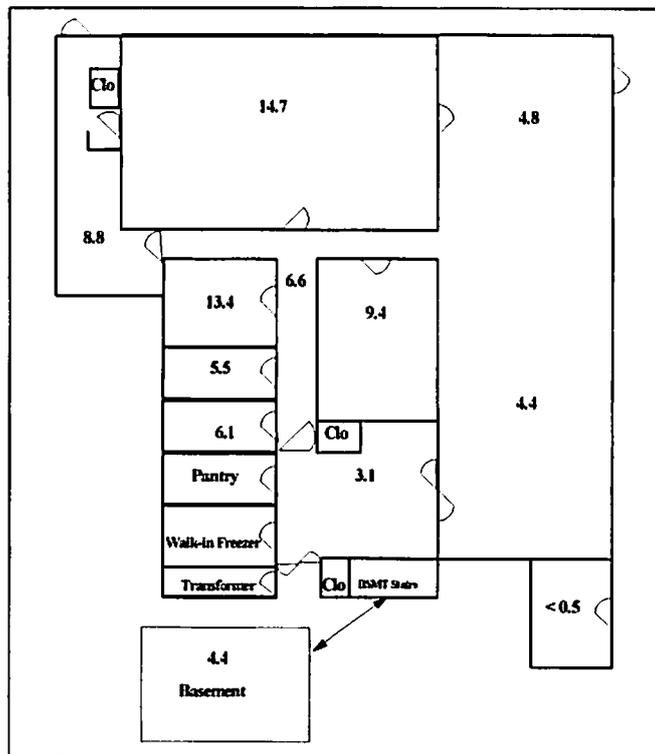
Figure 3. Short-term radon results in pCi/L

follow-up tests confirmed the original long-term test data and identified three additional rooms for radon mitigation (Figure 3).

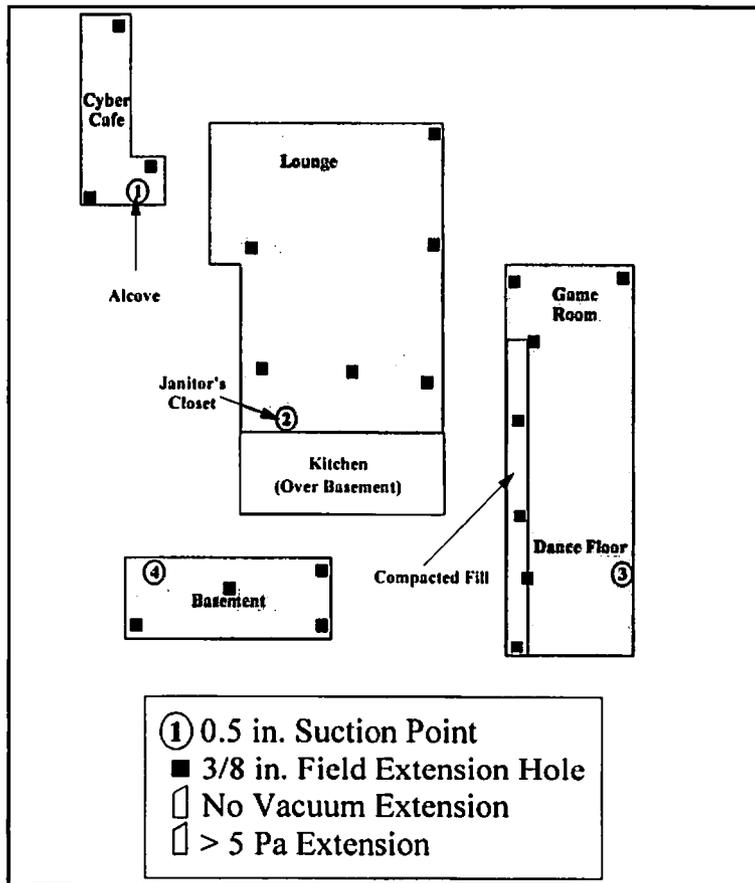
Figure 5. Subslab field extension

Because of the renovation history of the building, subslab diagnostics were performed on each of the three slab-on-grade subslabs and the basement slab to determine if active soil depressurization (ASD) was feasible (Figure 5). Field extension data collected with the air conditioning turned on and no exhaust systems operating [(-) 5 Pa] determined that a three-fan, three-suction point system (Figures 6, 7, 8, and 9) would cover 100% of the slab-on-grade subslabs. The diagnostics were then repeated at (-) 14 Pa (all exhaust systems except the grill), and the coverage dropped to about 60%. Coverage with all exhausts systems turned on [(-) 80 Pa] dropped subslab coverage to an average of <5%. With the marginal coverage at (-) 14 Pa for the slab-on-grade subslabs, it was estimated that three additional suction points would be needed. Two of these additional penetrations would be located on the exterior of the building and would not cause a problem. However, because of the usage of space and the mostly open floor plan, one of the suction points would need to be near the middle of the dance floor. Therefore, this option was discounted as well.

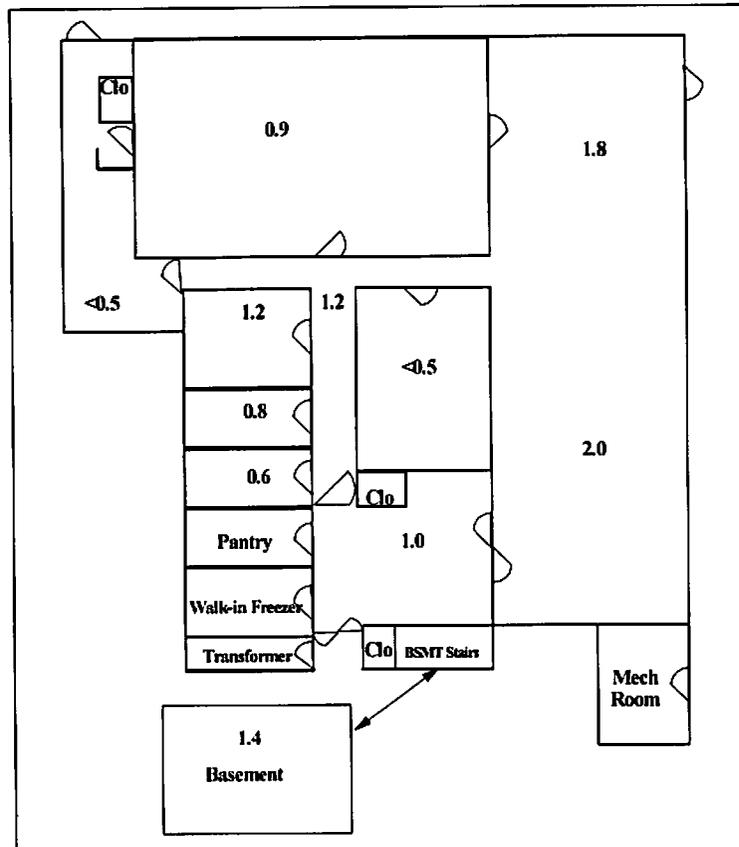
Figure 13. Postmitigation results in pCi/L

Postmitigation testing of the building with the passive kitchen louvers open, all three ASD systems operational, and the 5-ton supplemental makeup air system (800 CFM) operational found that radon levels within the building had dropped significantly (Figure 13). As an added benefit, the changes made to the building (e.g., passive louvers and the added cooling) significantly improved the overall comfort factor of the building. For one, these improvements eliminated the need to preload cool the building prior to opening. Second, condensation problems within various rooms of the building were eliminated. Third, for the first time, the two preexisting mechanical systems in the building actually achieved the desired thermostat setting and cycled off, meaning potentially lower energy and maintenance costs.

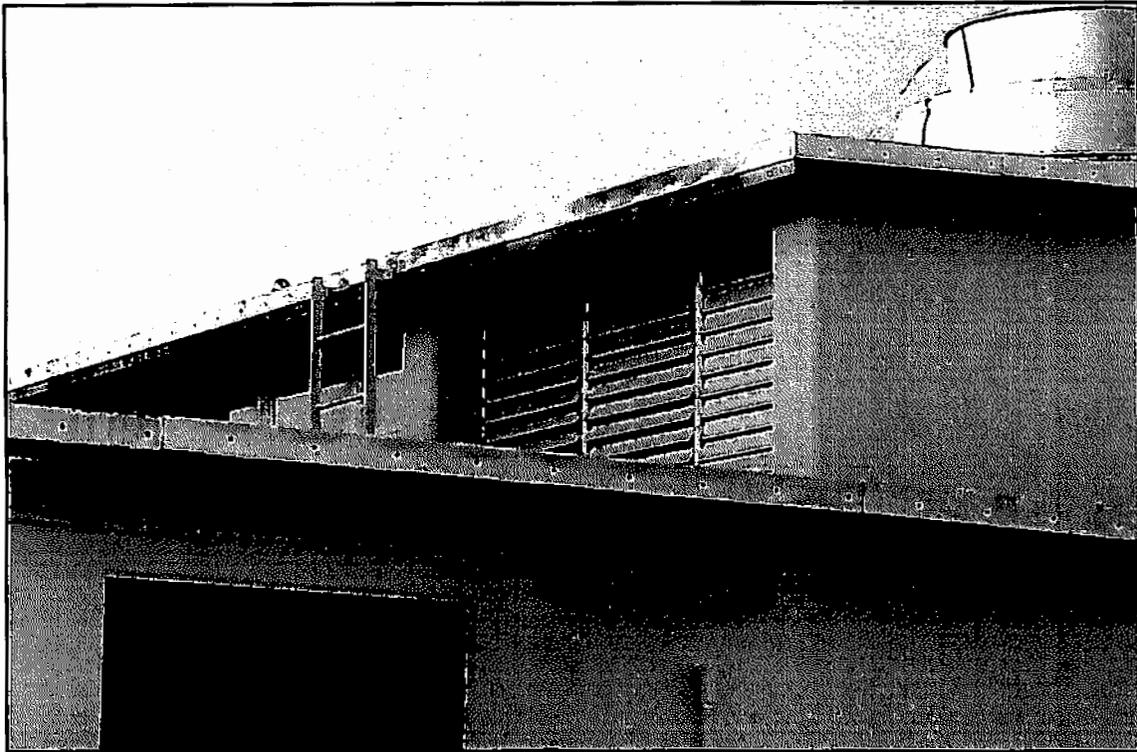
Picture 1. Installed louvers in the kitchen

Because the 10,000-CFM grill air-exhaust system was the largest single reason for the negative pressure in the building, it was examined first. The grill exhaust was installed in the late 1980s, and during installation, no allowances were provided for makeup air. The only source of makeup air for the kitchen was a wall/ceiling-mounted intake fan of about 500-CFM capacity. It is worth noting that the pressure differential in the room was so great that the small intake fan actually performed better when turned off and allowed to windmill (700 CFM). Because of code changes (fire and public health) since the kitchen was installed, modification of the grill exhaust system to incorporate fresh-air makeup would have required replacement of the entire fire suppression system, grill, exhaust hood, and exhaust blower and potentially a rework of the entire kitchen orientation (e.g., sink location and fire exits). Excluding the loss of revenue from food sales during down time for remodeling, the rework would have cost over \$60,000. However, because the kitchen was unconditioned, the problem with providing makeup air for the room could potentially be solved by installing a larger makeup air fan or by installing screened louvered windows.

At the conclusion of the diagnostics, it was realized that the obvious mitigation solutions were either too expensive (e.g., reworking the building's mechanical systems) or impractical (e.g., installing a suction pipe in the middle of the dance floor). Therefore, a combination approach using a multidiscipline team (radon mitigators and mechanical engineers) was adopted to address each of the problems. The first problem was how to neutralize the 10,000-CFM exhaust blower in the kitchen. Option 1 was to replace the currently inadequate 500-CFM intake fan with a suitable-size intake blower. The problem with this approach was where to deposit the 10,000 CFM of makeup air without creating a wind tunnel in the kitchen. Each proposed orientation of the ductwork would have resulted in air velocity problems for the workers in the room and may have caused problems with the kitchen exhaust. However, shell pressure diagnostics performed in the kitchen with the grill exhaust turned on found that about 30 ft² of outdoor leakage was needed to passively equalize the pressure in the room. Twelve feet above the kitchen floor and, most importantly, away from the direct line of the main work area were three windows with a combined 36 ft² of opening. Removal and replacement of these windows with screened, adjustable louvered windows lowered the building DP to (-) 14 Pa (Picture 1).
