LONG-TERM RELIABILITY OF COLLATERAL MITIGATION

ABSTRACT

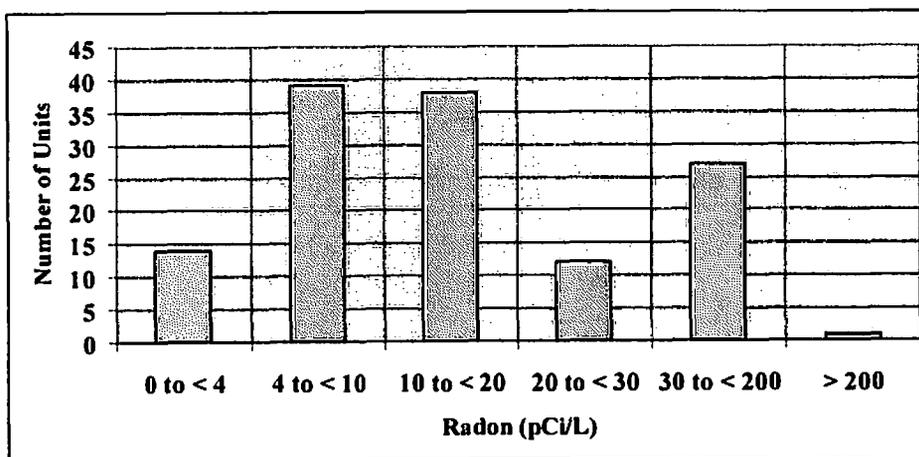
During 1995 to 1996, long-term radon measurements were made using alpha track detectors. Of the 130 units tested, 117 (89%) were identified as having elevated radon levels, ranging from 4.0 pCi/L to 370.7 pCi/L (Figure 7).

Figure 7. Complex Q radon distribution.

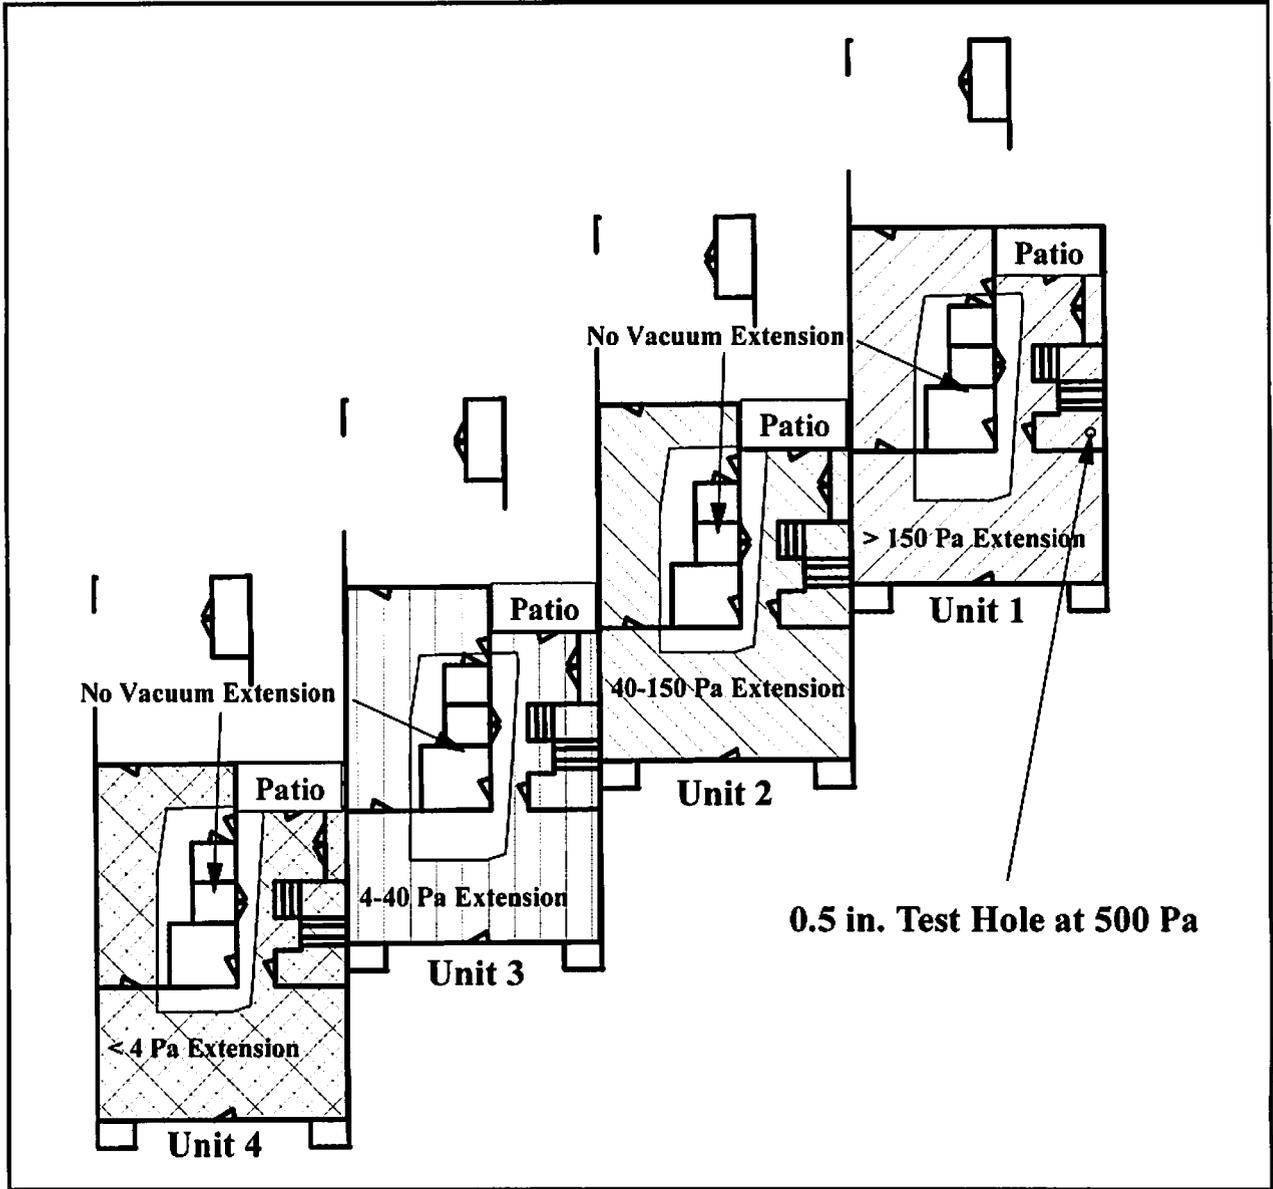
Because the LFE was so high along the perimeter, additional 3/8-in. test holes were placed in adjacent units to determine the full extent of the vacuum field. For fourplex buildings, the vacuum was found to extend about 60 ft, providing vacuum coverage for two additional units (Figure 10). For sixplex buildings, a grade beam between units 2 and 3 (Figure 11) prevented the vacuum from extending under the footings into the next unit (unit 3). However, if the field extension test was repeated in unit 6, the LFE was found to extend 60 ft, as in the fourplex, and to cover two additional units (units 4 and 5). As was observed in the initial test unit (Figure 9), all units had a trapezoid area along the center of the unit with no communication. Excavations in the other three test units found the identical compacted coral conditions. The placement of the suction point within interior units (e.g., units 2 or 3) (Figure 10) to enhance the vacuum field was also examined. However, the LFE extended only into the immediately adjacent units; no combination was found to extend the vacuum into all four units of the building.

Figure 10. LFE extension in fourplex buildings

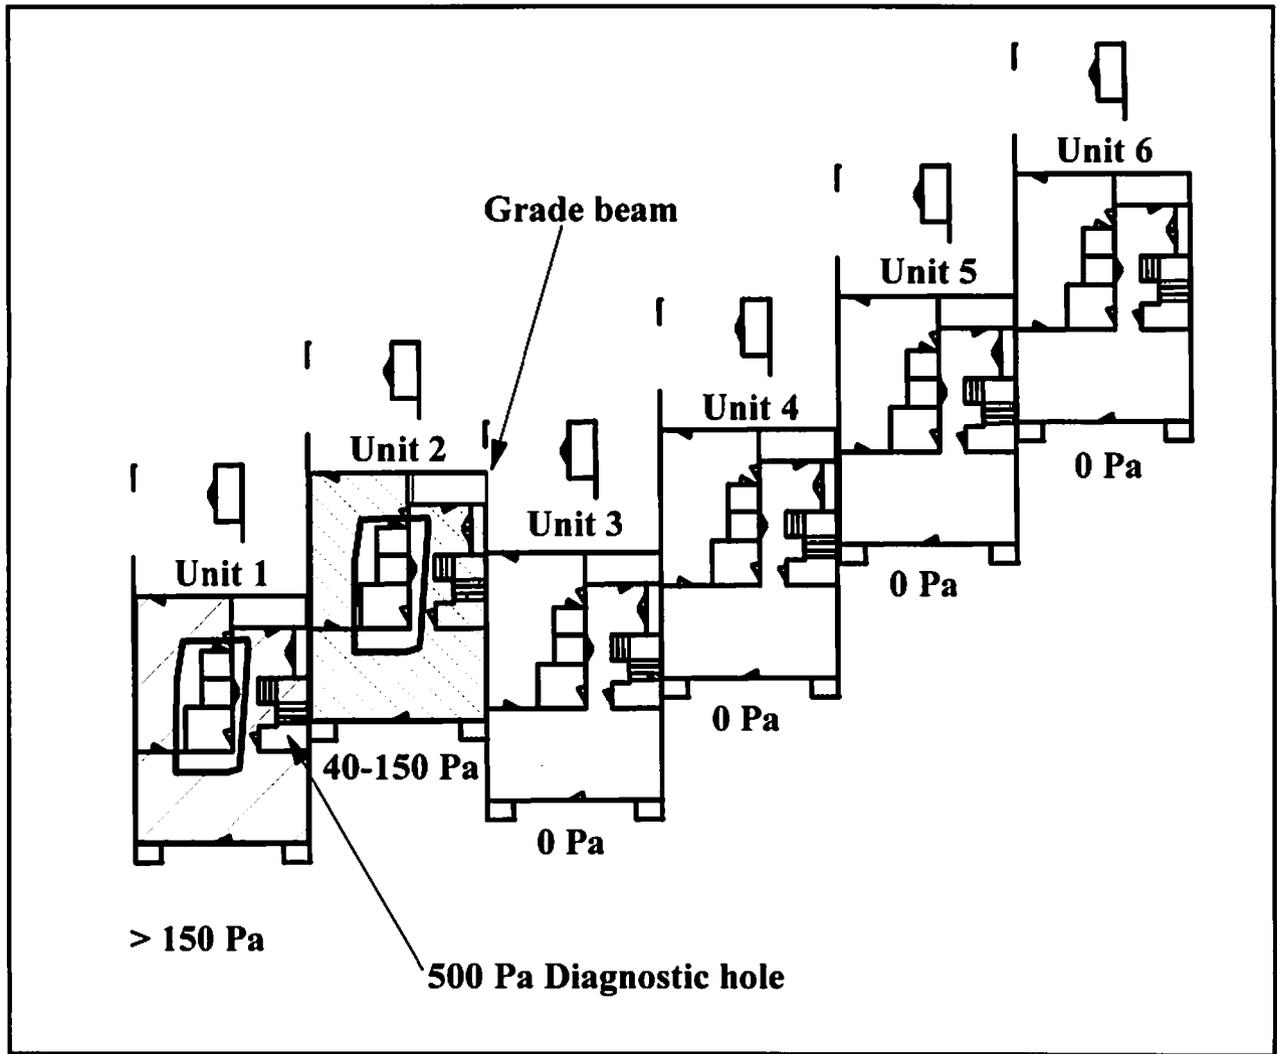
Figure 11. LFE in sixplex units

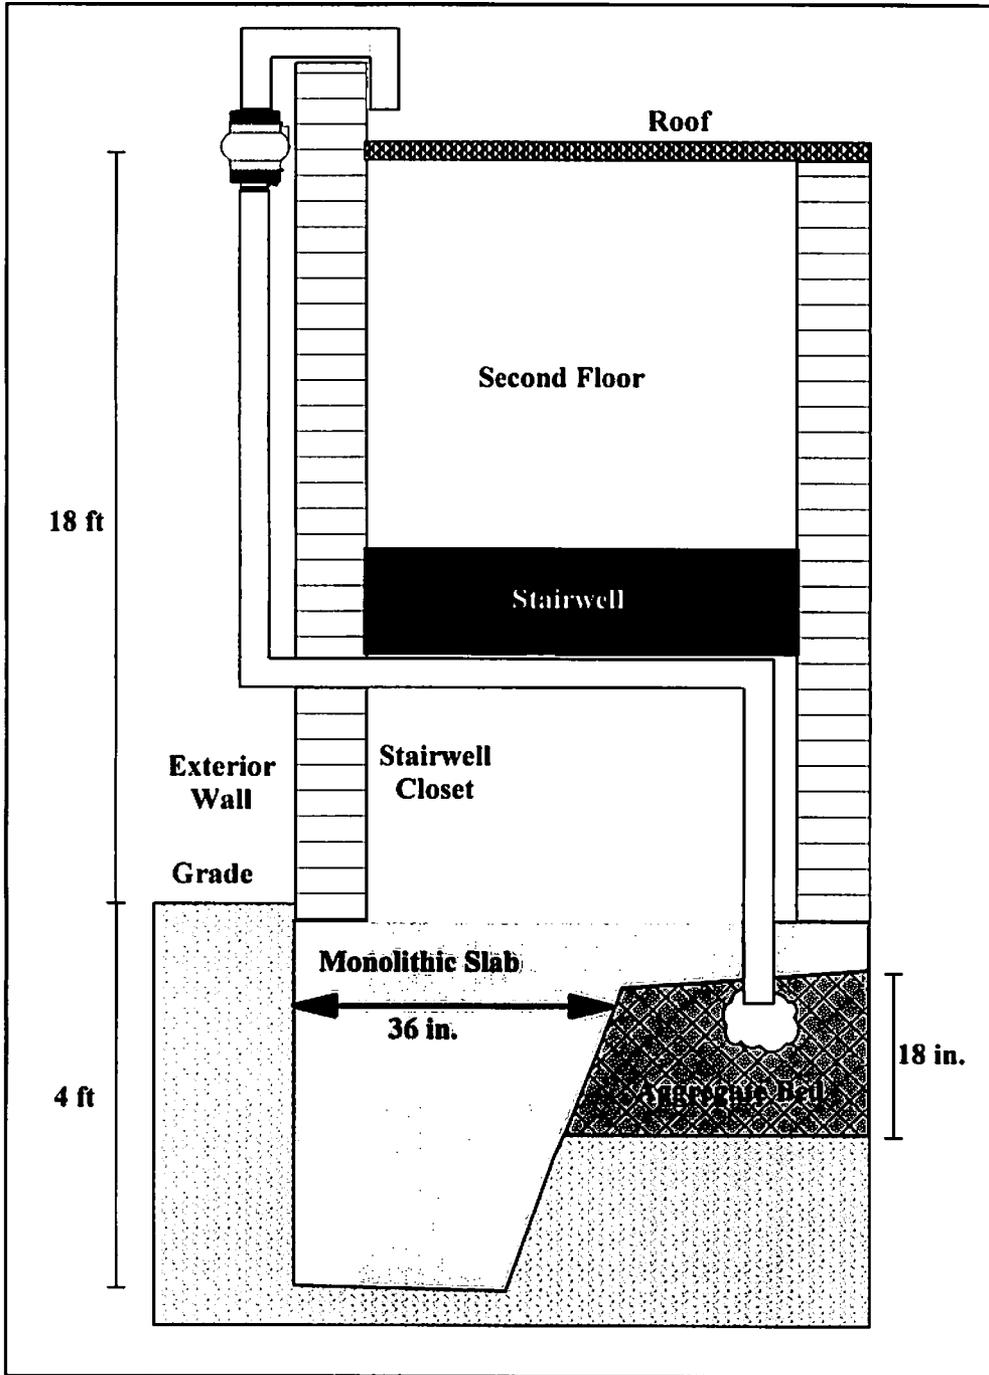
With respect to mitigation design, it was determined that a single suction point located in the stairwell closet (Figure 6) addressed all of the key customer concerns (e.g. aesthetics, loss of functional space, uniformity, etc.) about mitigation (Figure 12). An interior penetration was selected because diagnostics had found that the monolithic slab was about 36–40 in. thick at the point of side coring into the aggregate bed. With respect to fan selection, the diagnostics determined that to mitigate a single unit, the projected vacuum at the suction point would need to be around 250 Pa. However, in anticipation of CM, a larger fan capable of at least 500 Pa was selected and installed.

Figure 12. Mitigation design

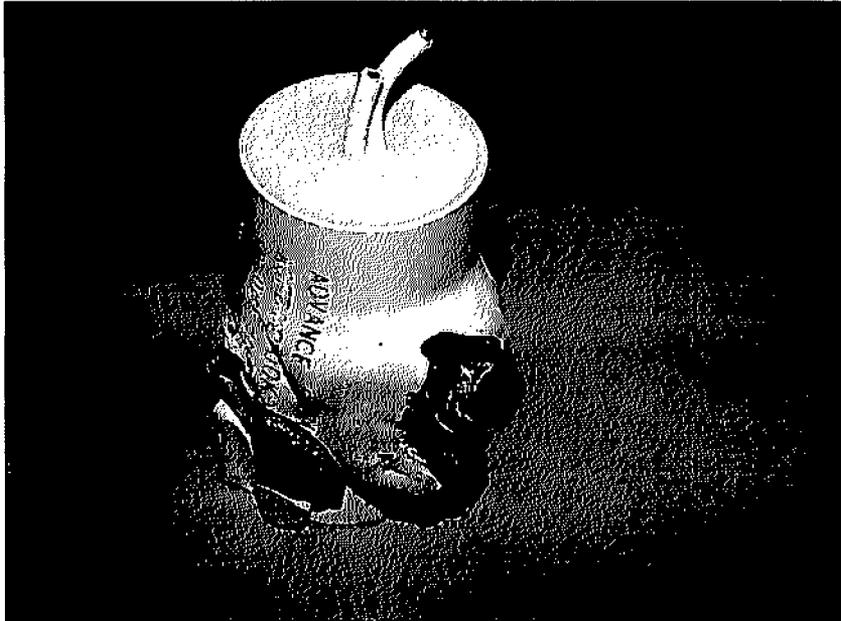
1. Two fans had been hit by something that had destroyed the fan housing, such as during a typhoon.
2. Six of the fans had suffered catastrophic capacitor failure (Picture 2).
3. Upon disassembly, four fans were found to contain bearings that showed excessive wear, resulting in fan lock-up.

After the blown capacitors were replaced and the fans reactivated, a noticeable vibration was observed. Flow measurements in the pipe found that the flow was 20–25% lower than when initially installed. Examination of the bearings found excessive wear when compared with a fan that had been procured at the same time but not installed. All eight fans with reduced capacity were observed to have increased vibration relative to the other nonsuspected fans. Three of these fans were selected at random and disassembled; again, excessive wearing of the bearings was identified as the cause. Using manufacturing dates found inside the 18 fans failed and suspected fans, it was determined that all were manufactured within a three-month period. Examination of the manufacturing date for the remaining 29 fans that were operating properly found that they were manufactured before or after this period. To remedy the situation, ORNL replaced all 18 fans with equivalent fans from a different manufacturer and retested the 24 units. All were found to again be < 4 pCi/L. In addition, LFE measurements performed in four of the CM units were similar to the 1998 measurements. As an added precautionary measure, LFE was also remeasured within eight units that were **not** noted as having fan problems. All of the LFE measurements were within $\pm 1\%$ of the post-installation value. One year later (summer 2001), the LFE was also rechecked within these eight units and four of the units whose fans had been replaced. Again, all of the LFE measurements were within $\pm 1\%$ of the post-installation value. A retest (short-term electret) of radon levels in these 12 CM units during 2001 found all still below 4 pCi/L.

Picture 2. Typical blown capacitor
