EFFECT OF SUB-SLAB PRESSURIZATION ON INDOOR BASEMENT TEMPERATURE AND RELATIVE HUMIDITY

Calvin Murphy
Allied Radon Services, Inc
18245 E IL Highway 15
Mt Vernon, IL 62864
calvin@alliedradon.com

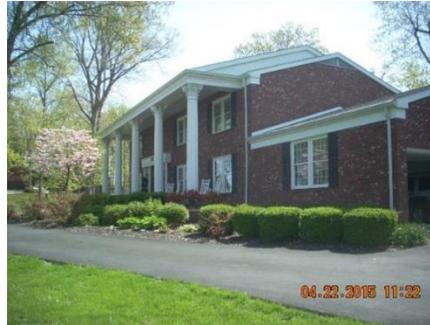
The house which is the subject of this paper is one that would be considered to be a very normal mitigation project. The house is approximately 30 years old. It is a two-story brick veneer frame house with a poured basement that is 75% finished. There is a sump pump that has been added after construction with a bolted down cover; a slab on grade Sun Room on the rear of the house; an attached garage; and an in-ground pool in the back yard with brick pavers between the house and the pool. The house has a high efficiency furnace that did not have a source of exterior makeup air and was pulling makeup air from the basement. The basement has one exit door and no basement windows. The initial radon level was 6.7 pCi/L

Figure (1) Exterior Picture of house.

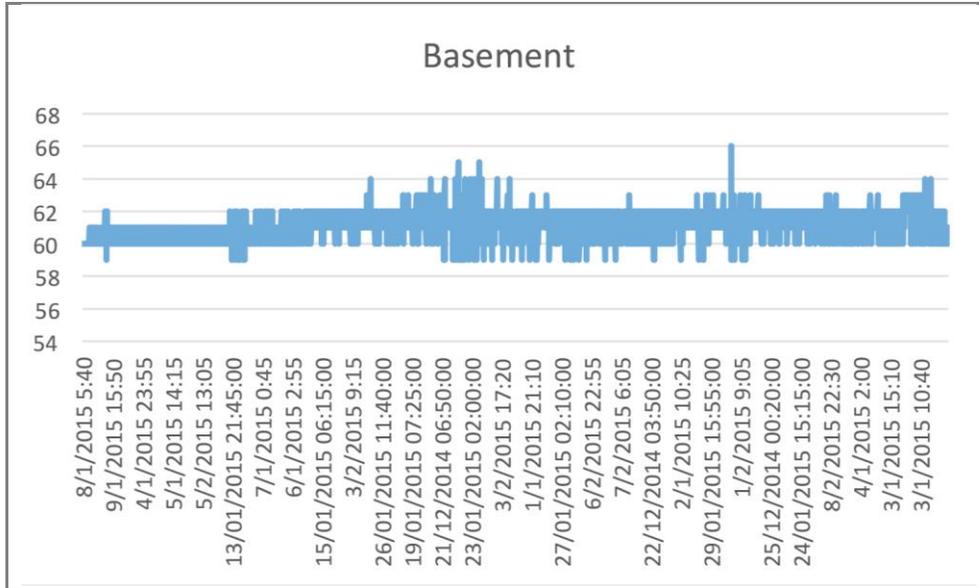
Figure (3) Basement Temperature

Pressurization did have some impact on basement temperature. While exterior temperatures ranged from a high of 63 F to a low of 5 F, basement temperatures ranged from a high of 66 F to a low of 59 F. Basement temperatures generally correlate to outside temperatures. It is felt that the closet data logger temperatures tended to be less than the other interior data logger readings because the data logger was located approximately 10 feet from the pressurization point versus approximately 20 feet for the other data logger. A graph of the basement temperature data is shown in Figure (3). Figure (4) displays the temperature comparisons of all data points.

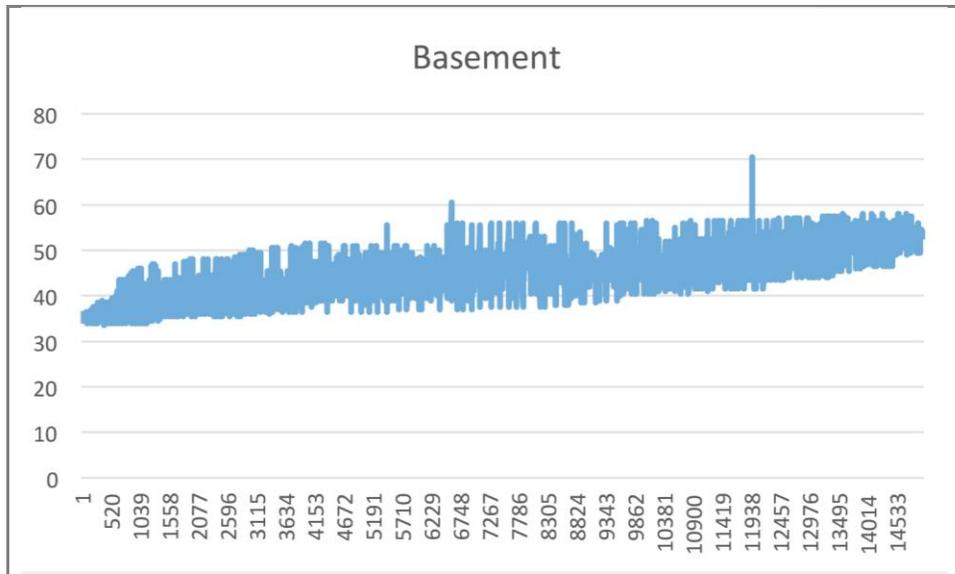
Figure (5) Basement humidity

Pressurization of the subslab had a definite impact on relative humidity levels in the basement. Initially, relative humidity levels were in the 35% range. By the end of the data collection period, relative humidity levels were consistently in the 55% range. A graph of basement % relative humidity is displayed in Figure (5).

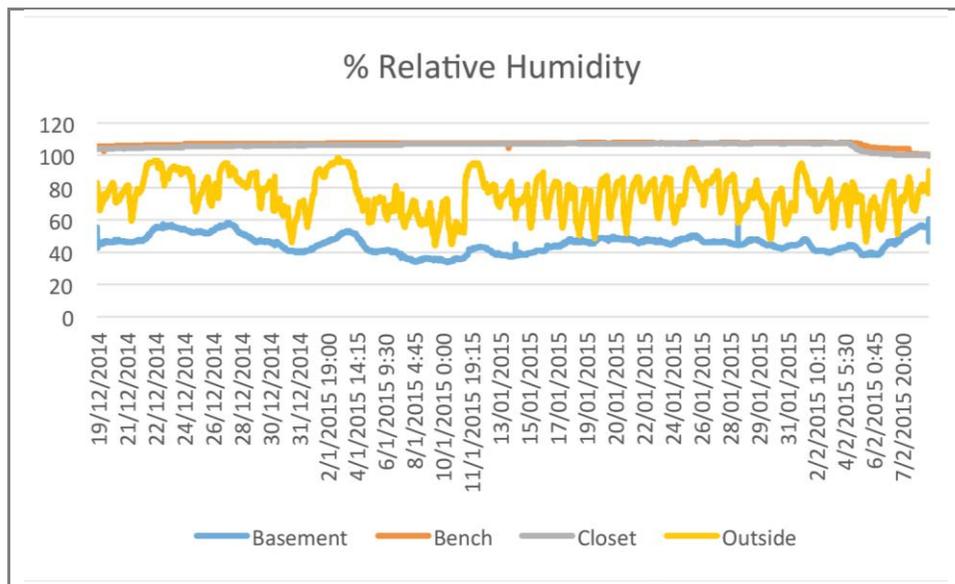
Figure (6) % Relative humidity

Mitigation systems utilizing subslab depressurization over time tend to decrease the humidity level beneath the slab. In the case of pressurizing the slab, the % relative humidity at both communication test holes consistently displayed 100%. For some reason, the data loggers recorded % relative humidity at the test holes in excess of 100%. A graph showing % relative humidity in the basement, at both test holes, and in the exterior atmosphere is shown in Figure (6).

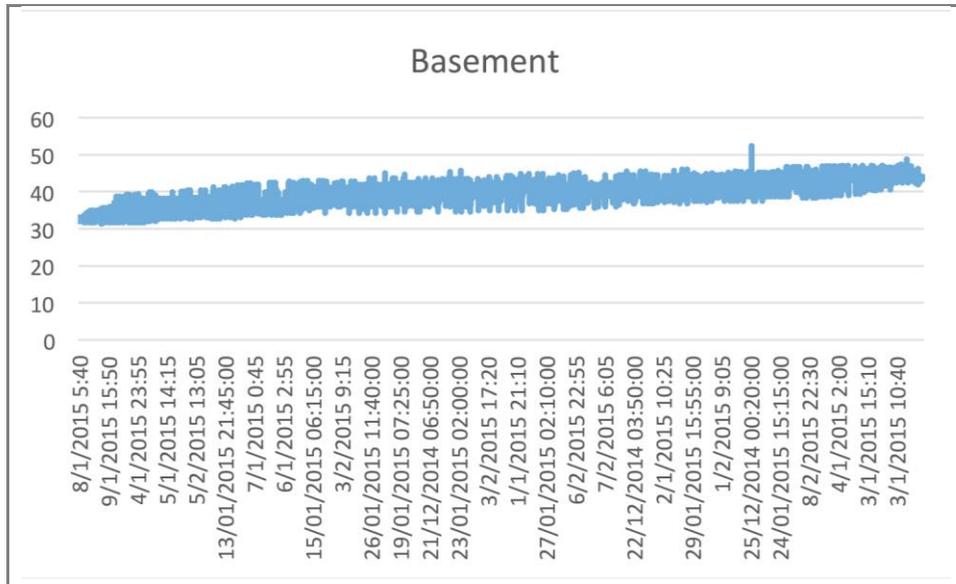
Figure (7) Basement Dew Point

The data loggers also calculated dew point. At the beginning of the data collection period, dew point in the basement was 32 degrees F. As % relative humidity rose during the collection

period, dew point increased to 43 degrees F. A display of basement dew point is displayed in Figure (7) and a comparison of basement, test holes and exterior dew points is shown in Figure (8).
