RADON DISCHARGE LOCATIONS THAT ARE SHOWN TO AFFECT INTERIOR RADON CONCENTRATIONS NEGATIVELY

Dr. Leo Moorman
Radon Home Measurement and Mitigation, Inc.
Fort Collins, CO
LMoorman1@aol.com

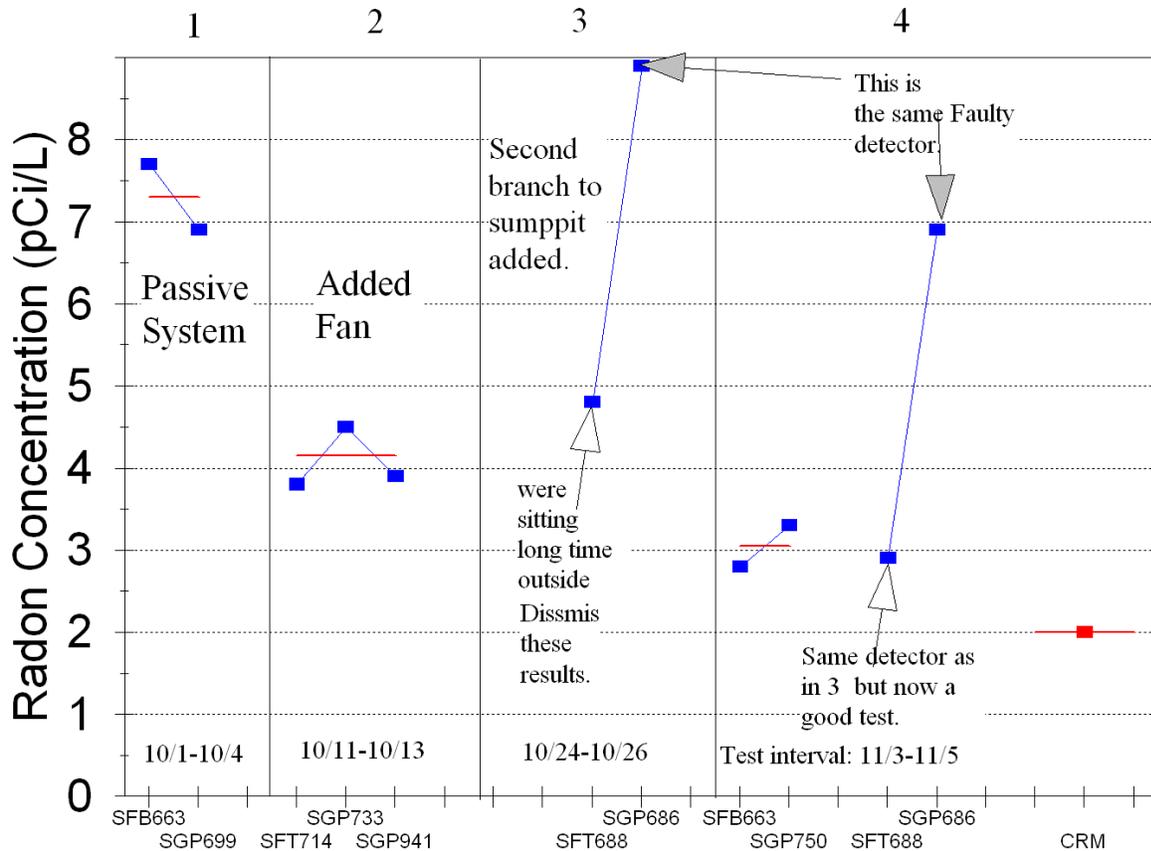
A simultaneous radon test with the passive mitigation system showed the house still had a high radon concentration in the basement after construction. During the activation of the system at the end of the year 2013 the single cavity of the system was relocated further towards the center in the unfinished basement slab near a furnace to achieve a better pressure field extension. The vent discharge was found to be through the roof over the one story utility area towards the main house and was located one foot below a soffit of the second story of the house, with an entry soffit vent register only one foot away from the vertical projection point of the pipe onto this soffit. An appropriate fan for the total friction of the system was added in the vertical pipe part in the attic. The sump pit through the slab was sealed with a transparent cover, and all expansion joints, grooves and cracks in the slab were sealed with an appropriate caulk. Subsequent short term simultaneous testing with three radon test devices showed that the described system decreased the radon concentration, but not below 4.0 pCi/L, as shown in the second window in Figure (1).

In an attempt to improve the system a side branch of two inches diameter with a ball valve (to be able to vary the flow through the side branch) was installed to take some of the air from a sump pit that was connected to an exterior drain pipe. A second set of two simultaneous tests were completed, whose results are shown in the third window insert of Figure (1). The test results were inconclusive, and since the post mitigation short term integrating E-PERM¹ test devices were left with the home occupant, and the test had been outside for a while before they had been picked up, another set of tests was proposed for confirmation. This time two independent test devices were used, a continuous radon monitor CRM510², and as a quality control check, it was decided to set up the same two tests that were used in the previous testing as well. Including the CRM device therefore five test devices were set up simultaneously. The results are shown in the fourth window of Figure (1). Four tests including the CRM showed levels below 4.0 pCi/L and one test was again high, close to 7 pCi/L. In addition, the CRM had more variability than is usually seen after a successful mitigation. On inspection the test that was high was the test device with the same serial number as the test that had been high during the earlier testing. Thus it was decided to send this device to the manufacturer for further investigation. Nevertheless, from a practical point of view the problem seemed to be solved since both independent E-PERM tests during this last test period SFB663, SGP705 and the CRM had shown comparable low average results in the basement (as well as the detector SFT688) as is shown in the fourth window of Figure (1).

However, when the manufacturer returned the test device it came with the message they had inspected and had found nothing wrong with the device, which was inconsistent with our experience in Figure (1). Nevertheless, because the RPD of our set of independent test devices passed our QA requirement the testing passed and it was recommended the home owner should test again in a year and thereafter every two years as is standard recommendation after each successful radon mitigation.

Figure (1). History of test results during the process of activation of House #1.

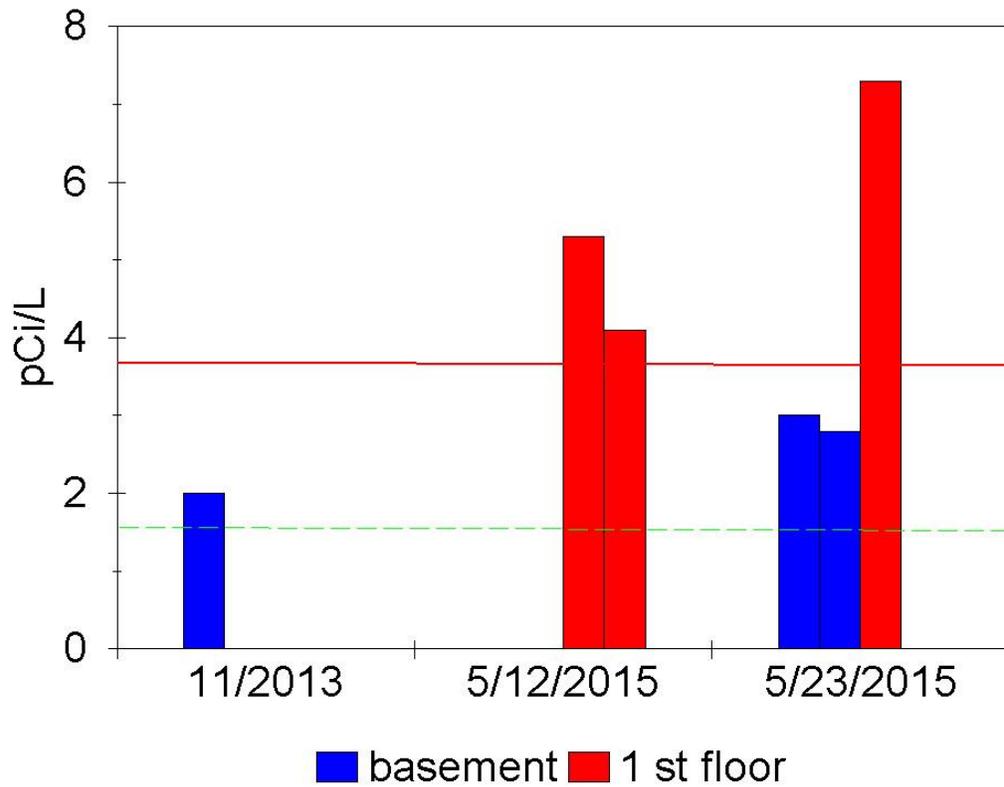
About one and a half years later the home owner had completed their own independent test with a simultaneous double test kit and reported to us that the radon concentration value seemed to be higher than 4.0 pCi/L as is shown in Figure (2) in May, 2015. This time they had tested the level on the first floor, which is what had been discussed with them before, since that is where they were mostly living. A confirming set of tests was done as shown in Figure (2) (last set in the histogram) and found consistent with the home owner's tests of high levels on the first floor as well, and still low radon concentrations in the basement. Figure (3) shows a sketch of the second story of the vertical south elevation of the house. The lower roof is joined perpendicular onto the main house at the level of the second floor bedroom. The garage roof is not drawn on the right side outside the boundary of this sketch. As shown, the vertical radon mitigation discharge pipe stack is located under the main building's second floor soffit.

Figure (2). Follow up tests 1.5 y later of (#1) that showed the radon concentration is high on the first floor.

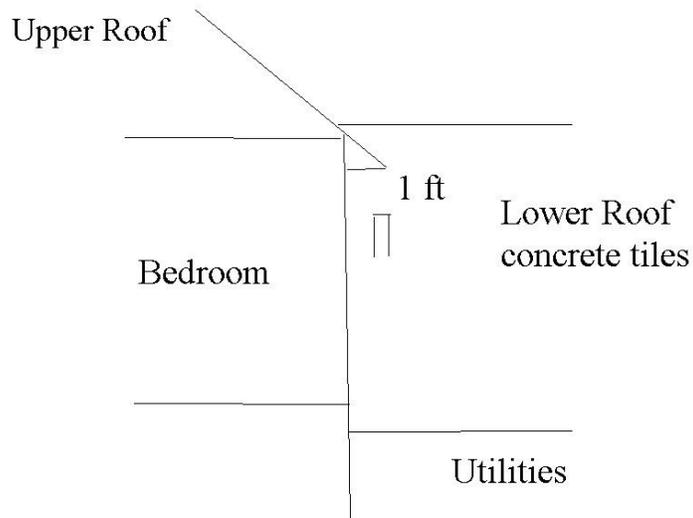
Figure (3). Sketch of vertical south elevation of the House # 1 with discharge pipe location of the passive system as installed during the construction of the house by others.

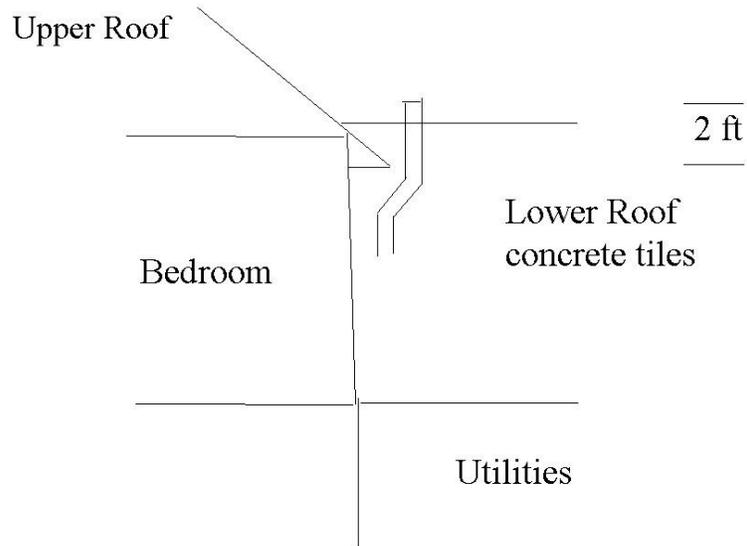
Figure (4): Sketch of same House #1 as in Figure (3), here with modified discharge.

One more verifying radon test was done in the bedroom on the second floor with the CRM that found that the radon level was indeed higher than 4 pCi/L as well. It was decided to immediately modify the exhaust pipe discharge to bypass the soffit with a pipe stack, including two pipe bends, while making sure the top of the discharge would be at least two feet above the nearest opening at the bottom of the soffit per standard requirement as shown in the sketch in Figure (4).

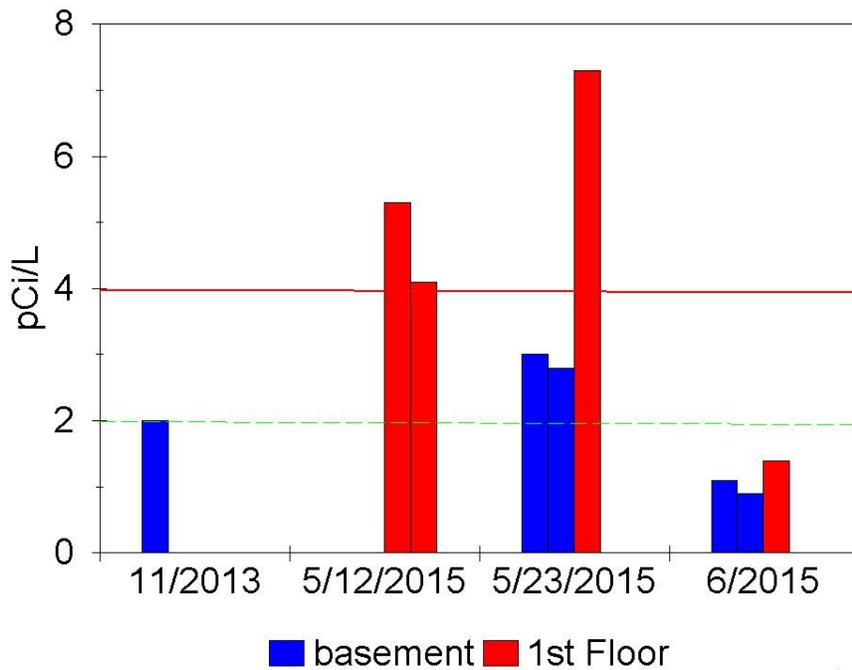
Figure (5). Test results showing high values measured by home owner and resolution after relocating the discharge point to two feet above the soffit vent.

The resulting radon test is for comparison added to the earlier test results and shown in Figure (5). The conclusion is that all radon tests on both first and second floor are now below 4.0 pCi/L and that the levels even in the basement have decreased, thus that the effect of soffit vent entry effected the whole house.

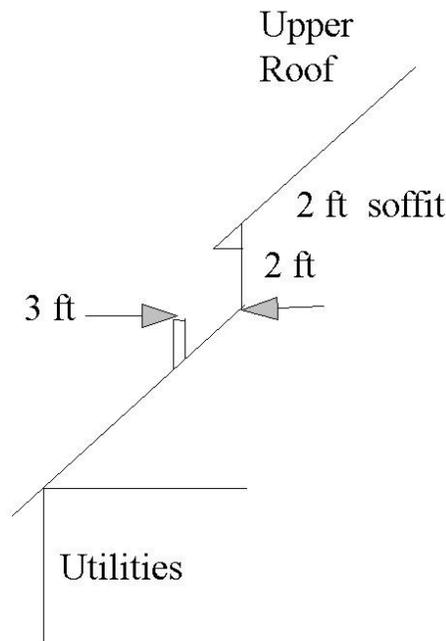
Figure (6). Sketch of discharge location with respect to main second story for House #2.

The vent discharge was found to be through the roof above the one story utility area towards the main house, three feet away from the second story exterior wall with bathroom on the side of the loft, and two feet below the soffit, as shown in Figure (6). The second story roof at that location has a soffit with vent line of openings. The fan was added in the vertical pipe part under the pipe penetration through the roof. Because the slab was finished in the basement, caulking of the slab could not be done except for a very limited area in the boiler room. Subsequent short term

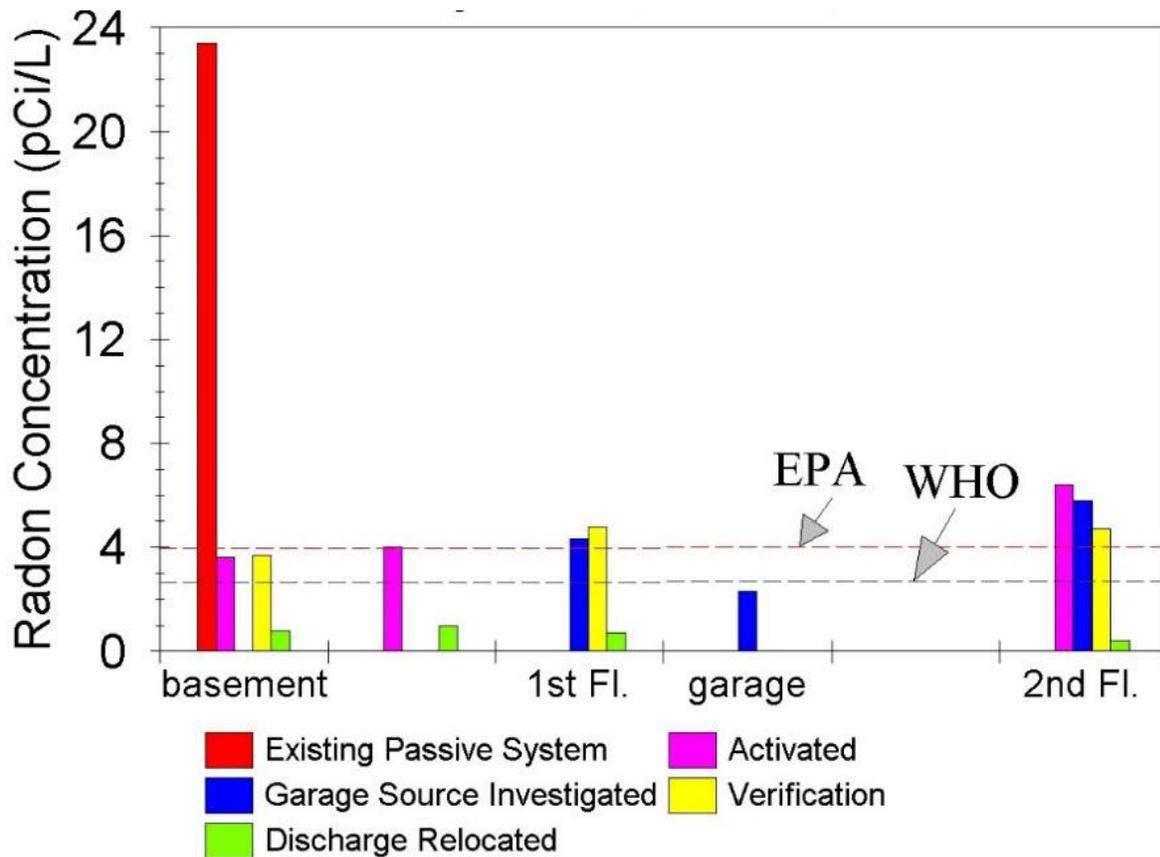
simultaneous testing with three E-PERM radon tests showed that this passive system decreased the radon concentration in the basement significantly as shown in Figure (7), but not below 4.0 pCi/L on the second floor in the bedroom located in the loft area next to where the fan was located. A suspicion of a possible entry pathway for radon from the garage into this area via the attic over the utility room prompted us to complete a second follow up test with simultaneous tested first floor, garage and second floor areas. As shown in Figure (7) the garage radon test result was lower than both other areas. This excluded the garage as the source for the high radon concentrations measured on second and first floor. Next, a third set of verifying radon tests comparing basement, first floor and second floor were done, yet again showing the same pattern with the higher values on first and second floor and a lower value in the basement. The existing discharge opening was capped off and the pipe routed to a new discharge location approximately 15 feet away from the main house on the other side of the ridge line of the garage, with the fan located in the attic of the garage immediately under the new discharge location. The four radon tests, two in basement, one on first floor and one inside the second floor loft at this point all measured radon concentrations below 2.0 pCi/L.

Figure (7). For House # 2, this shows the results of a sequence of radon measurements, each simultaneously done over various floor levels and garage, until resolution of the radon problem after the discharge was relocated.
