SUMMARY OF SOLUTIONS FOR 175 ACTIVE MITIGATION FAILURES

KEITH VOLSTED, FOUNDER/CEO

VSI RADON REDUCTION CORP.

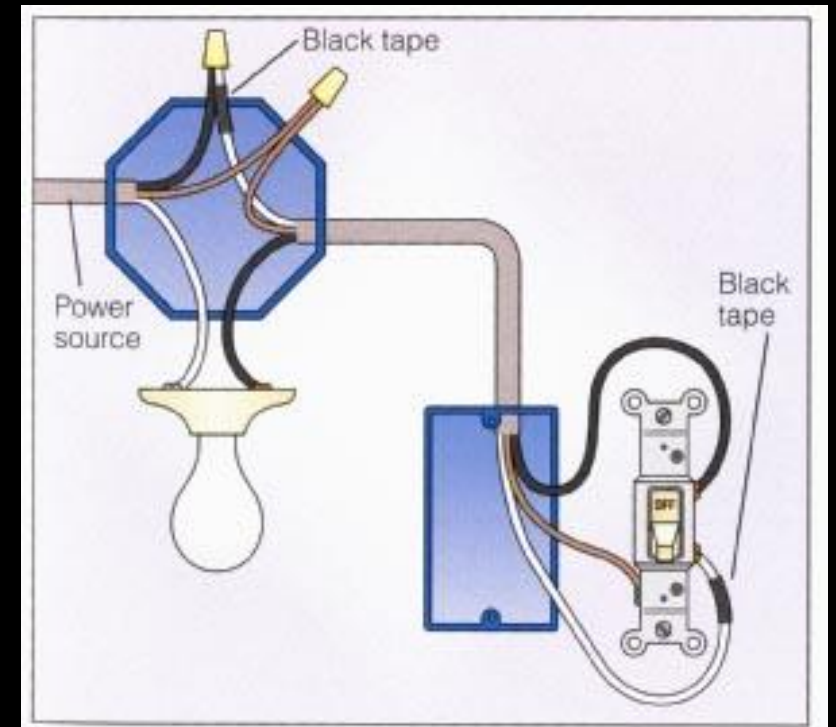
- 12 systems failed due to fan tied into a switched wire.

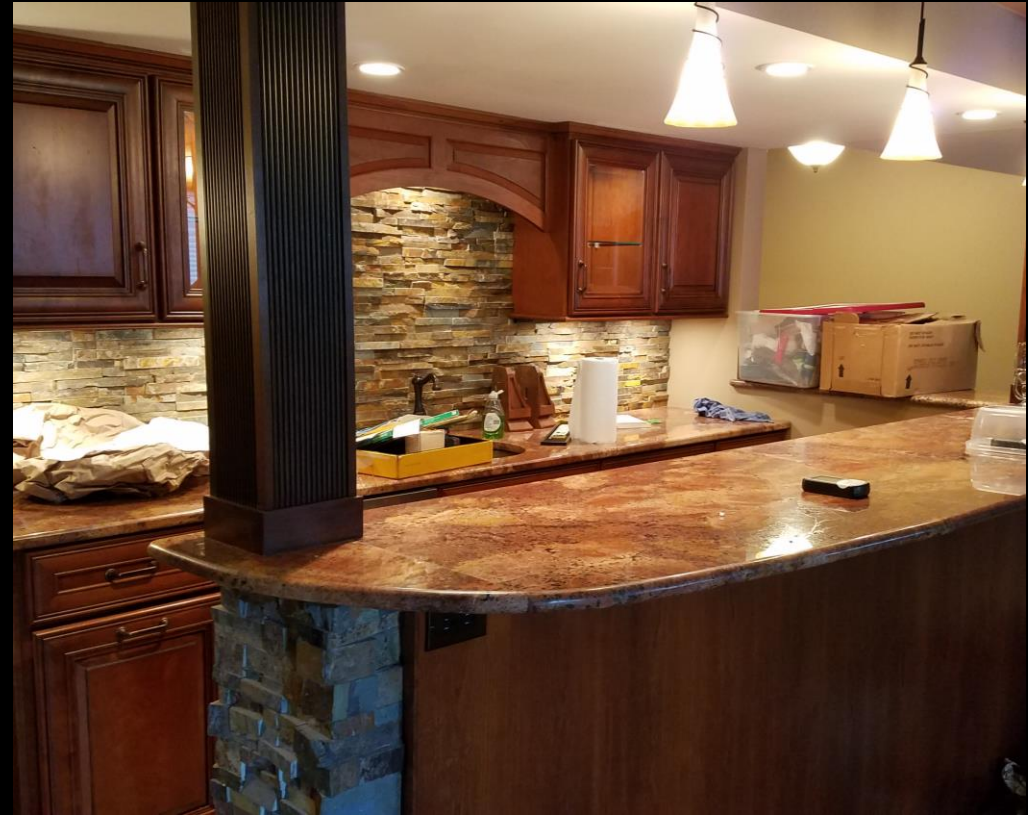
1- FAILED DUE TO A
GRANITE COUNTERTOP.

20.4 PCI/L ON COUNTER.

1.0 PCI/L – 3 FEET AWAY.

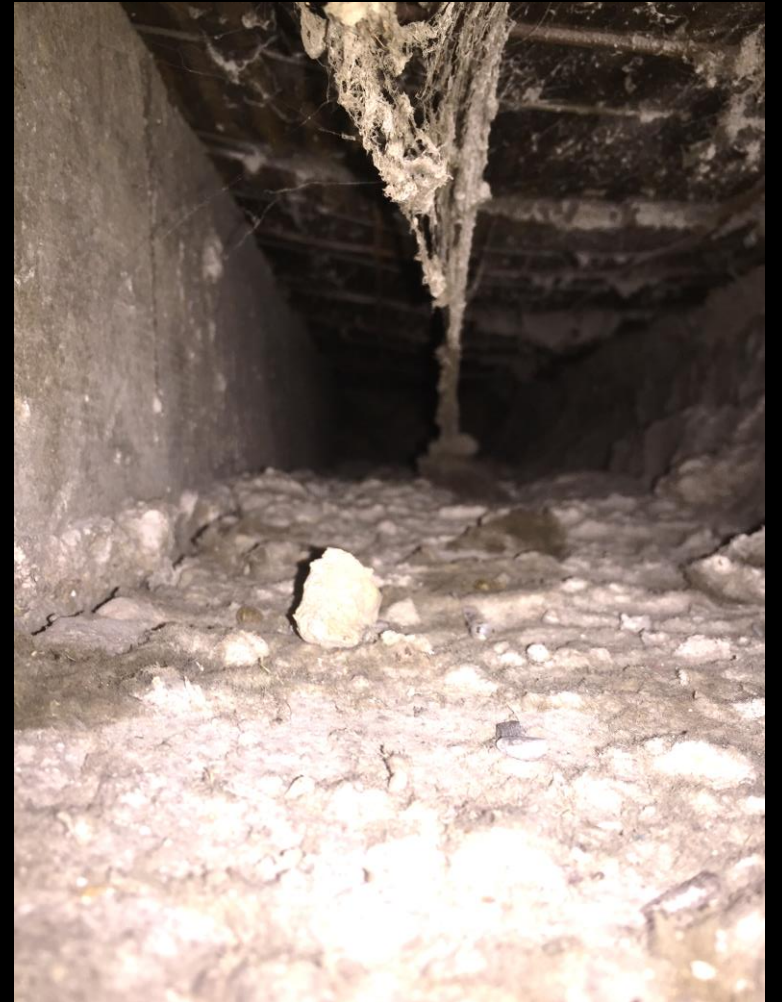
ONE-OFF

Proper inspection is important!
HVAC Returns below slab were missed
by initial inspector and installer.

Not sure if returns were sealed or
abandoned. Post test 0.1 pCi/L
