PRESENTATION OBJECTIVES

BVQ LOFTS CLEVELAND OHIO

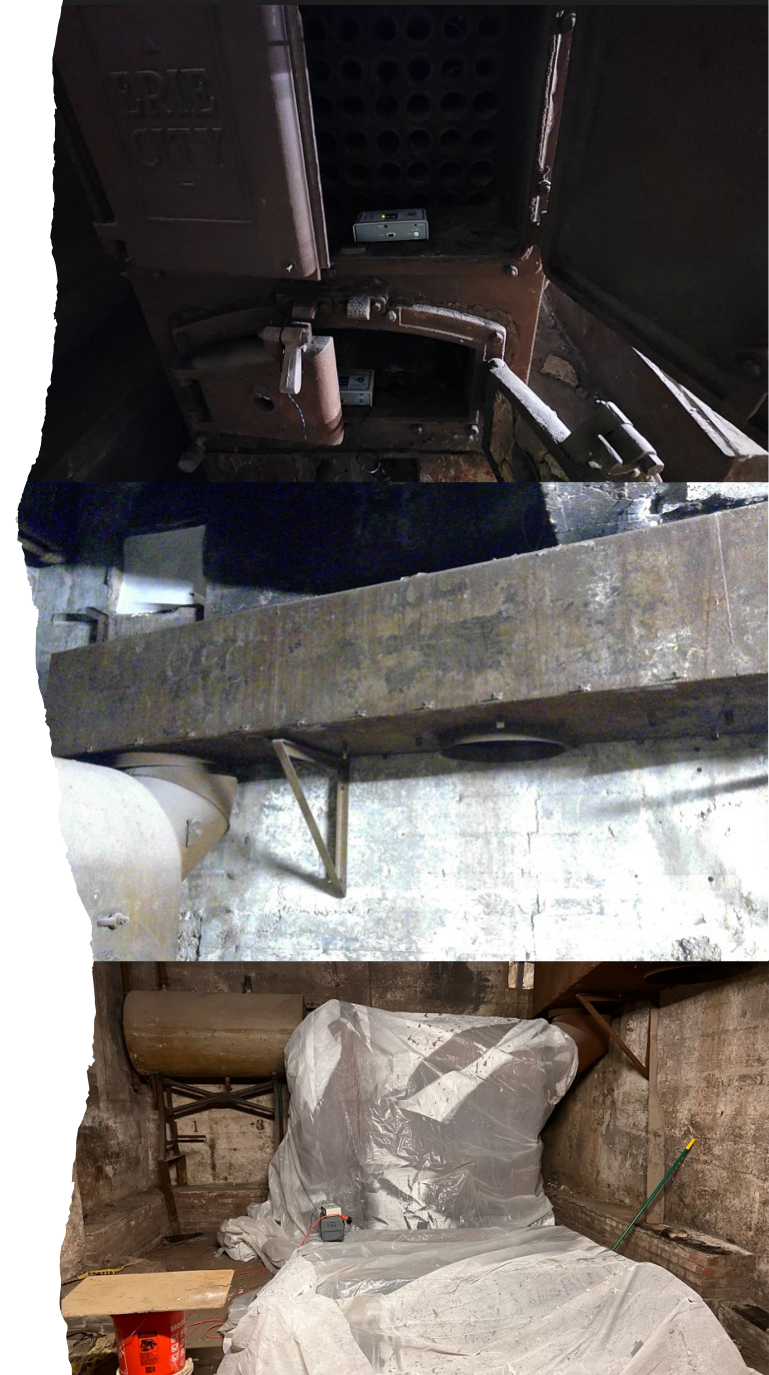
- Two decommissioned boilers in sub basement.
 1. Visual inspection.
 2. Grab sampler used in boiler.
 3. Boilers wrapped in Vapor barrier and a CRM placed inside to take readings.
- Duct work no longer in use.
 1. Monitoring devices placed in ducts.
 2. Duct work removed and sealed by a third-party contractor.
- 200 ft Chimney
 1. chimney sealed (2 openings).
- Cracks and small patches of missing concrete.
 1. Cracks caulked, and missing concrete patched by owner.
- Plumbing line running into basement from parking garage.

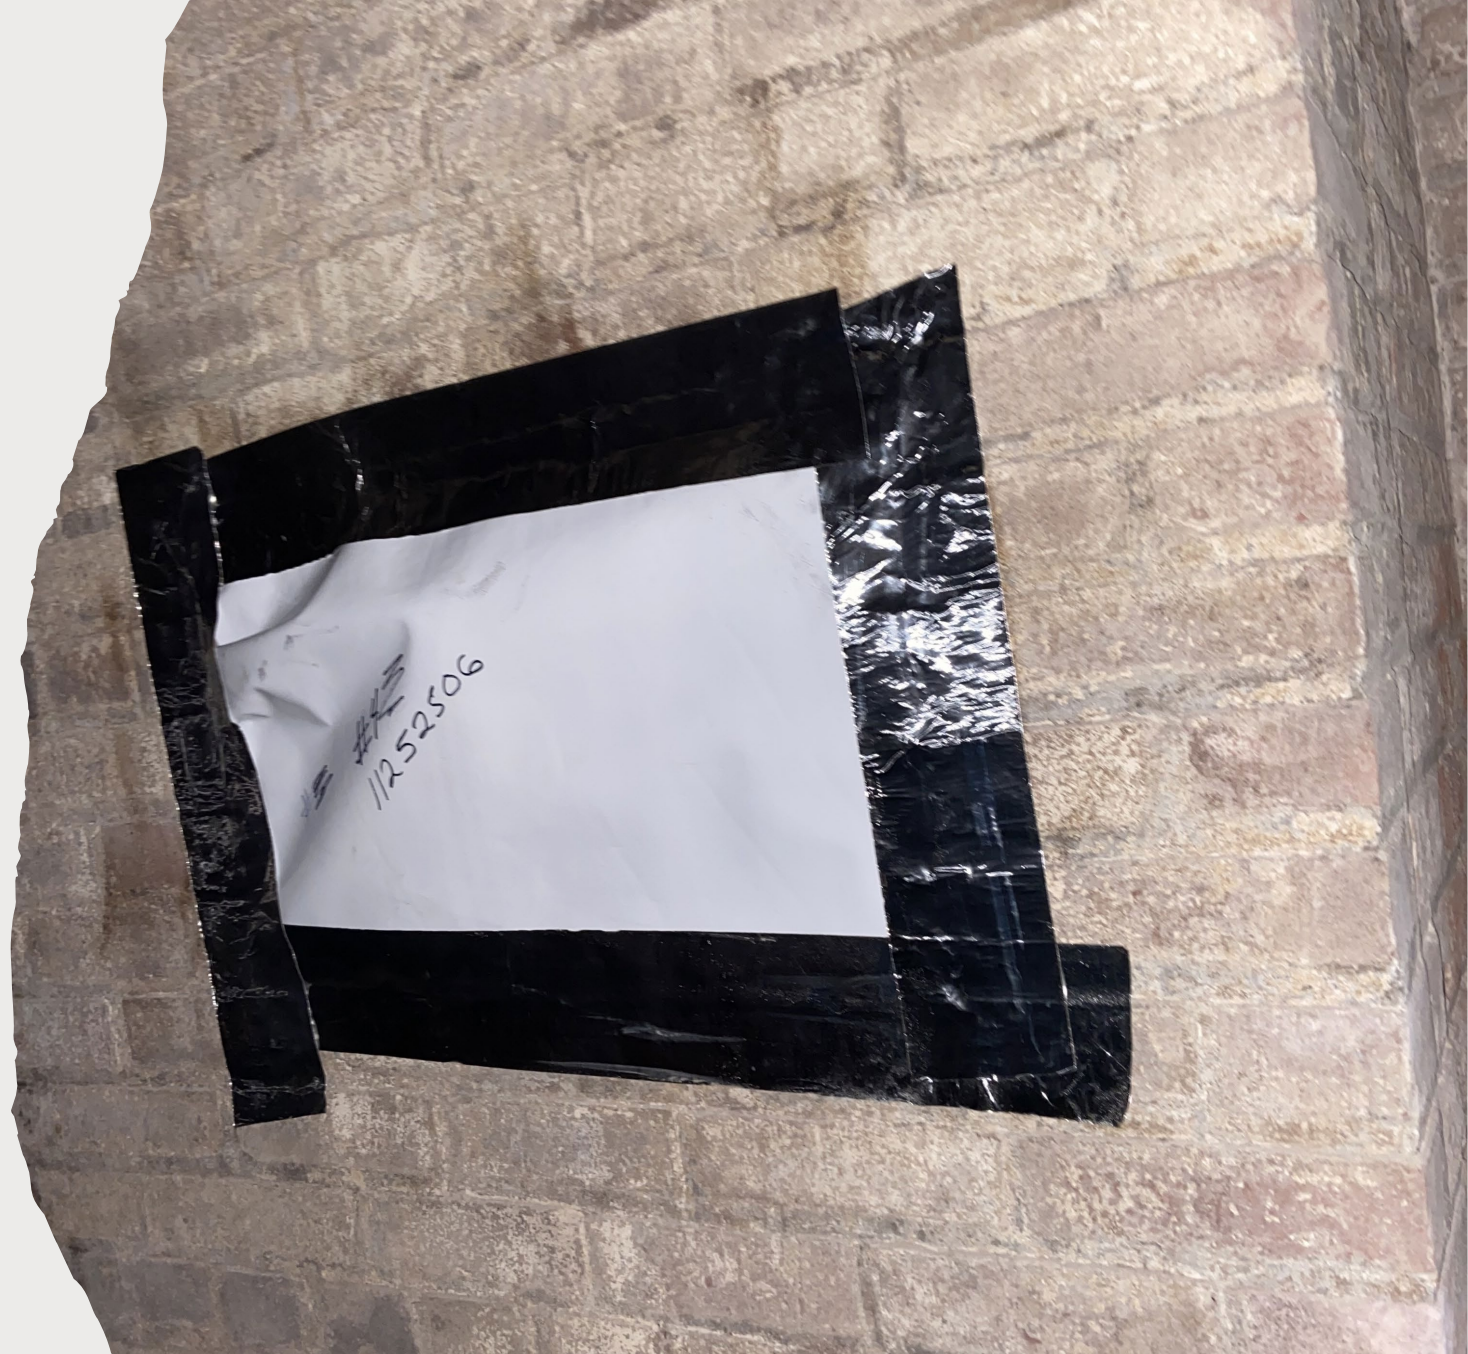
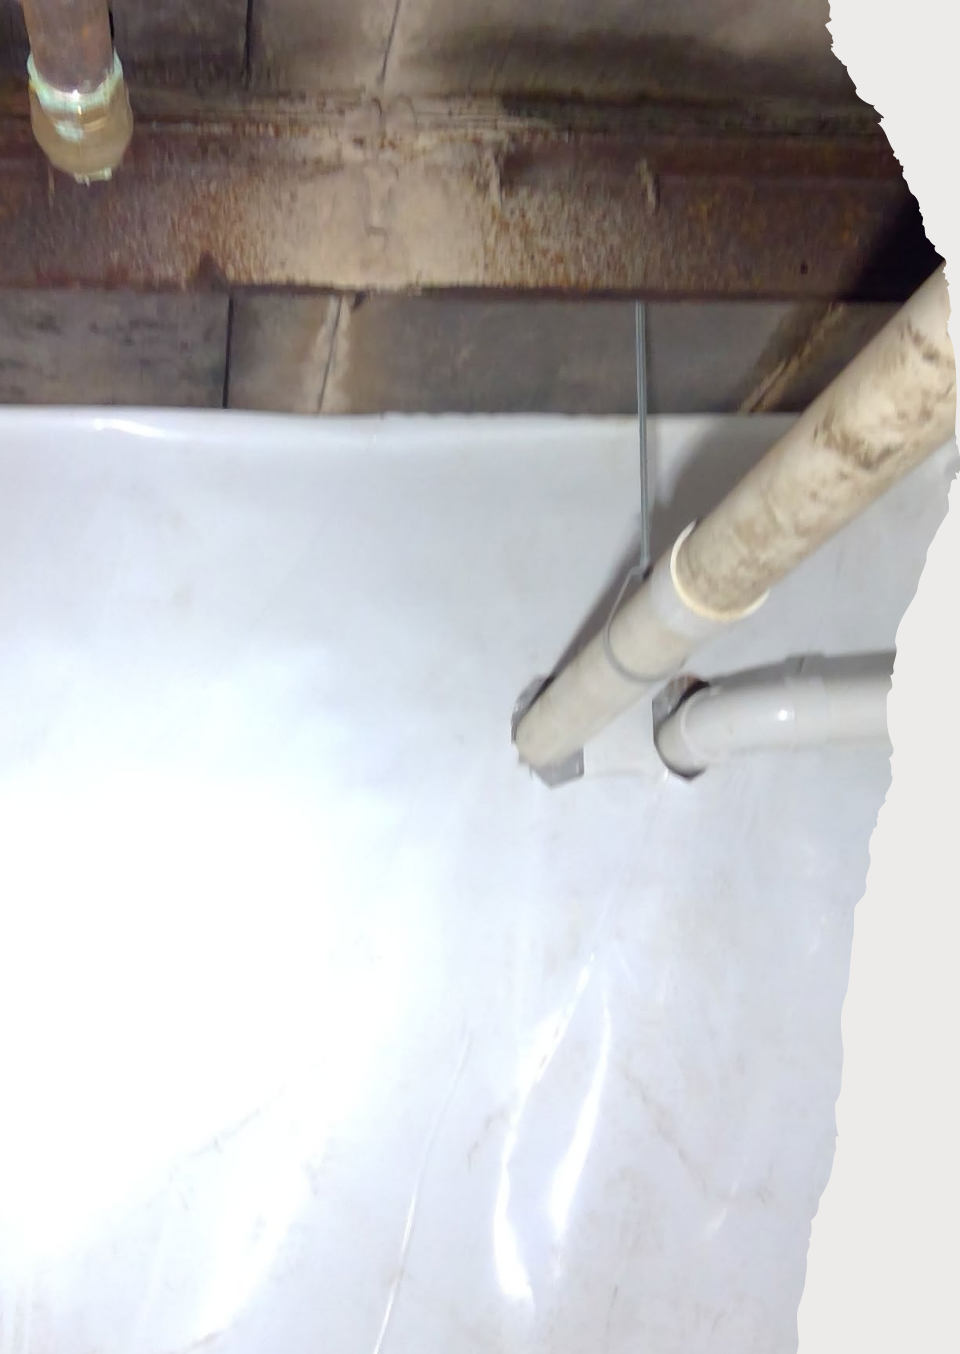
FLUX TESTING

- Flux testing was determined to be the best course of action to source the radon pathway.
- Flux testing was conducted on 10/19/2022.
- Diagnostic test to diagnose radon pathways.
- Important to seal suspected area with Vapor Barrier and Butyl Tape Sealant
- Air Chek charcoal envelopes deployed for 48 hrs.
