Following Uncertified Installers

Reasons all states need regulation

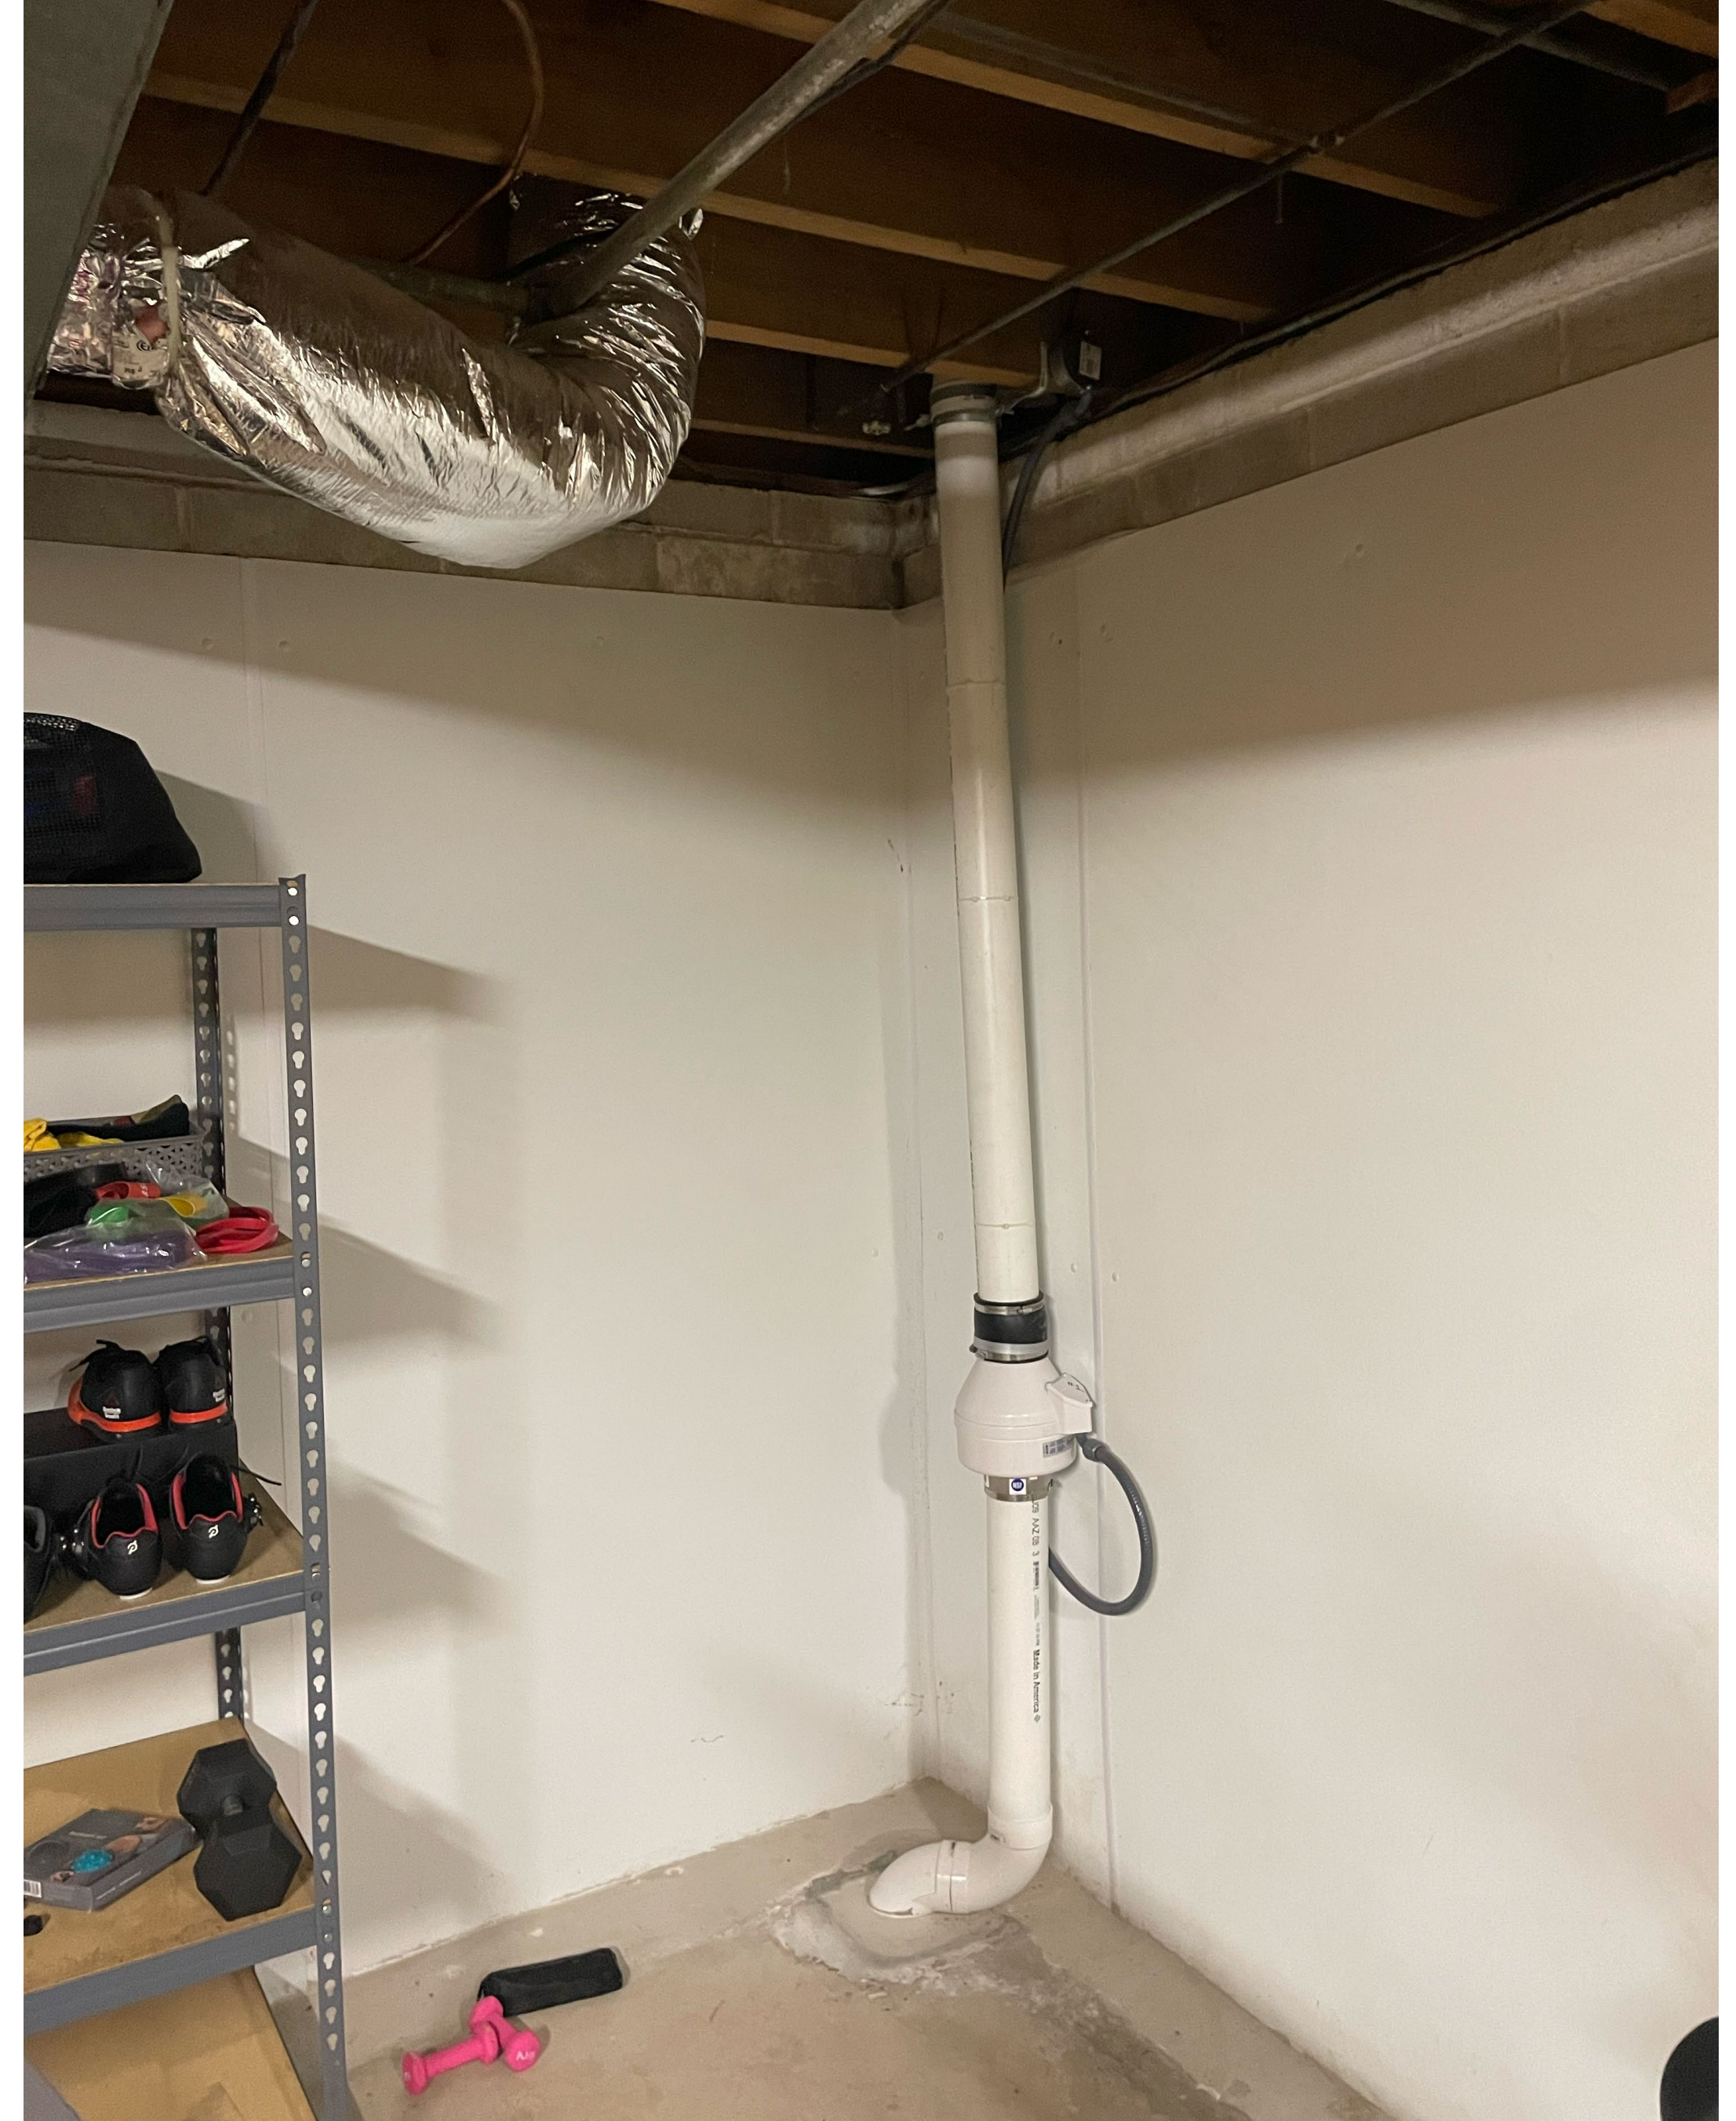
Not a single thing right

All in one shot

- This is one of two systems on a house in Alabama that did not see a real reduction in radon levels after mitigation by an uncertified company.
- So many violations in one photo, my lead guy said “you’d think they’d have accidentally gotten something right, but no”

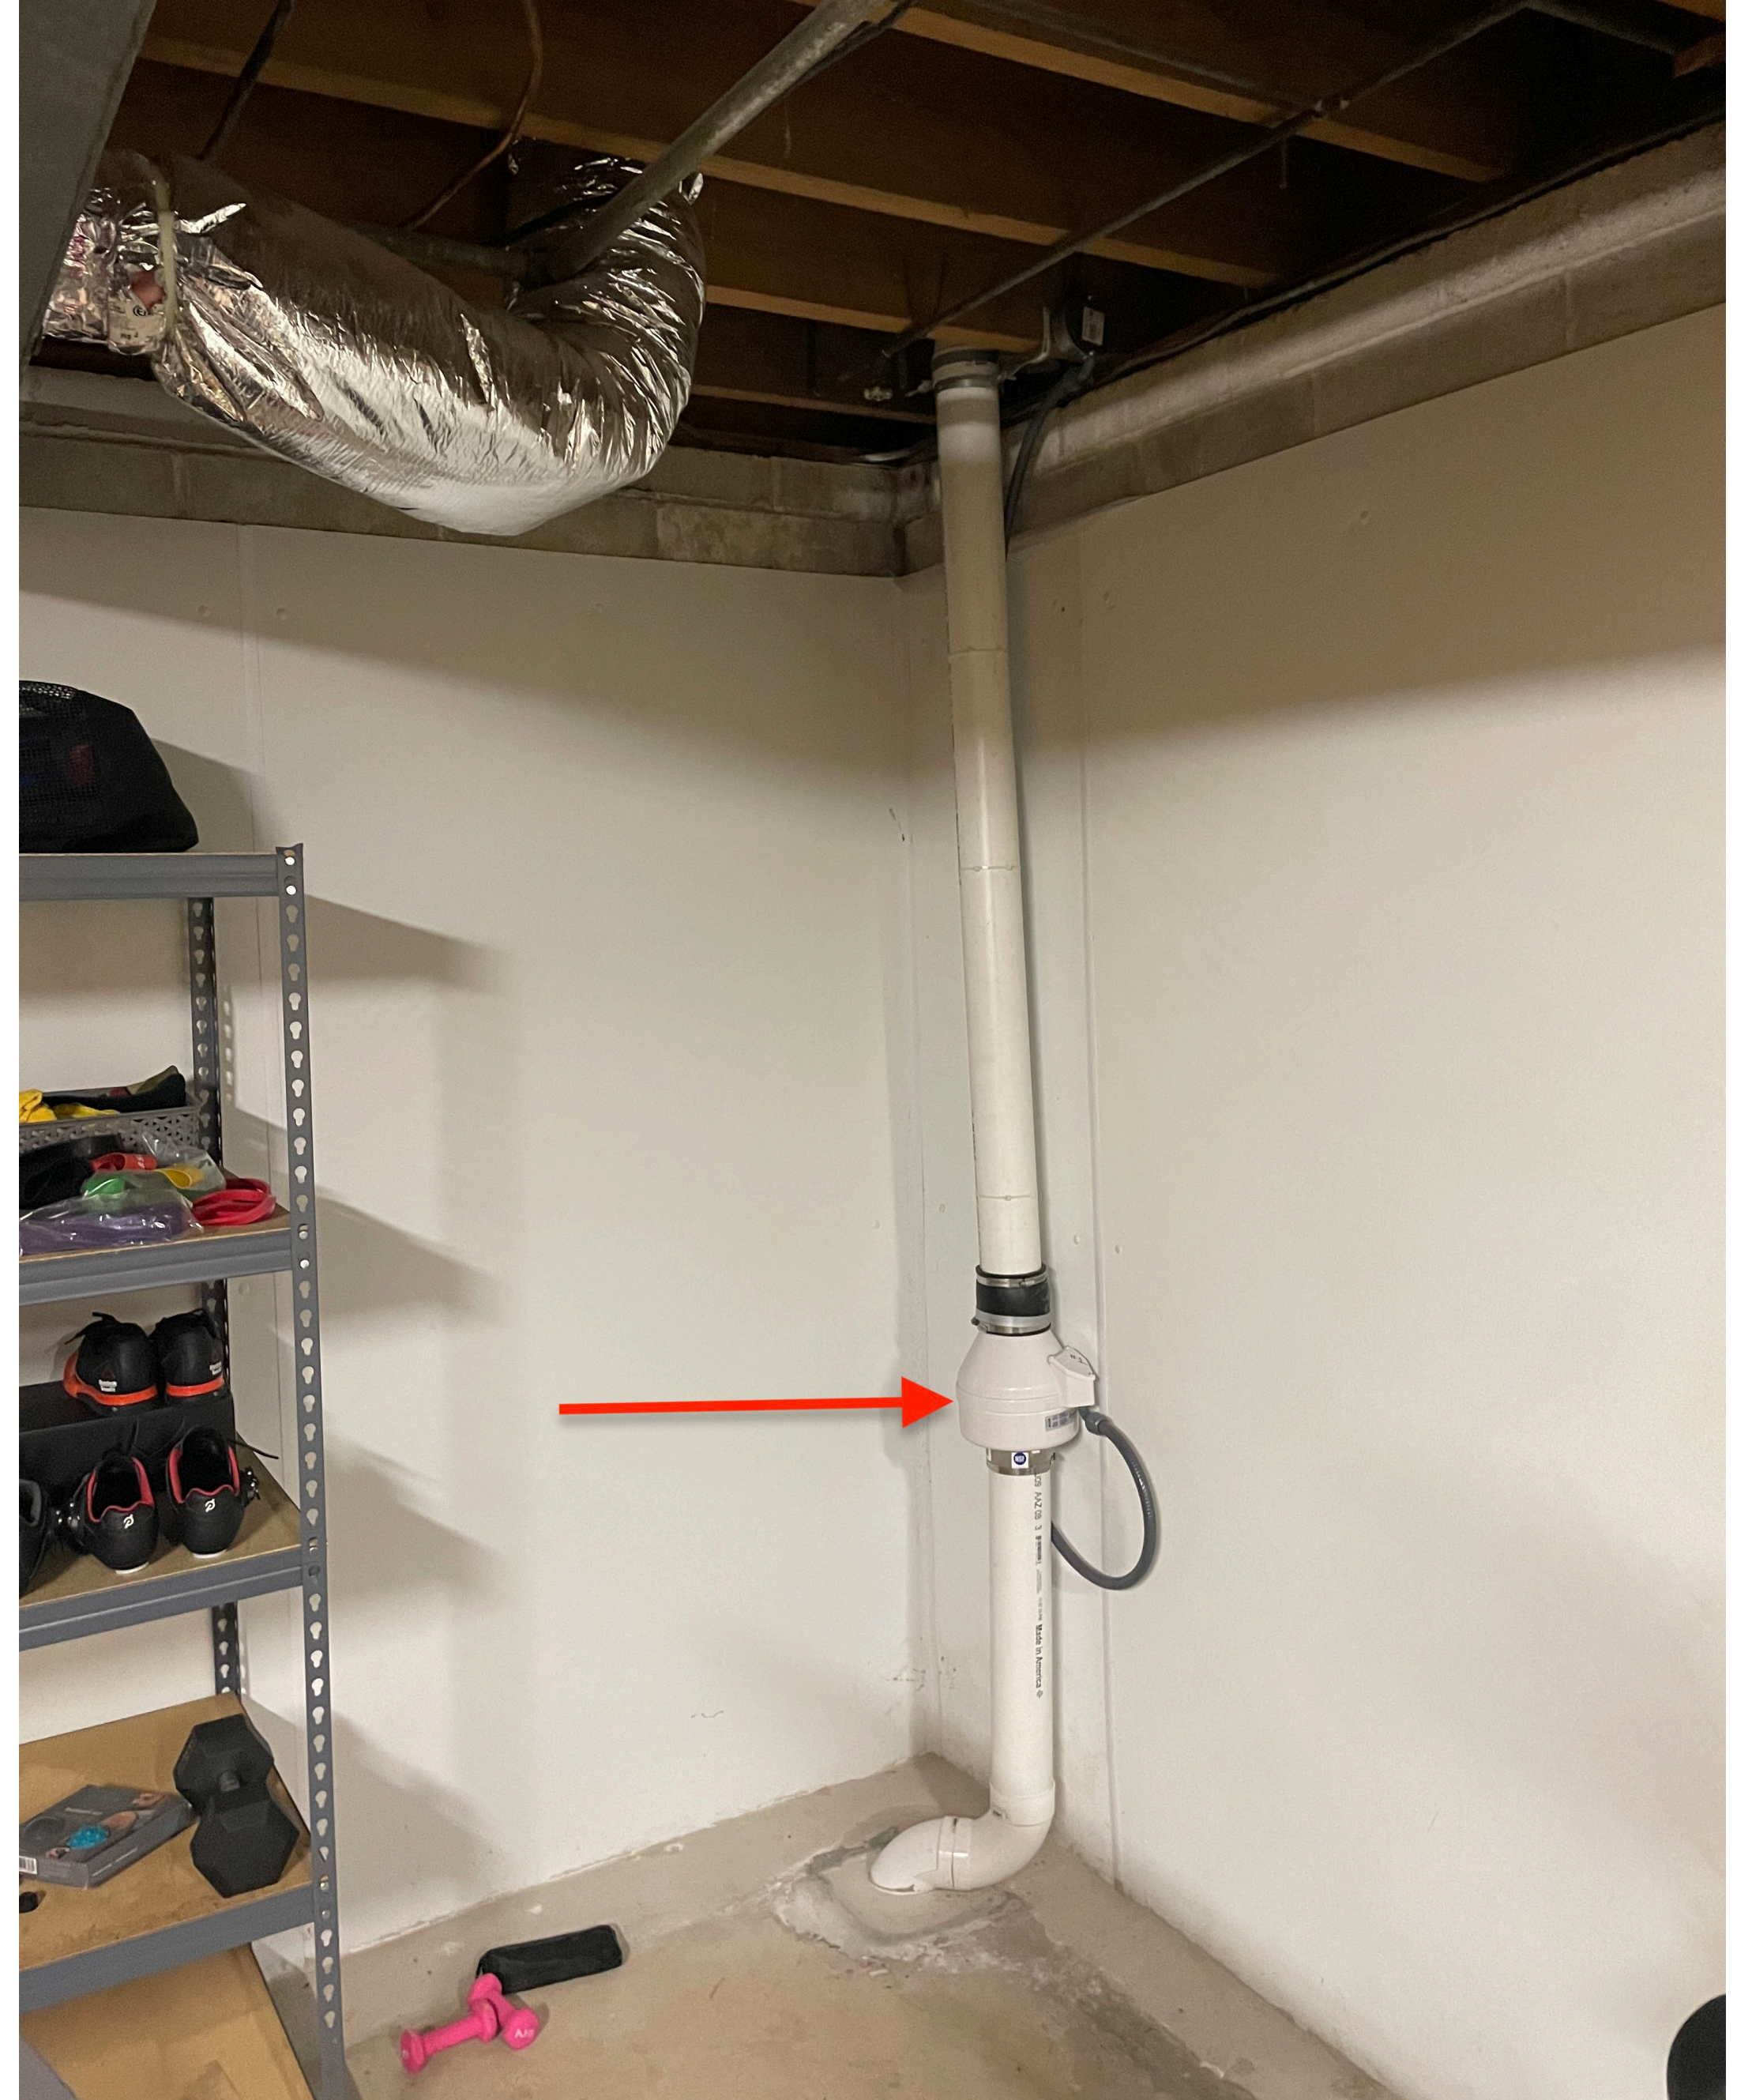
Fan in the basement

- There will be another slide, where the fan was installed in the basement, not outside as our standard dictates.
- If there is a poor connection at the fernco fitting or the glue joint of the pipe, especially above the fan, then radon is being captured below the slab and exhausted into the basement and house.

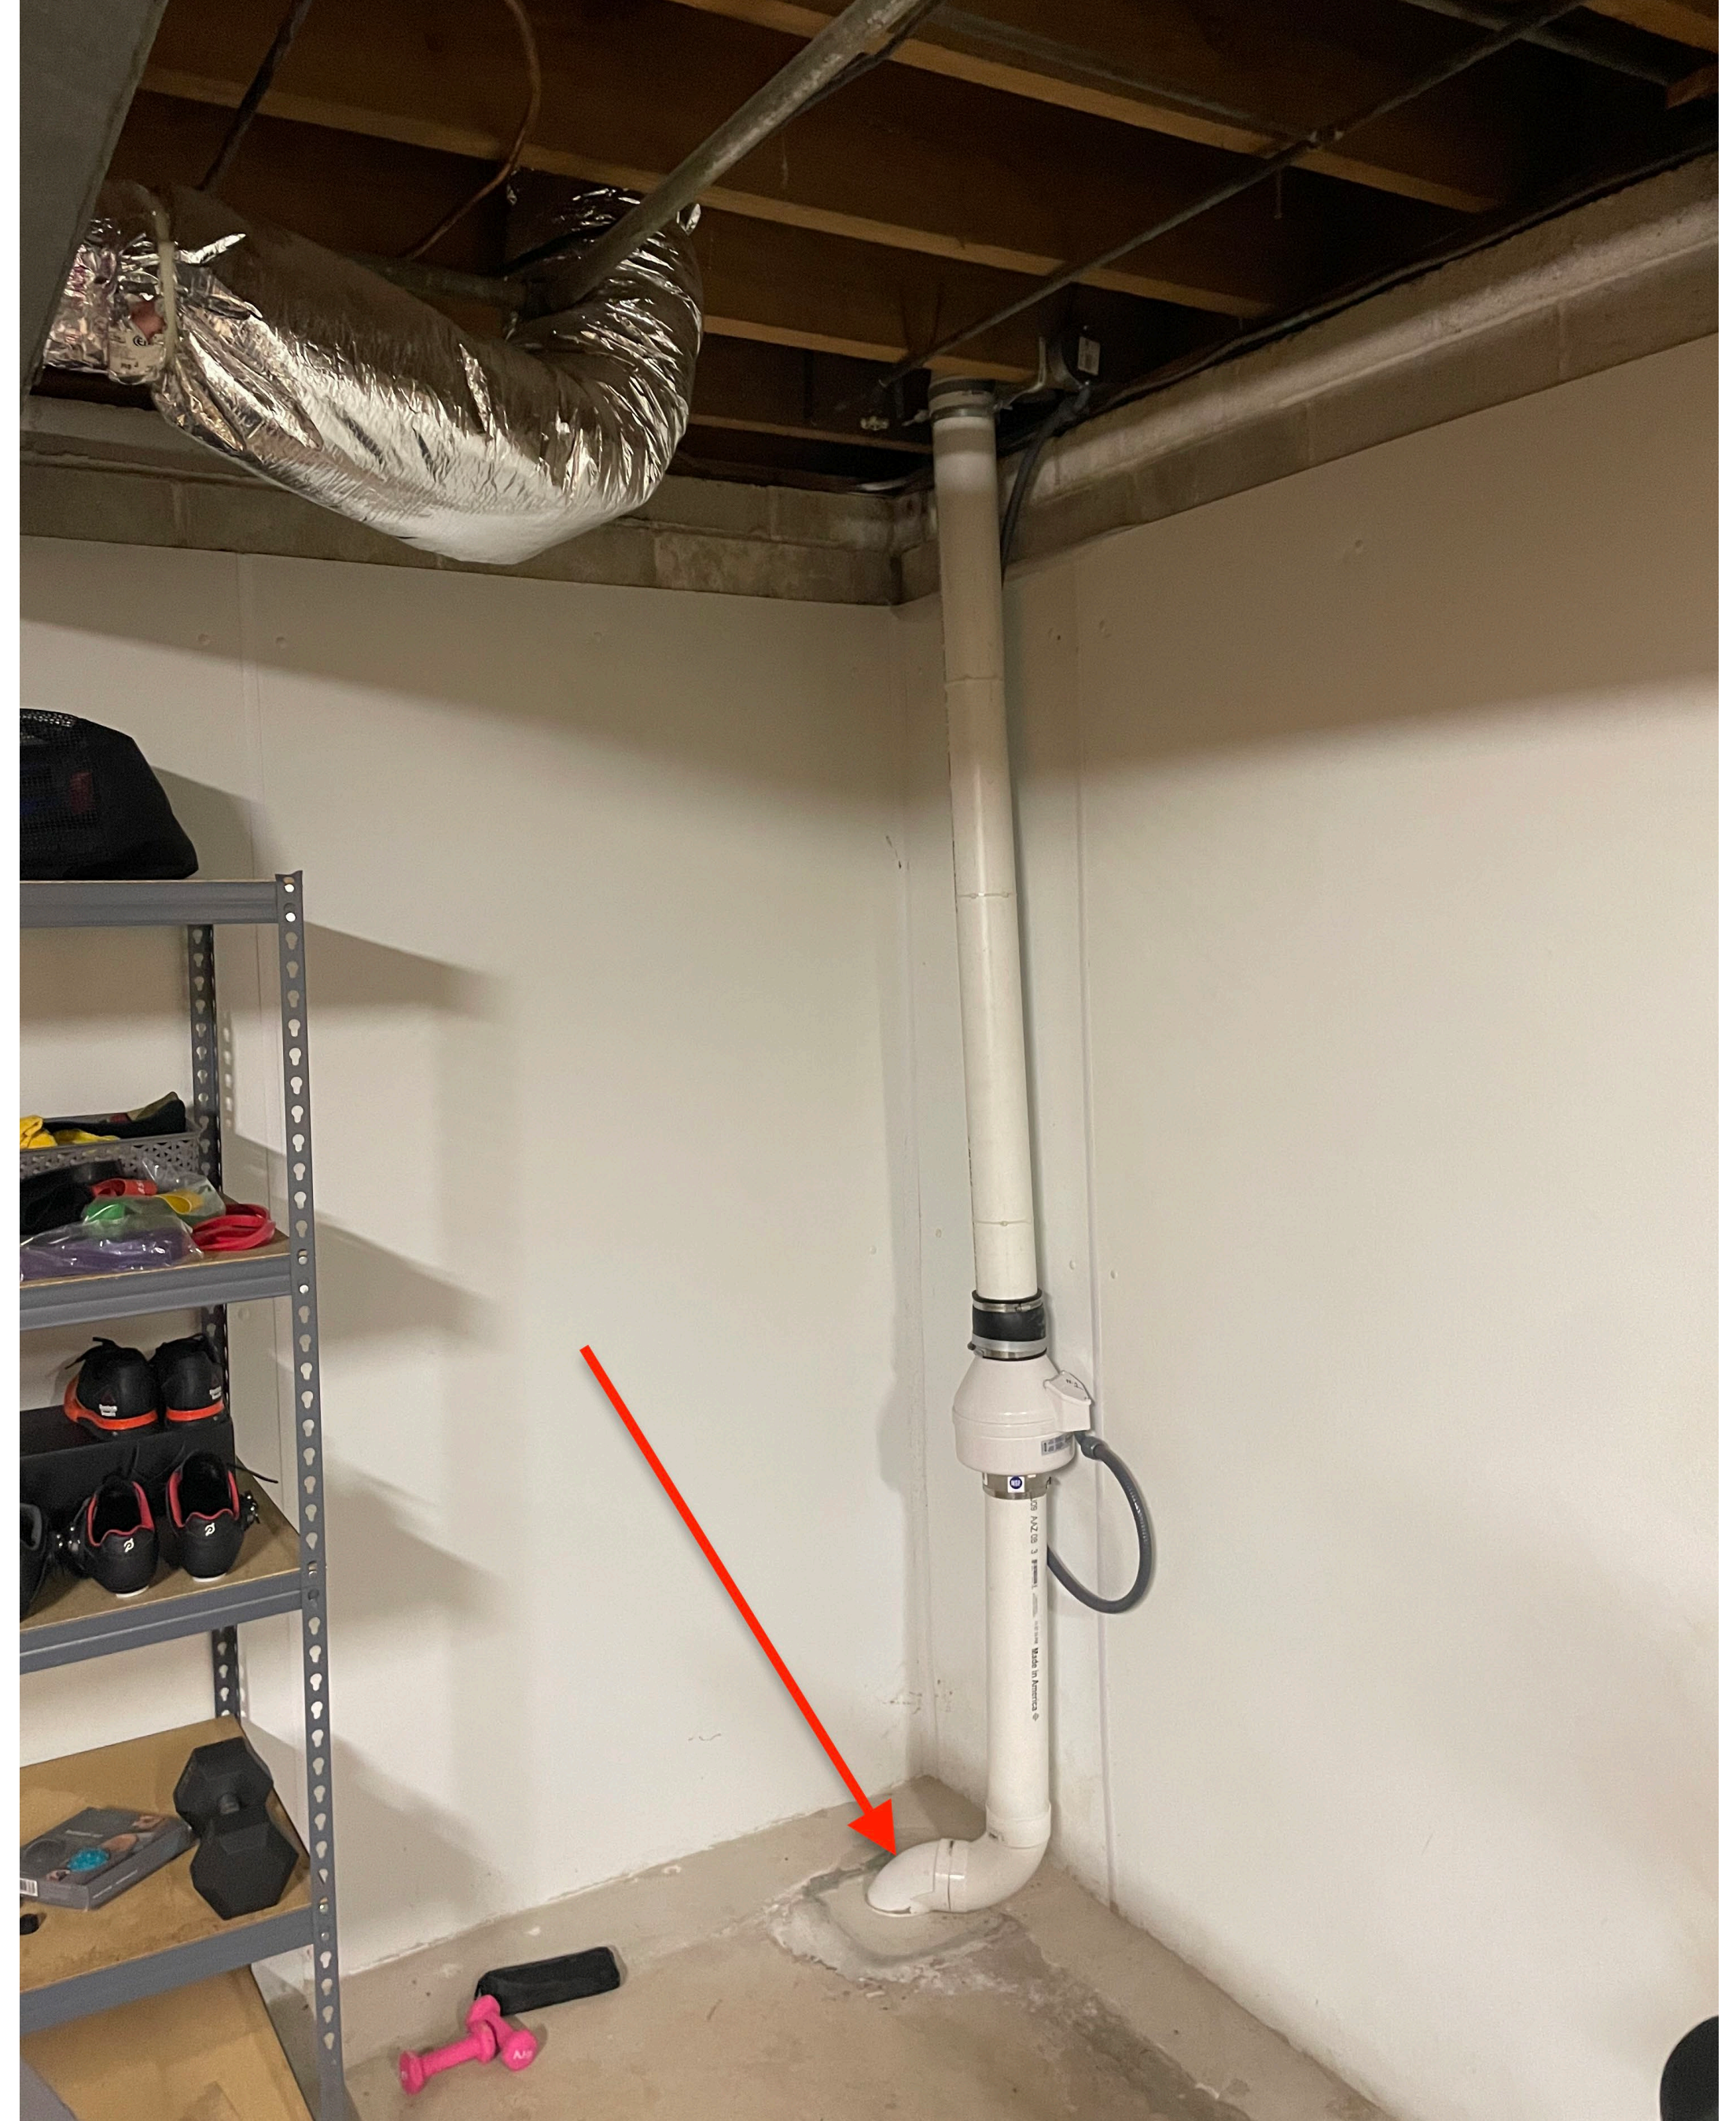
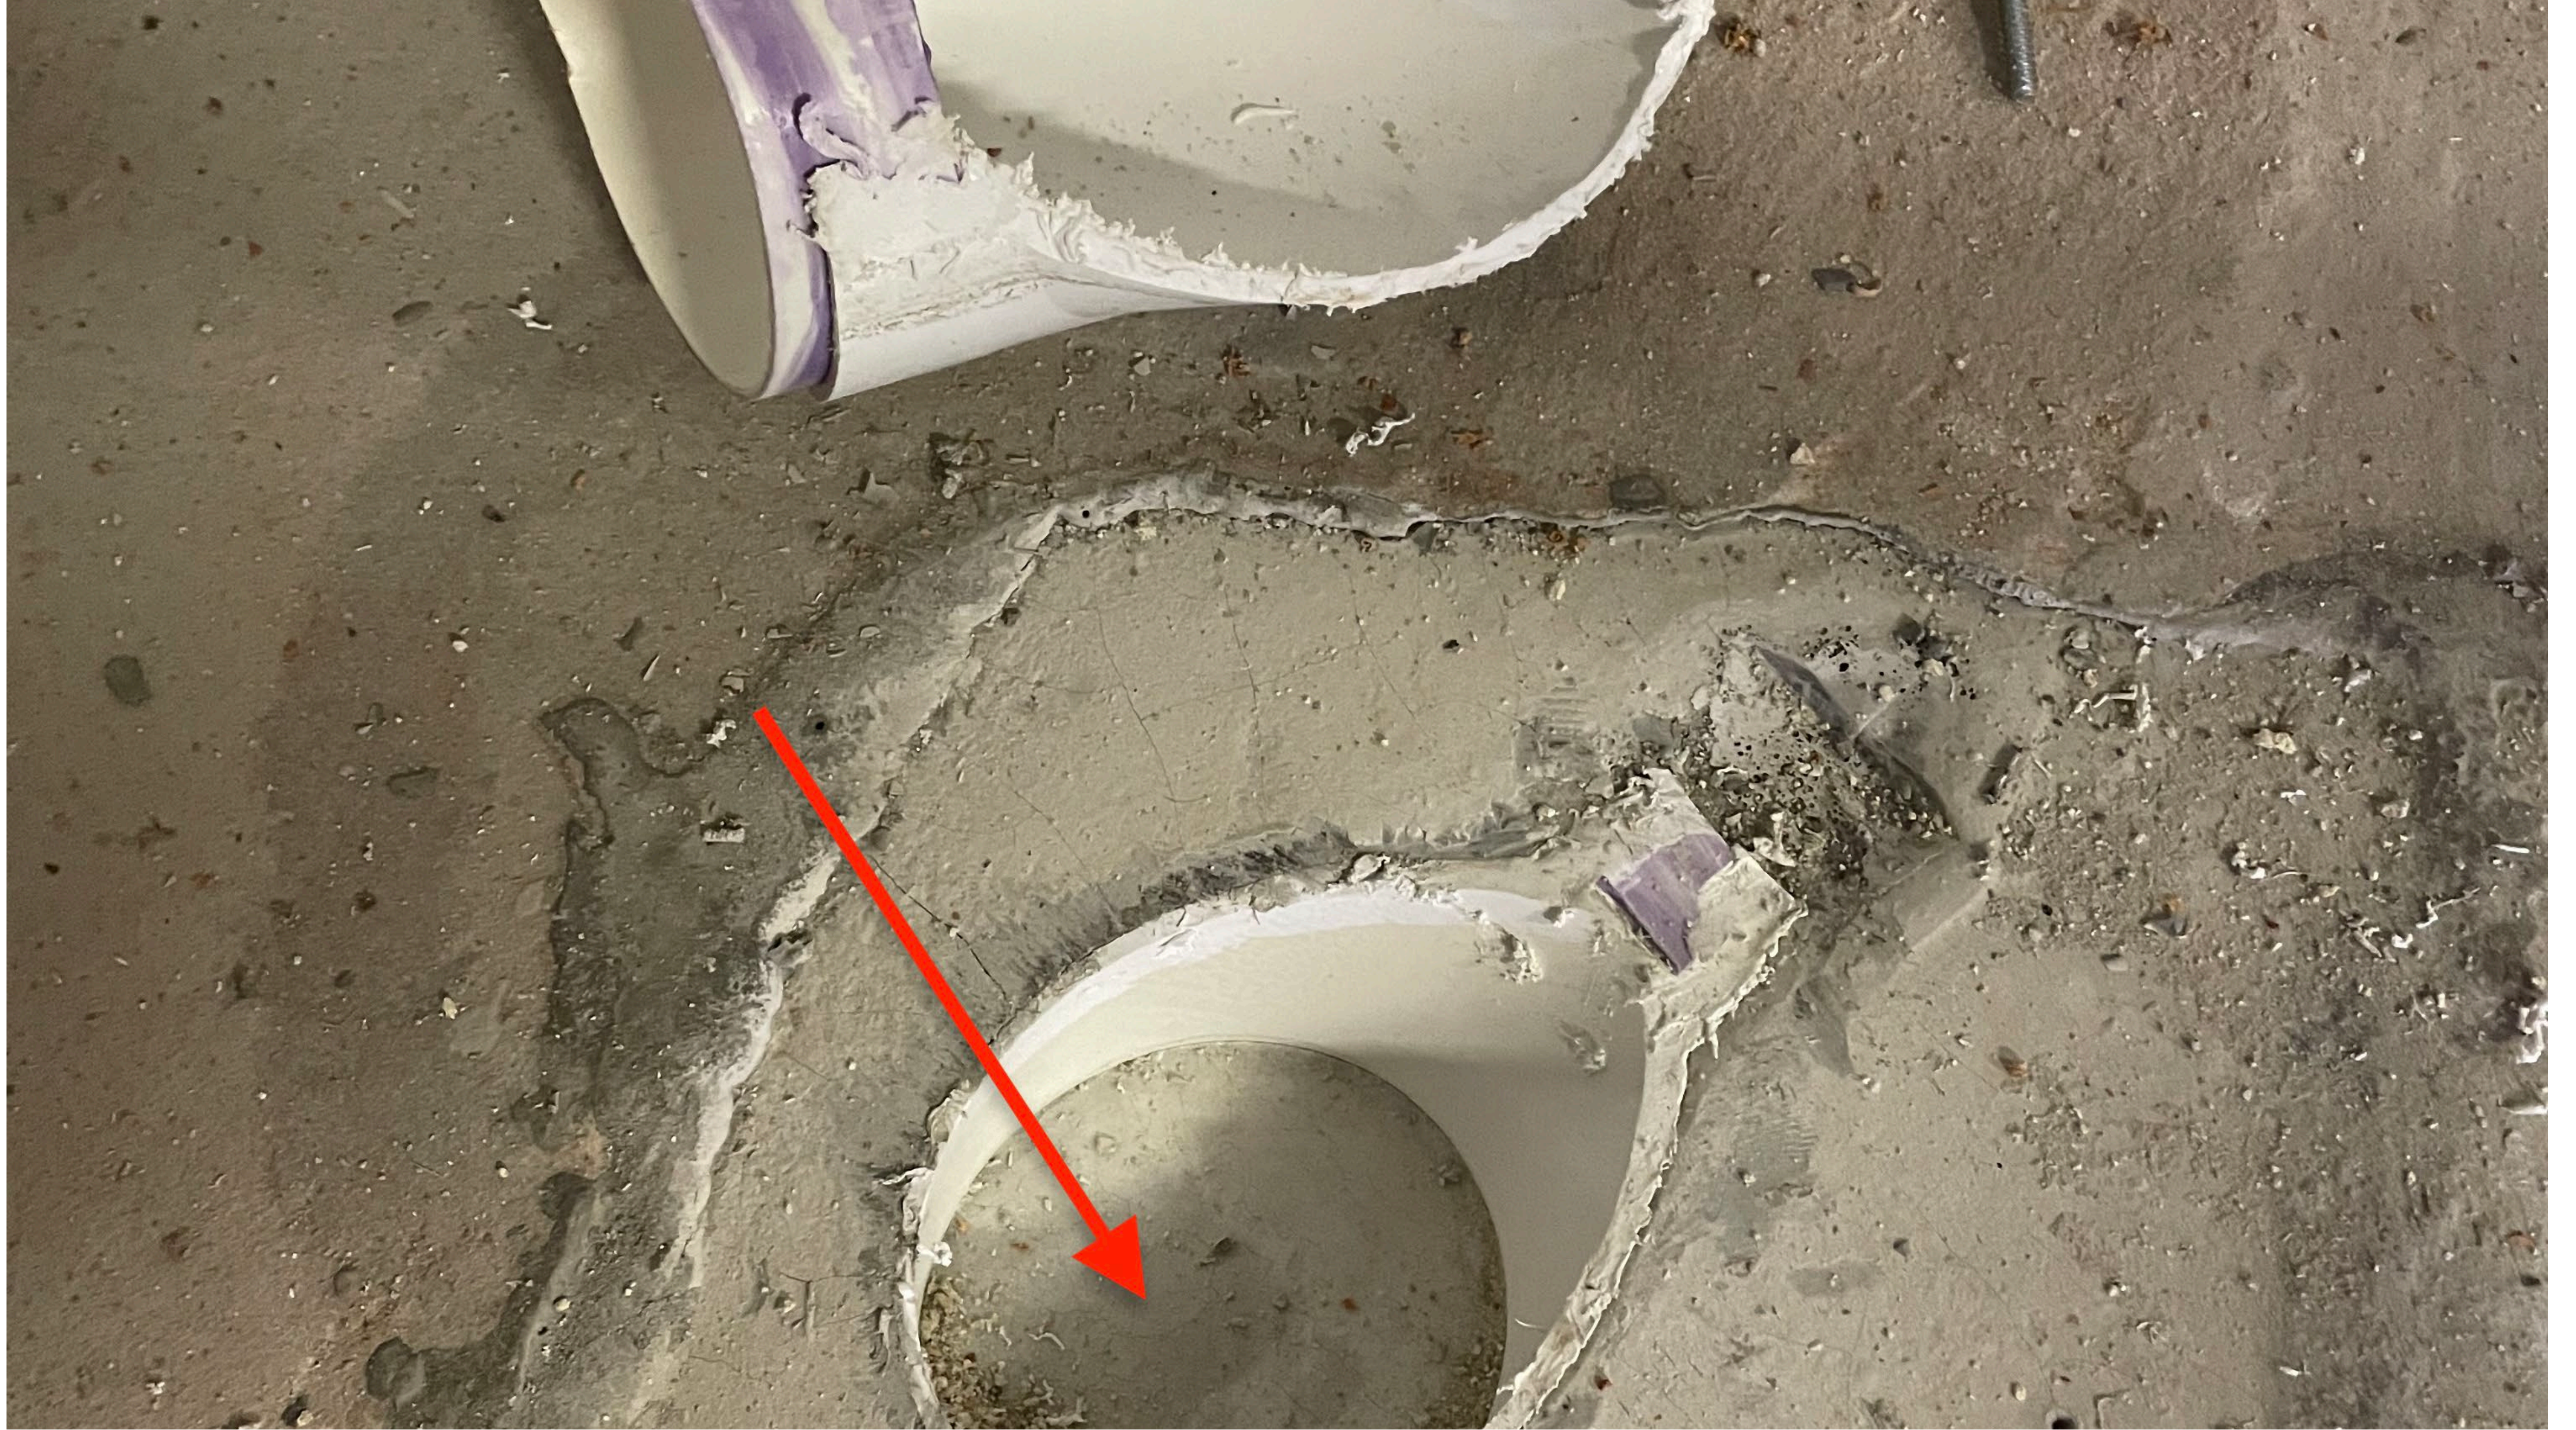
Slab cut, not cored

- The slab has been cut with a saw. When I saw this, and the fact that the fill in material for the cut was similar to leveling concrete, I had immediate serious concerns about the plenum below the suction point.

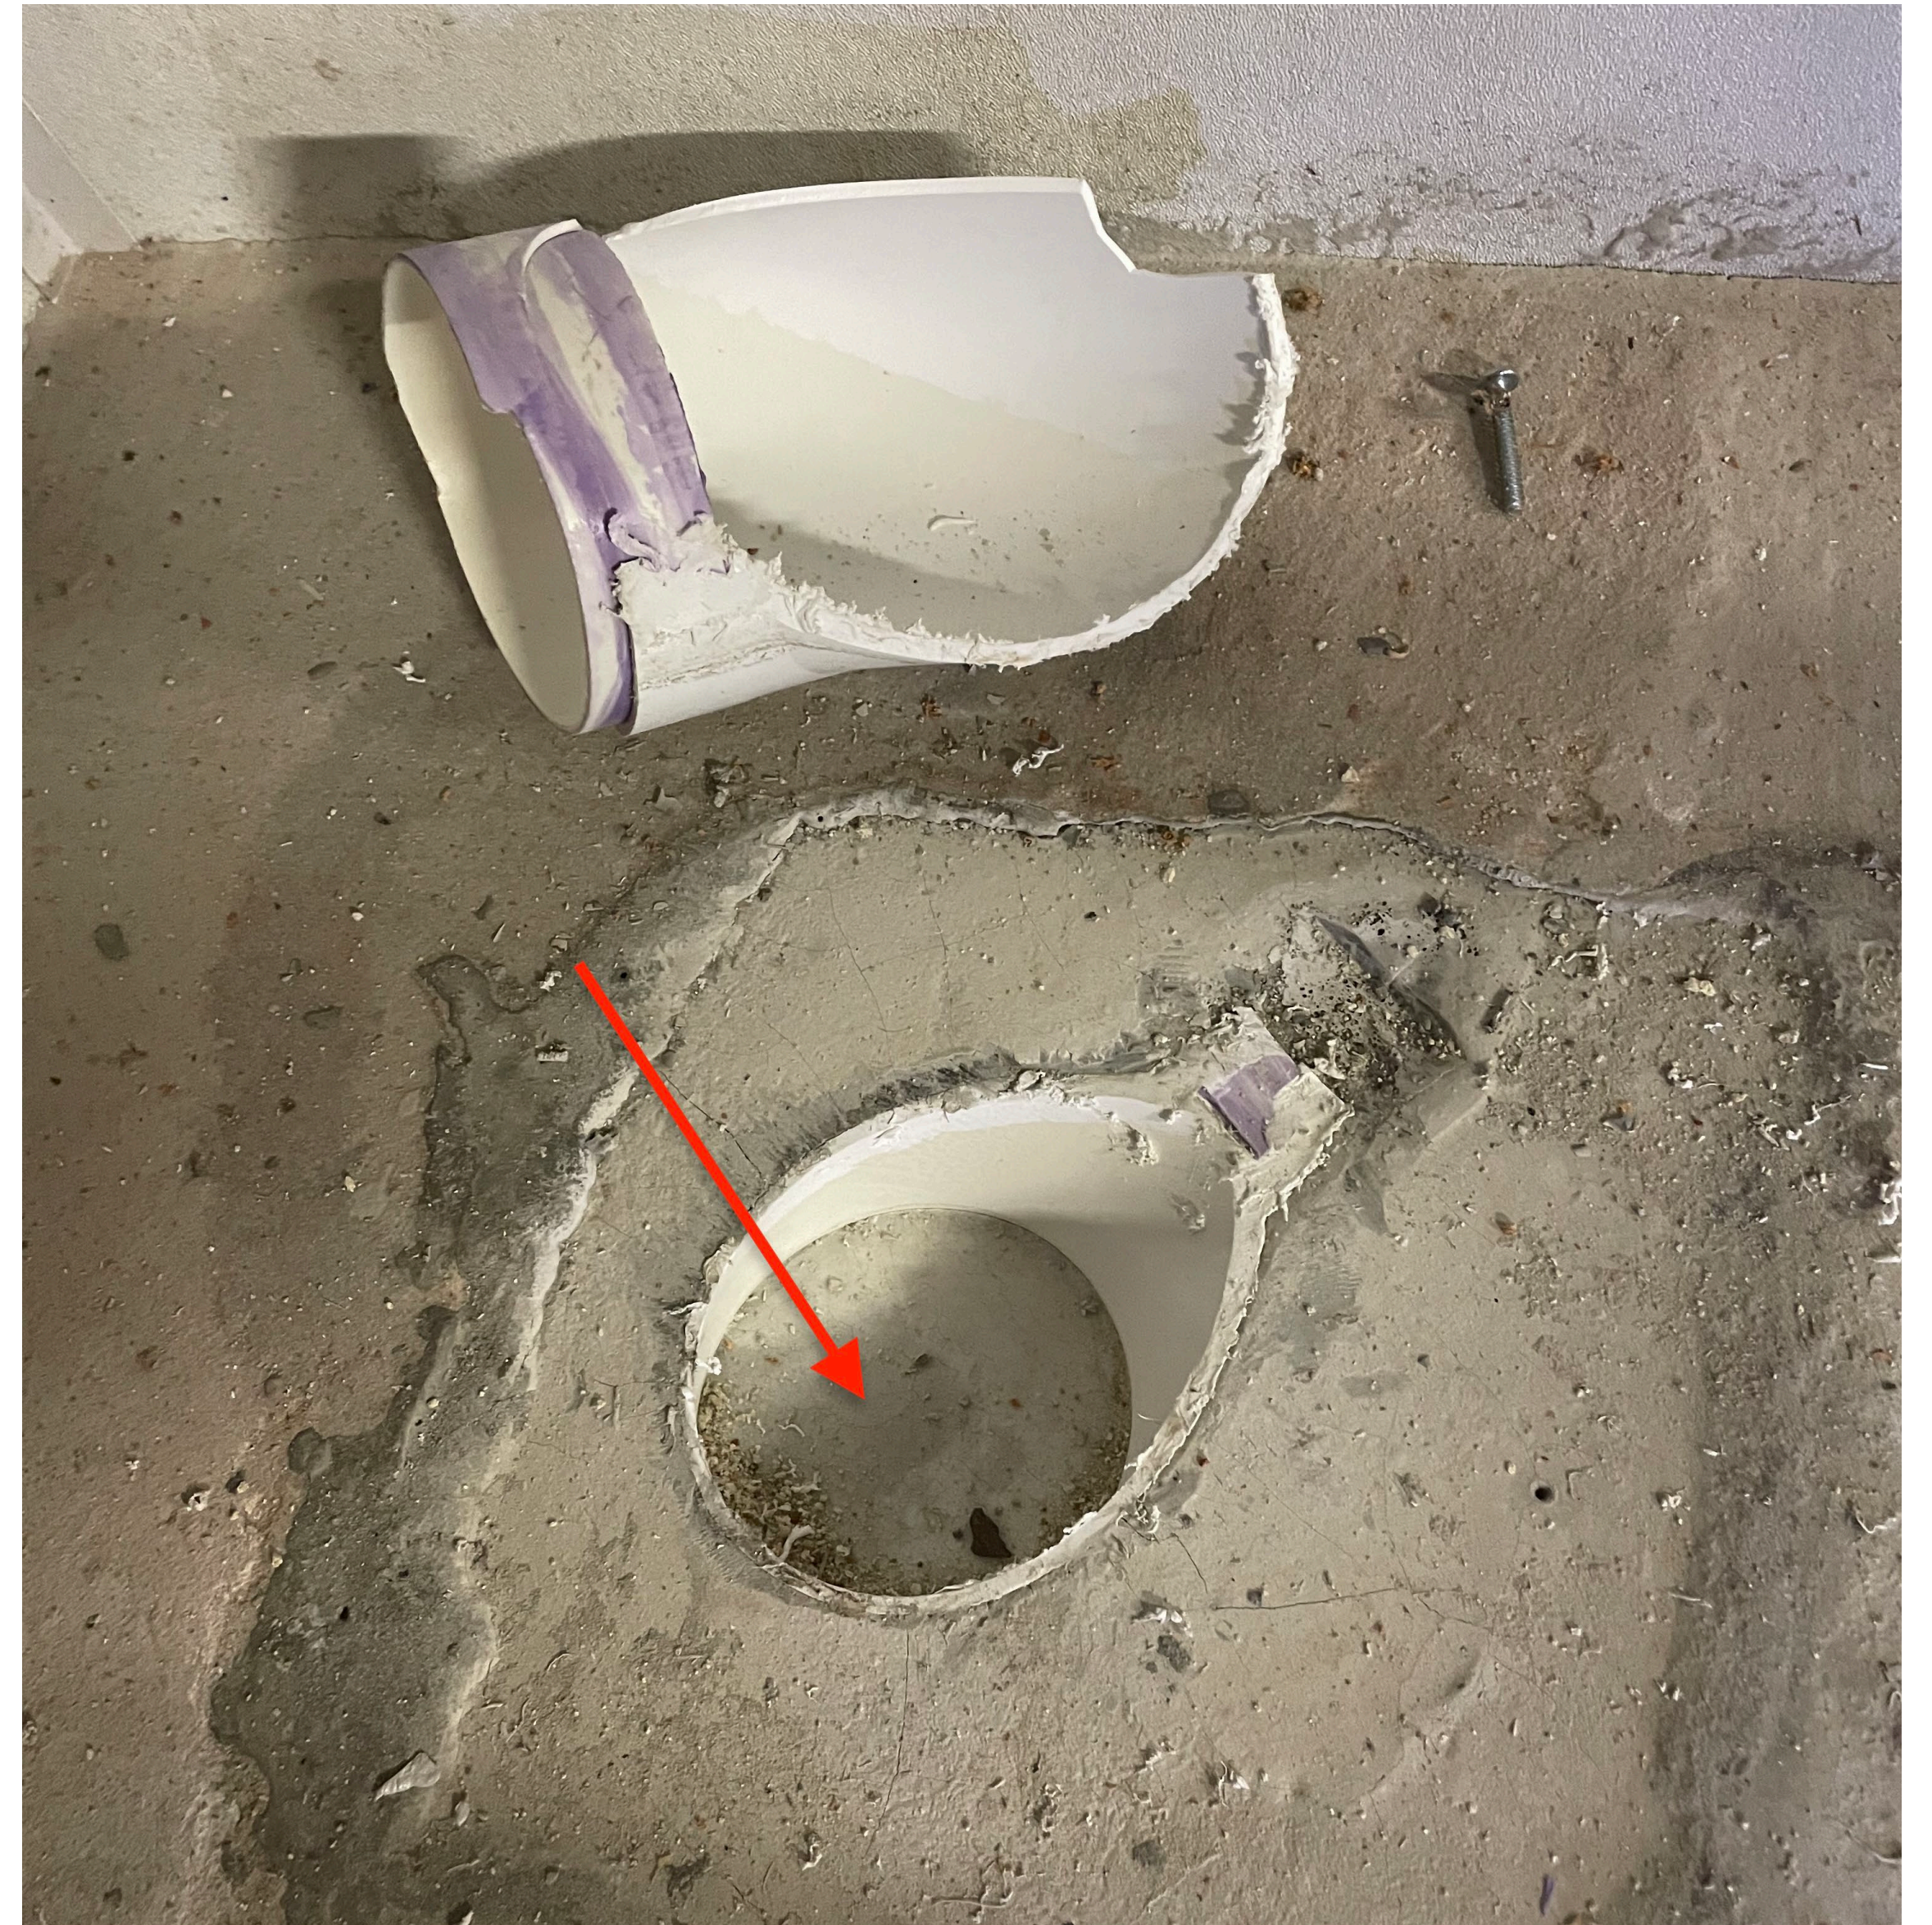
But is there a benefit?

- Is there a benefit to this situation?
- No plenum and suction point full of concrete.
- You can see that they filled the void with self leveling compound including the pipe!!!
- But honestly, is there a benefit?

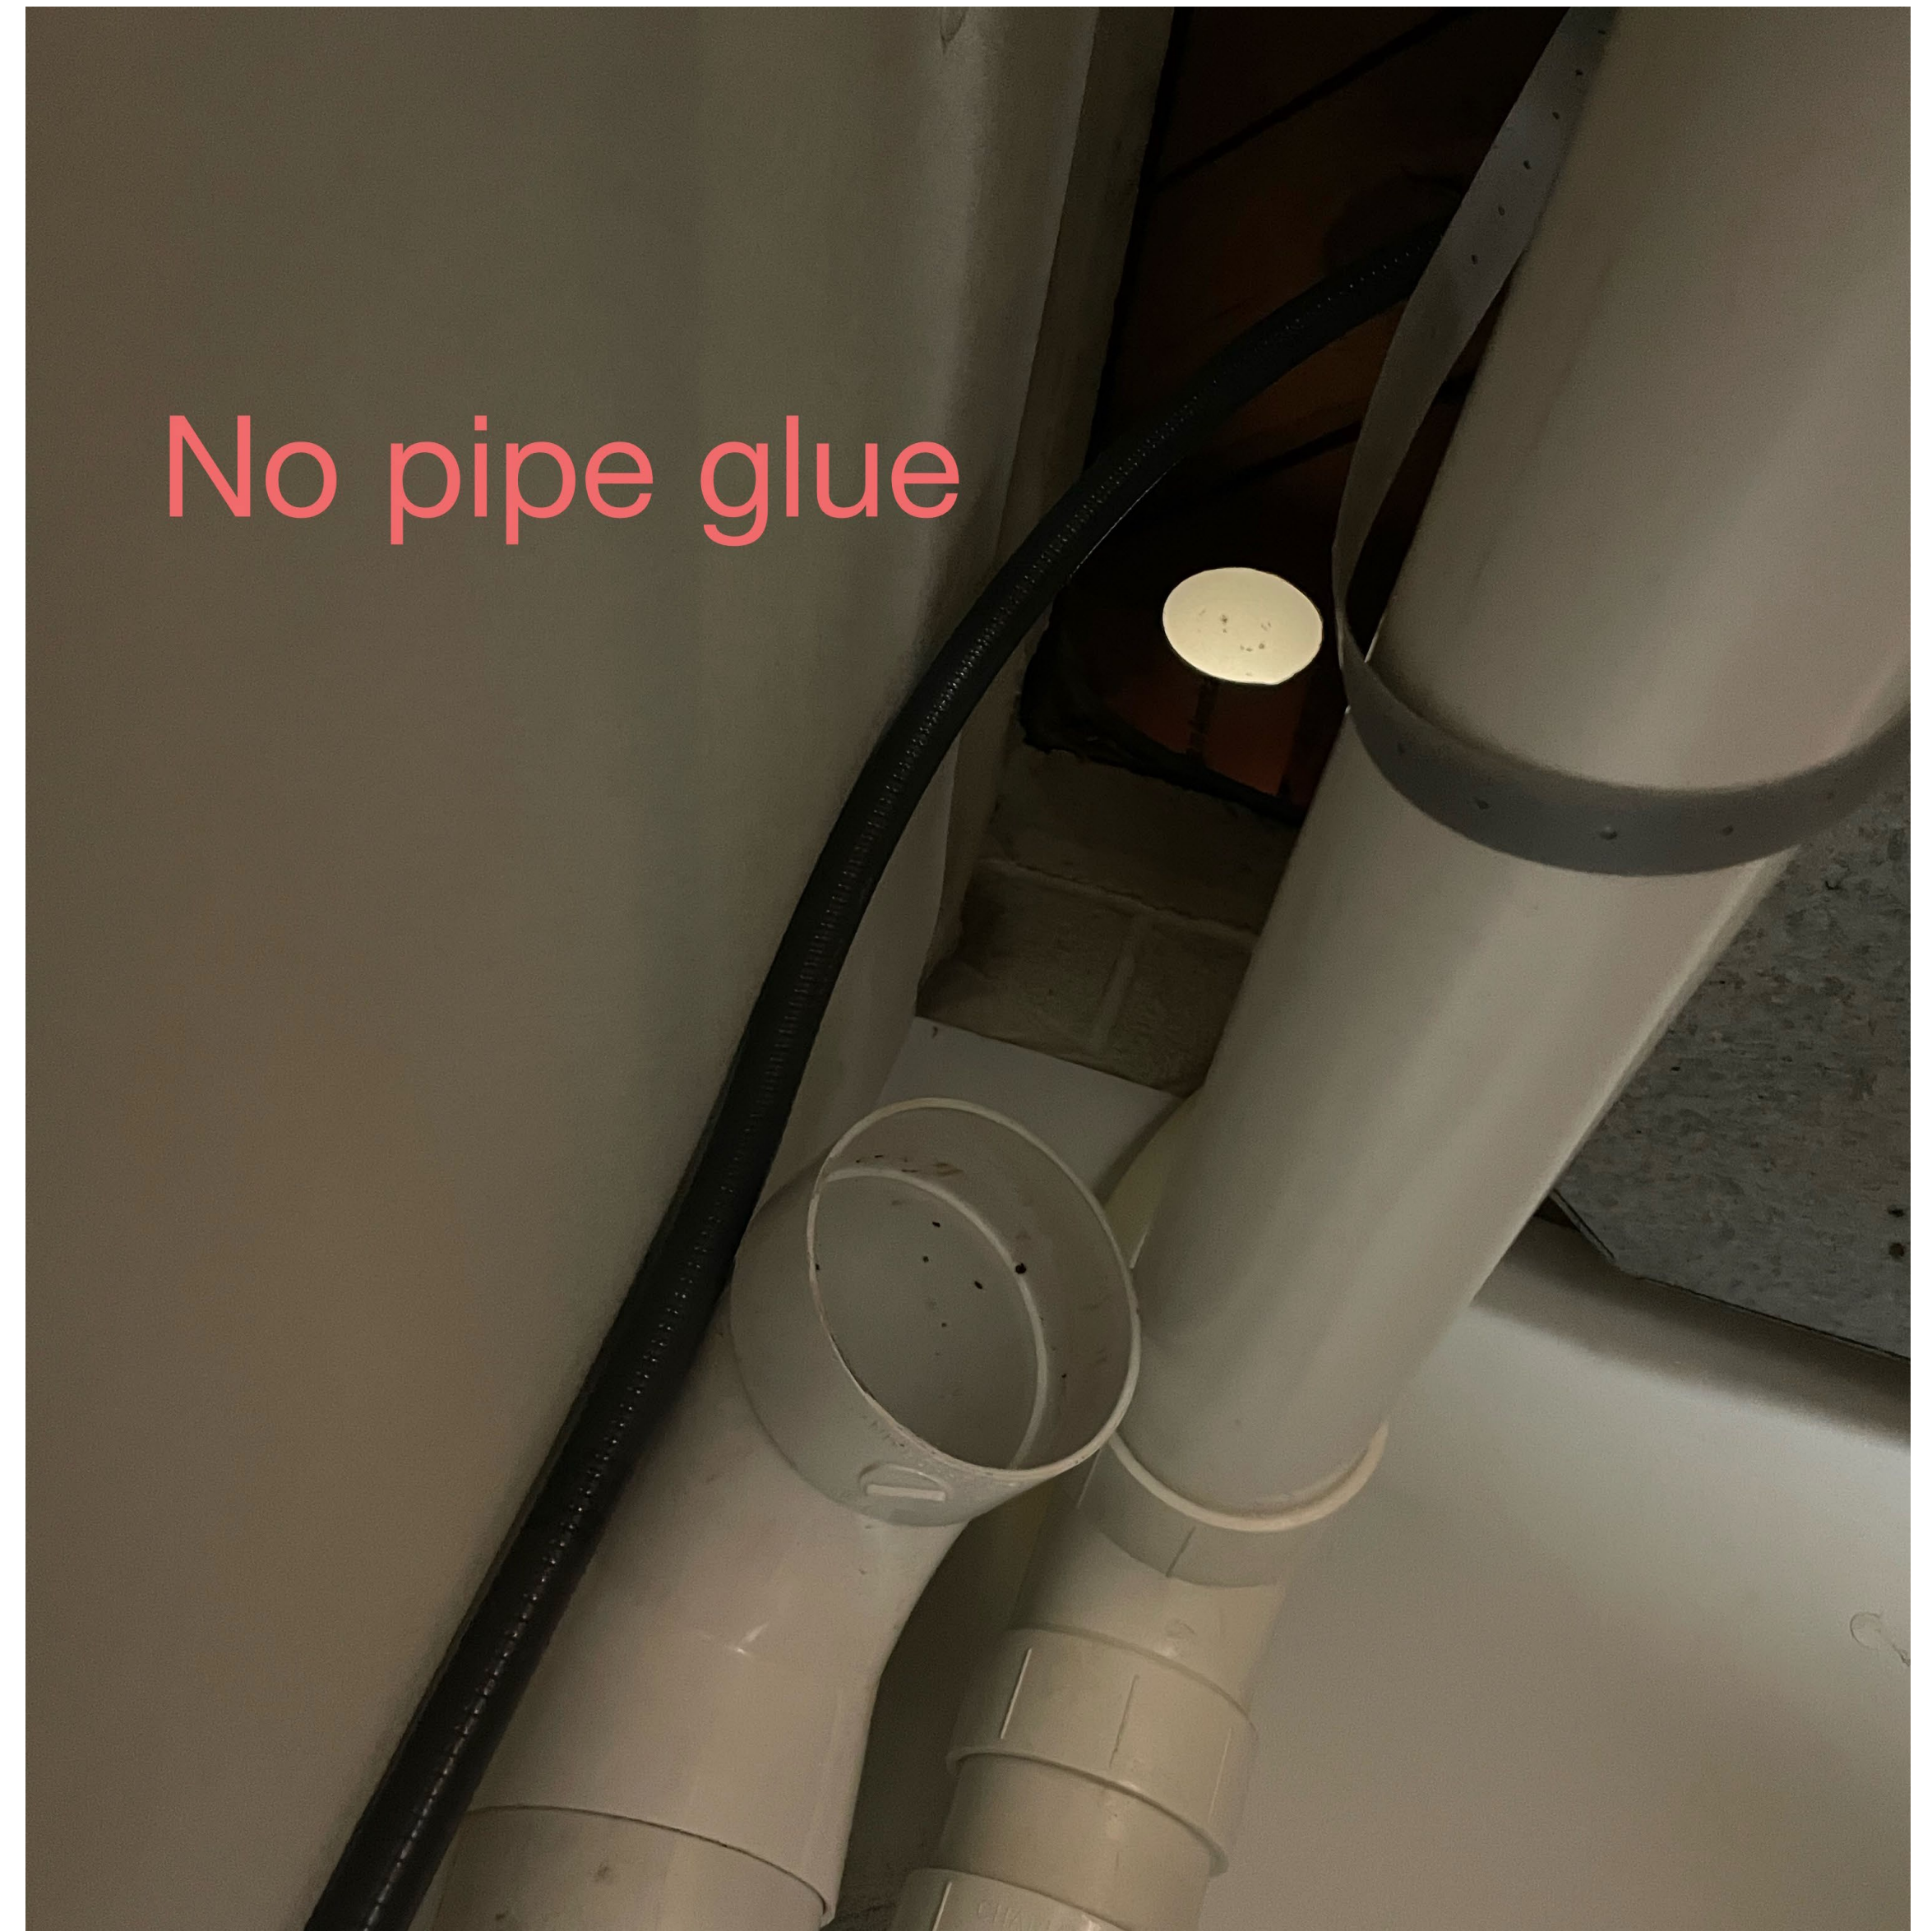
Yes, the benefit emerges

- If you are going to install the fan inside the house, using sewer pipe, and ignore glueing the pipe joints, then not being able to grab the radon below the surface does become a benefit.
- Here is the reason there is no change in radon levels when this install was complete
- Cudos to Radonaway, I dont know how the fans didnt burn up.
