Following Uncertified Installers

Reasons all states need regulation

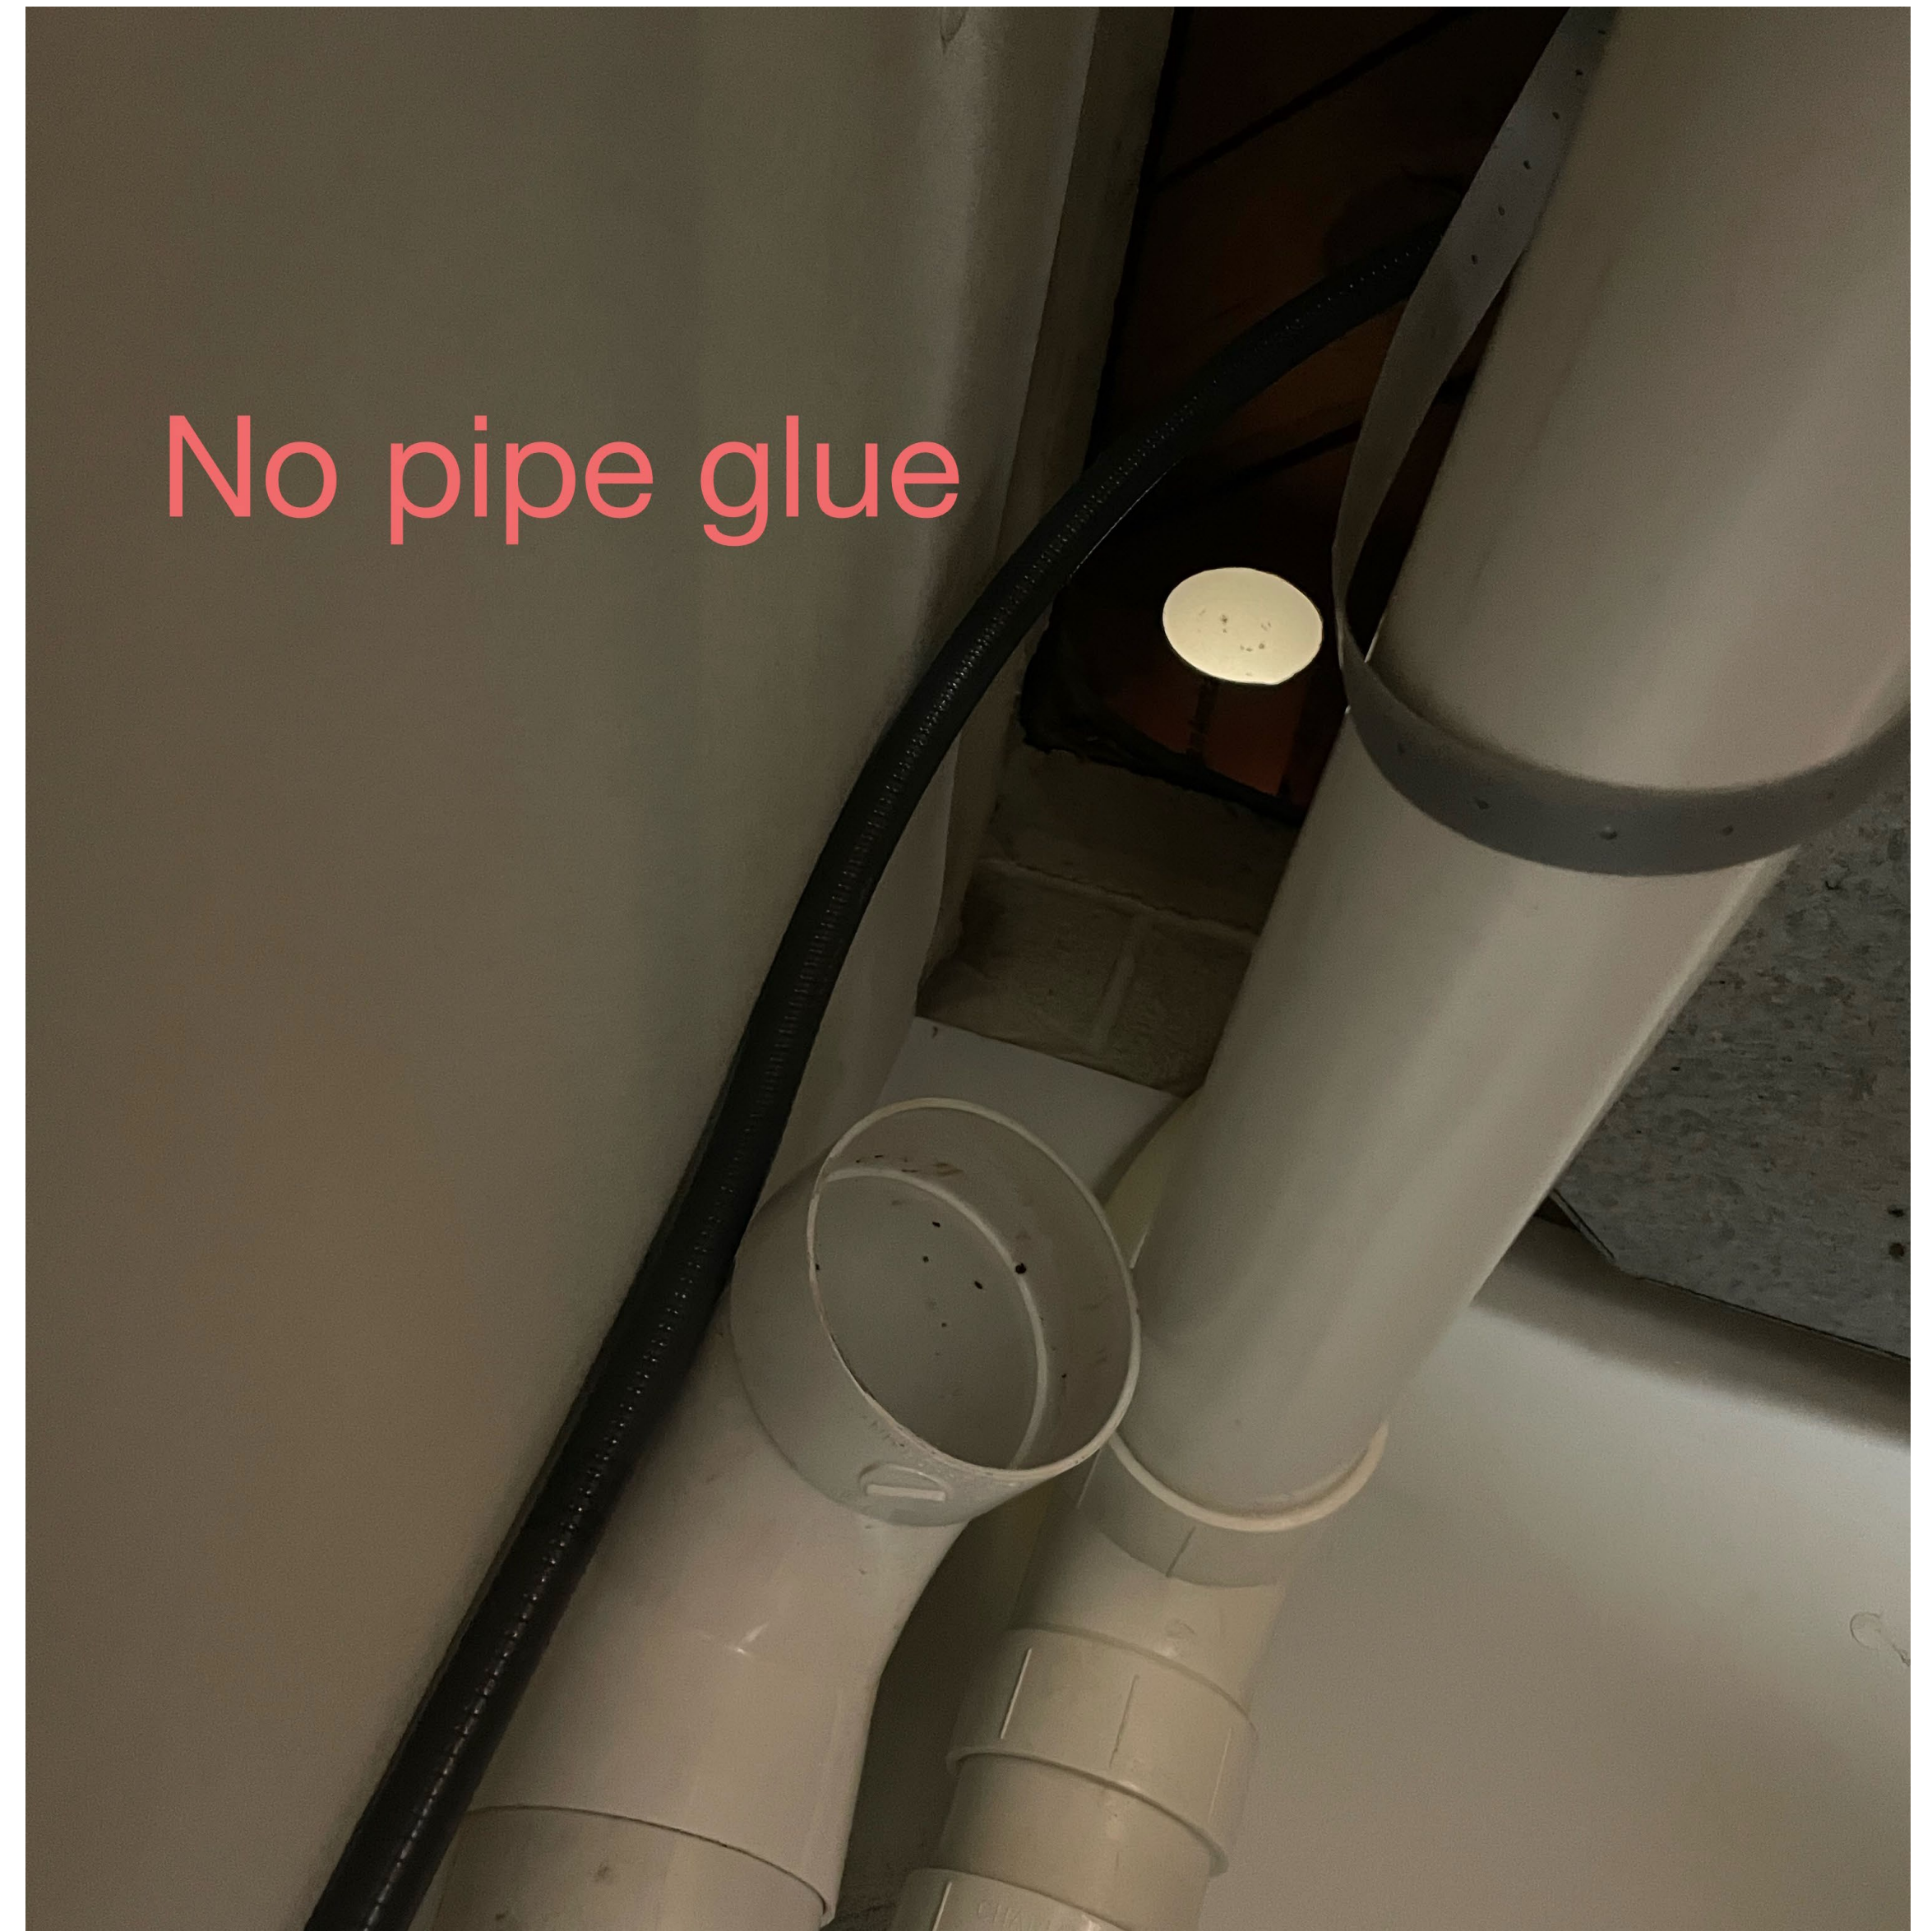
No glue issue

- In all sincerity, if this system was actually pulling radon, a portion of that radon would have been under pressure and being exhausted into the basement.
- Those of us that work in uninspected states need to be very conscious of this situation. Think of the liability if you are shown to have exhaust radon into the home and the results that can follow.

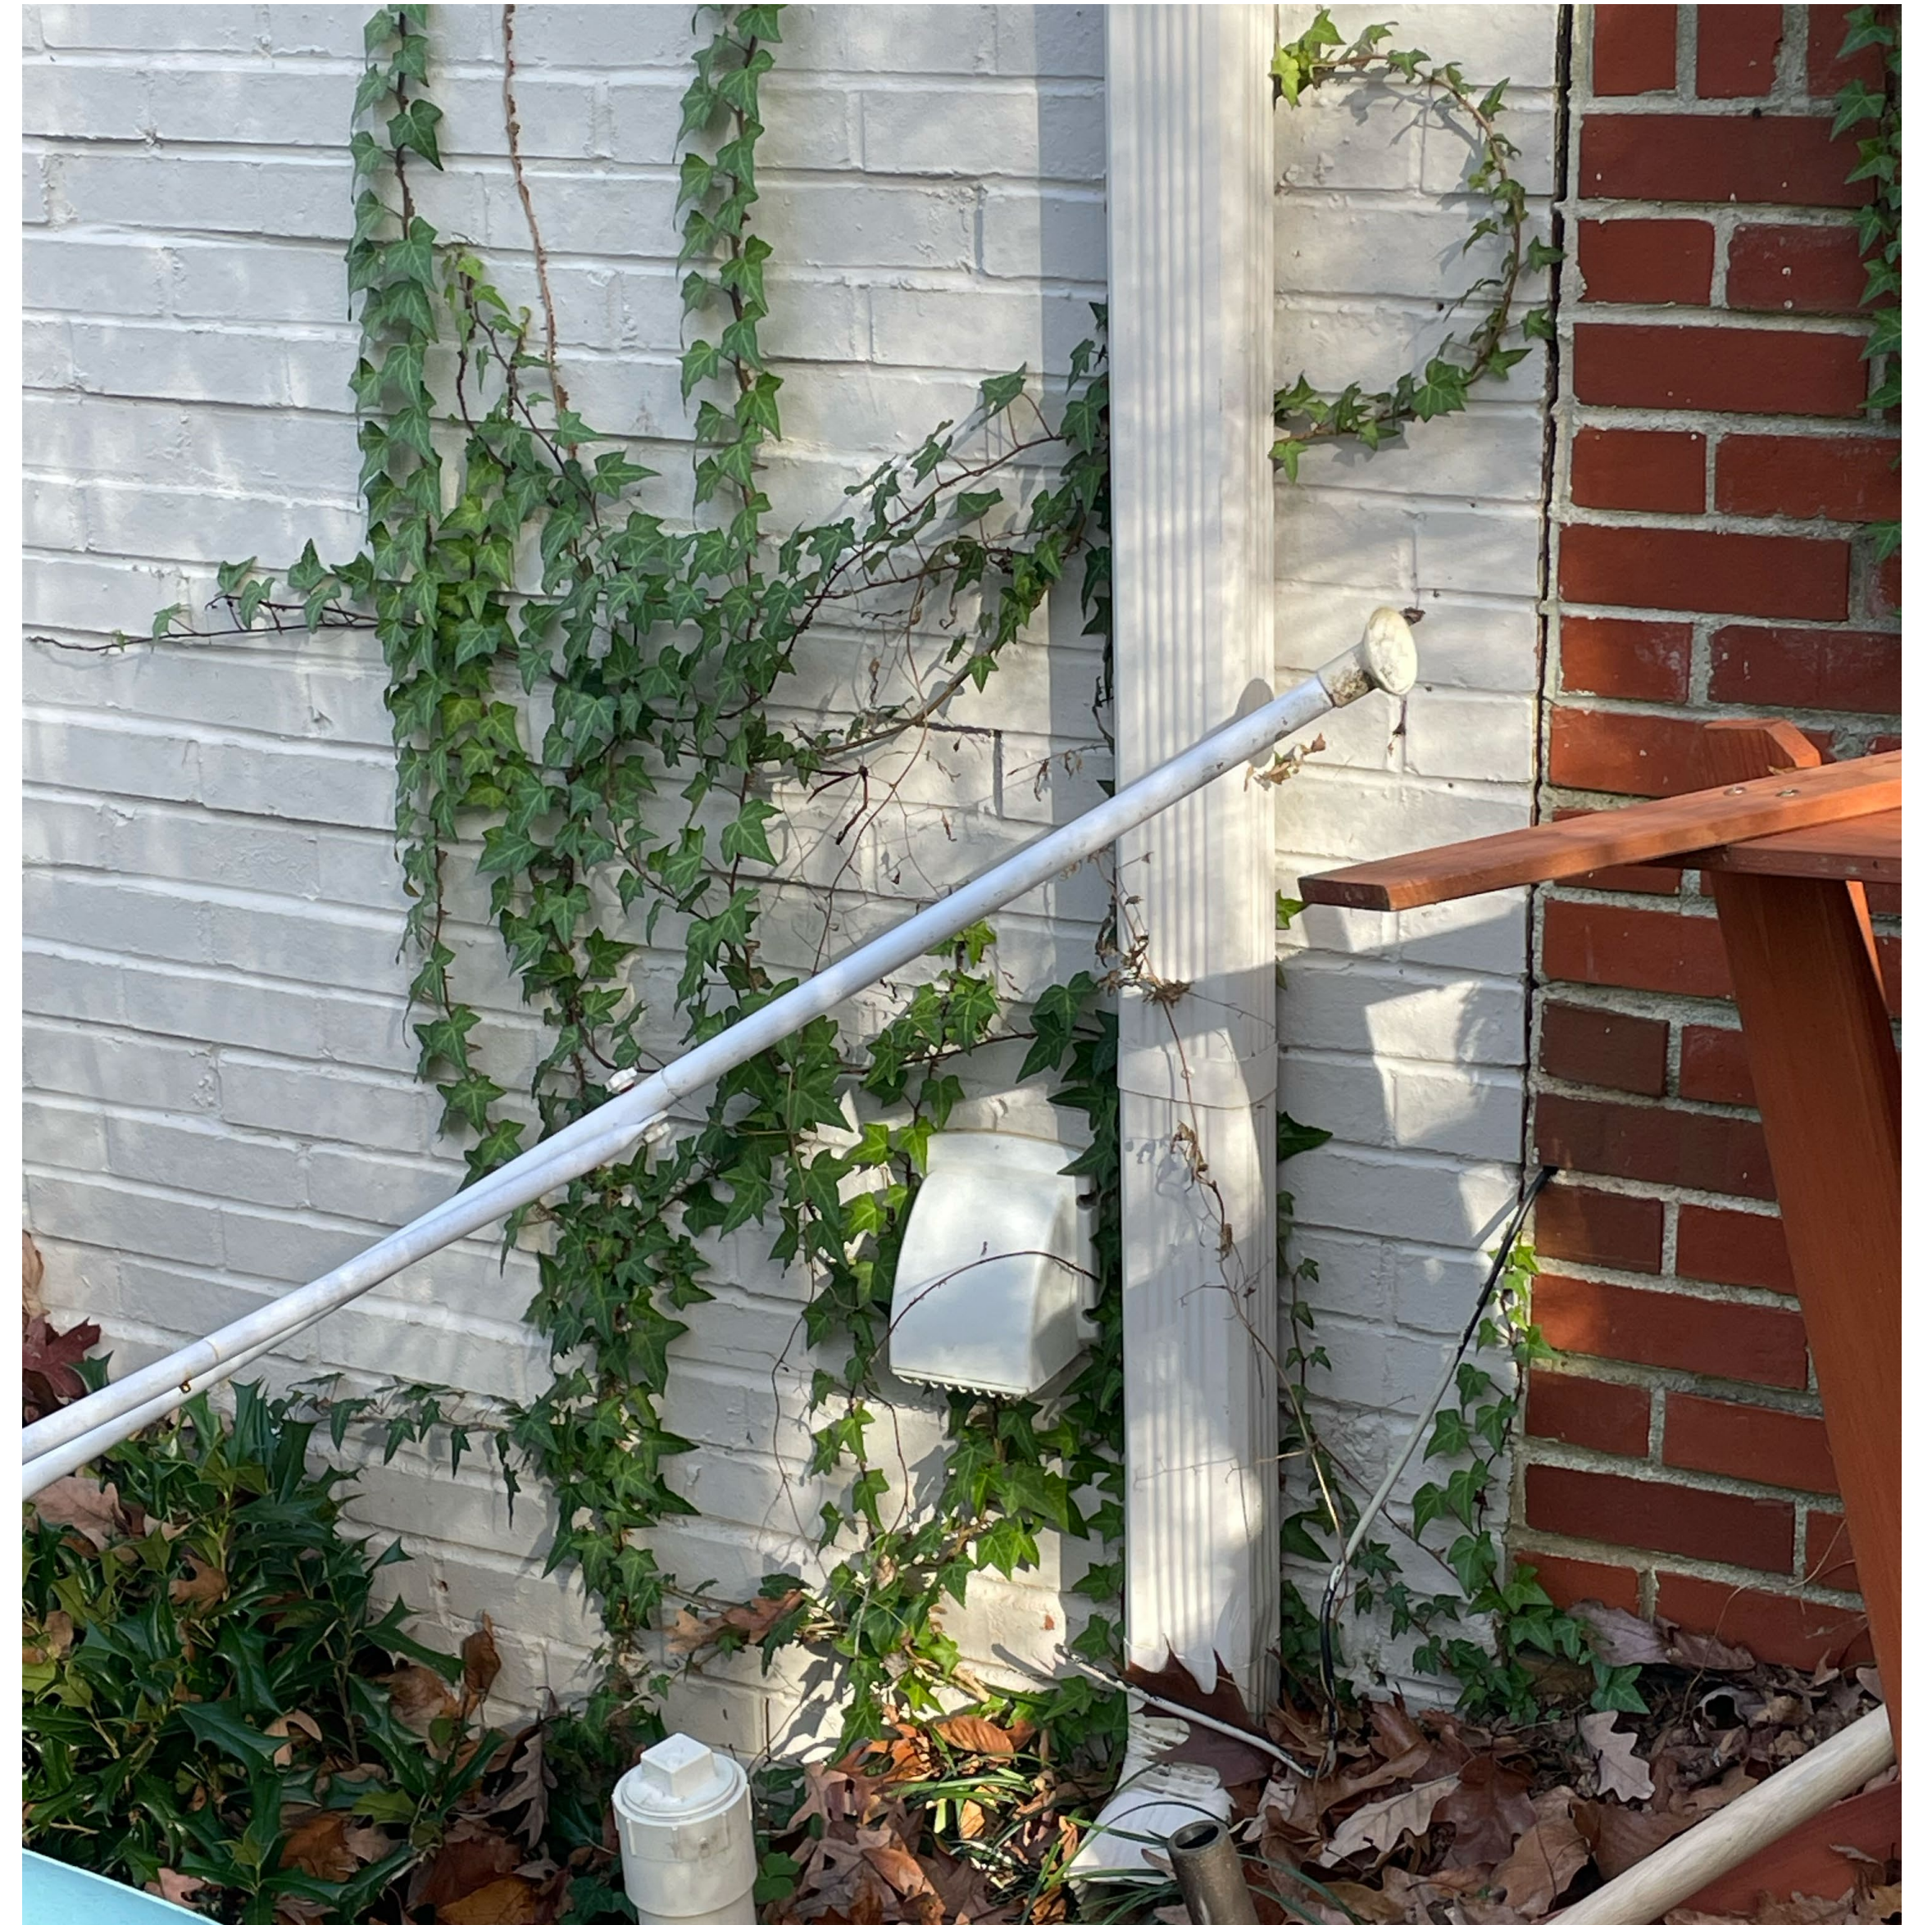
Exhaust point at ground level

- The dryer vent seen in this photo is the exhaust point from one of the interior radon systems.
- There is a path all around this house, and a window just above this exhaust.

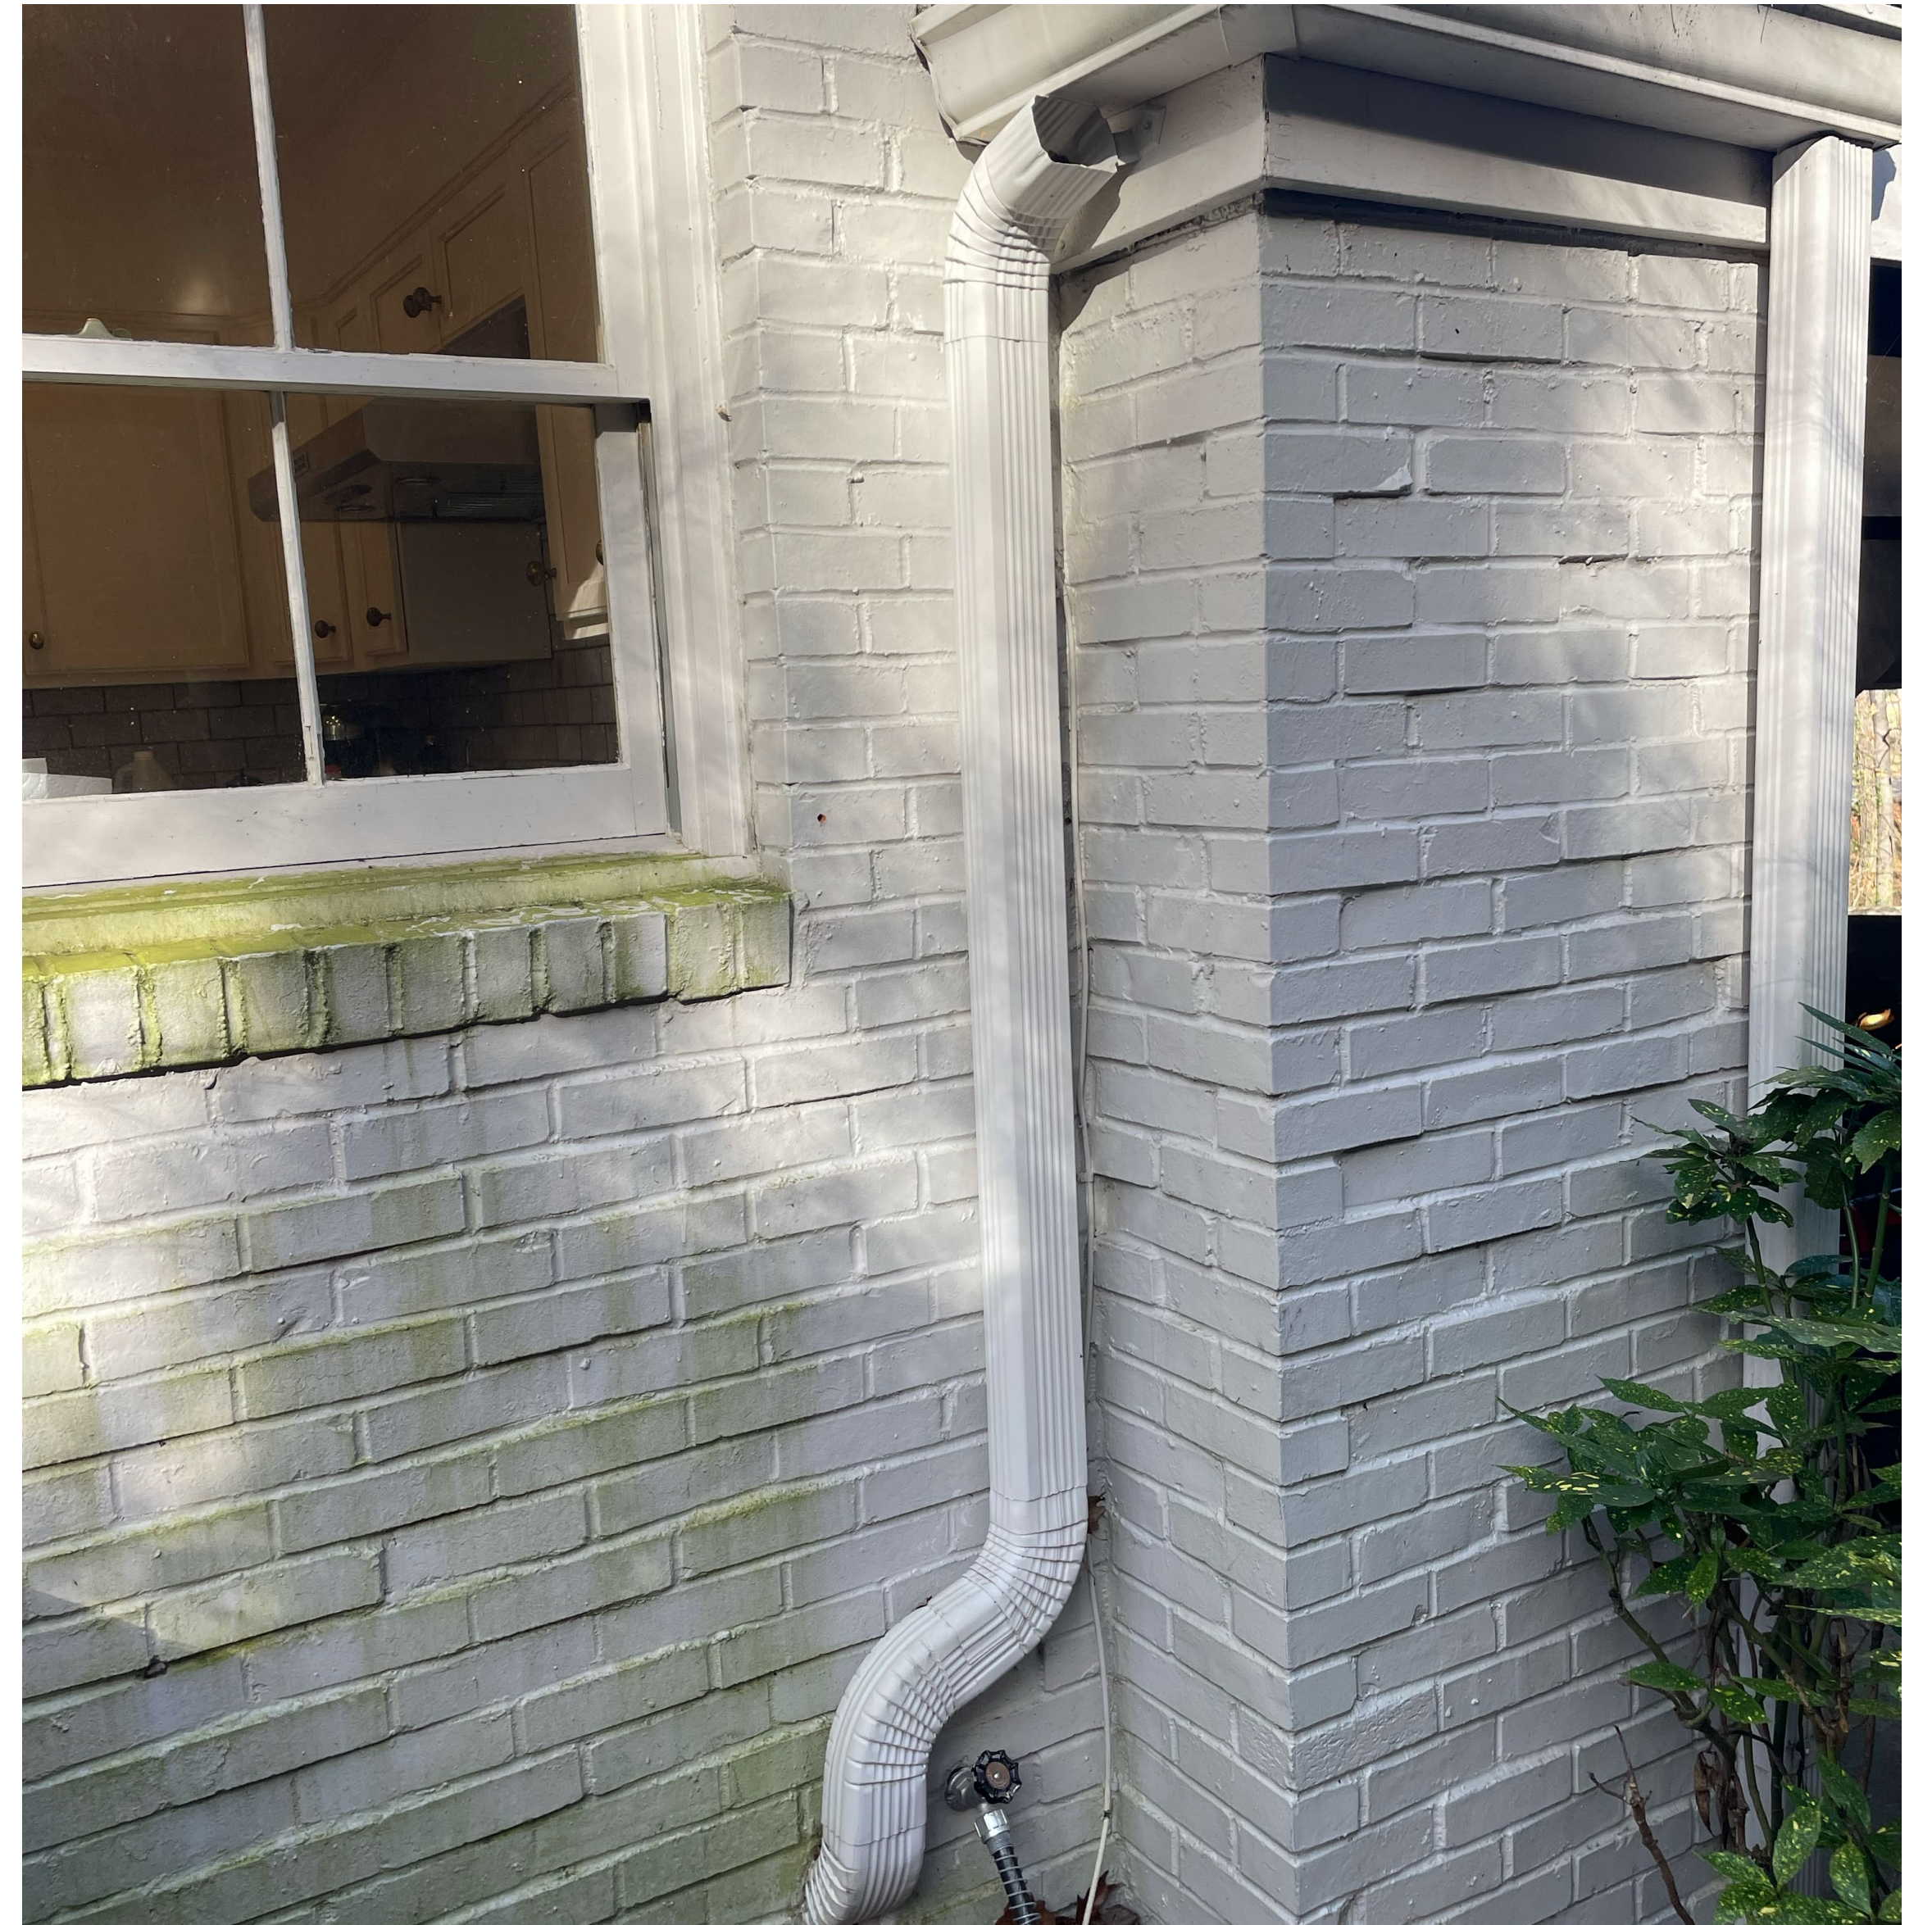
Exhaust next to window

- Again, multiple things wrong here
- Gutter material is not an accepted piping material as it cannot be sealed at the joints
- Again, this pipe also right next to a path, probably used daily as it is from the carport to the rear entry of the home

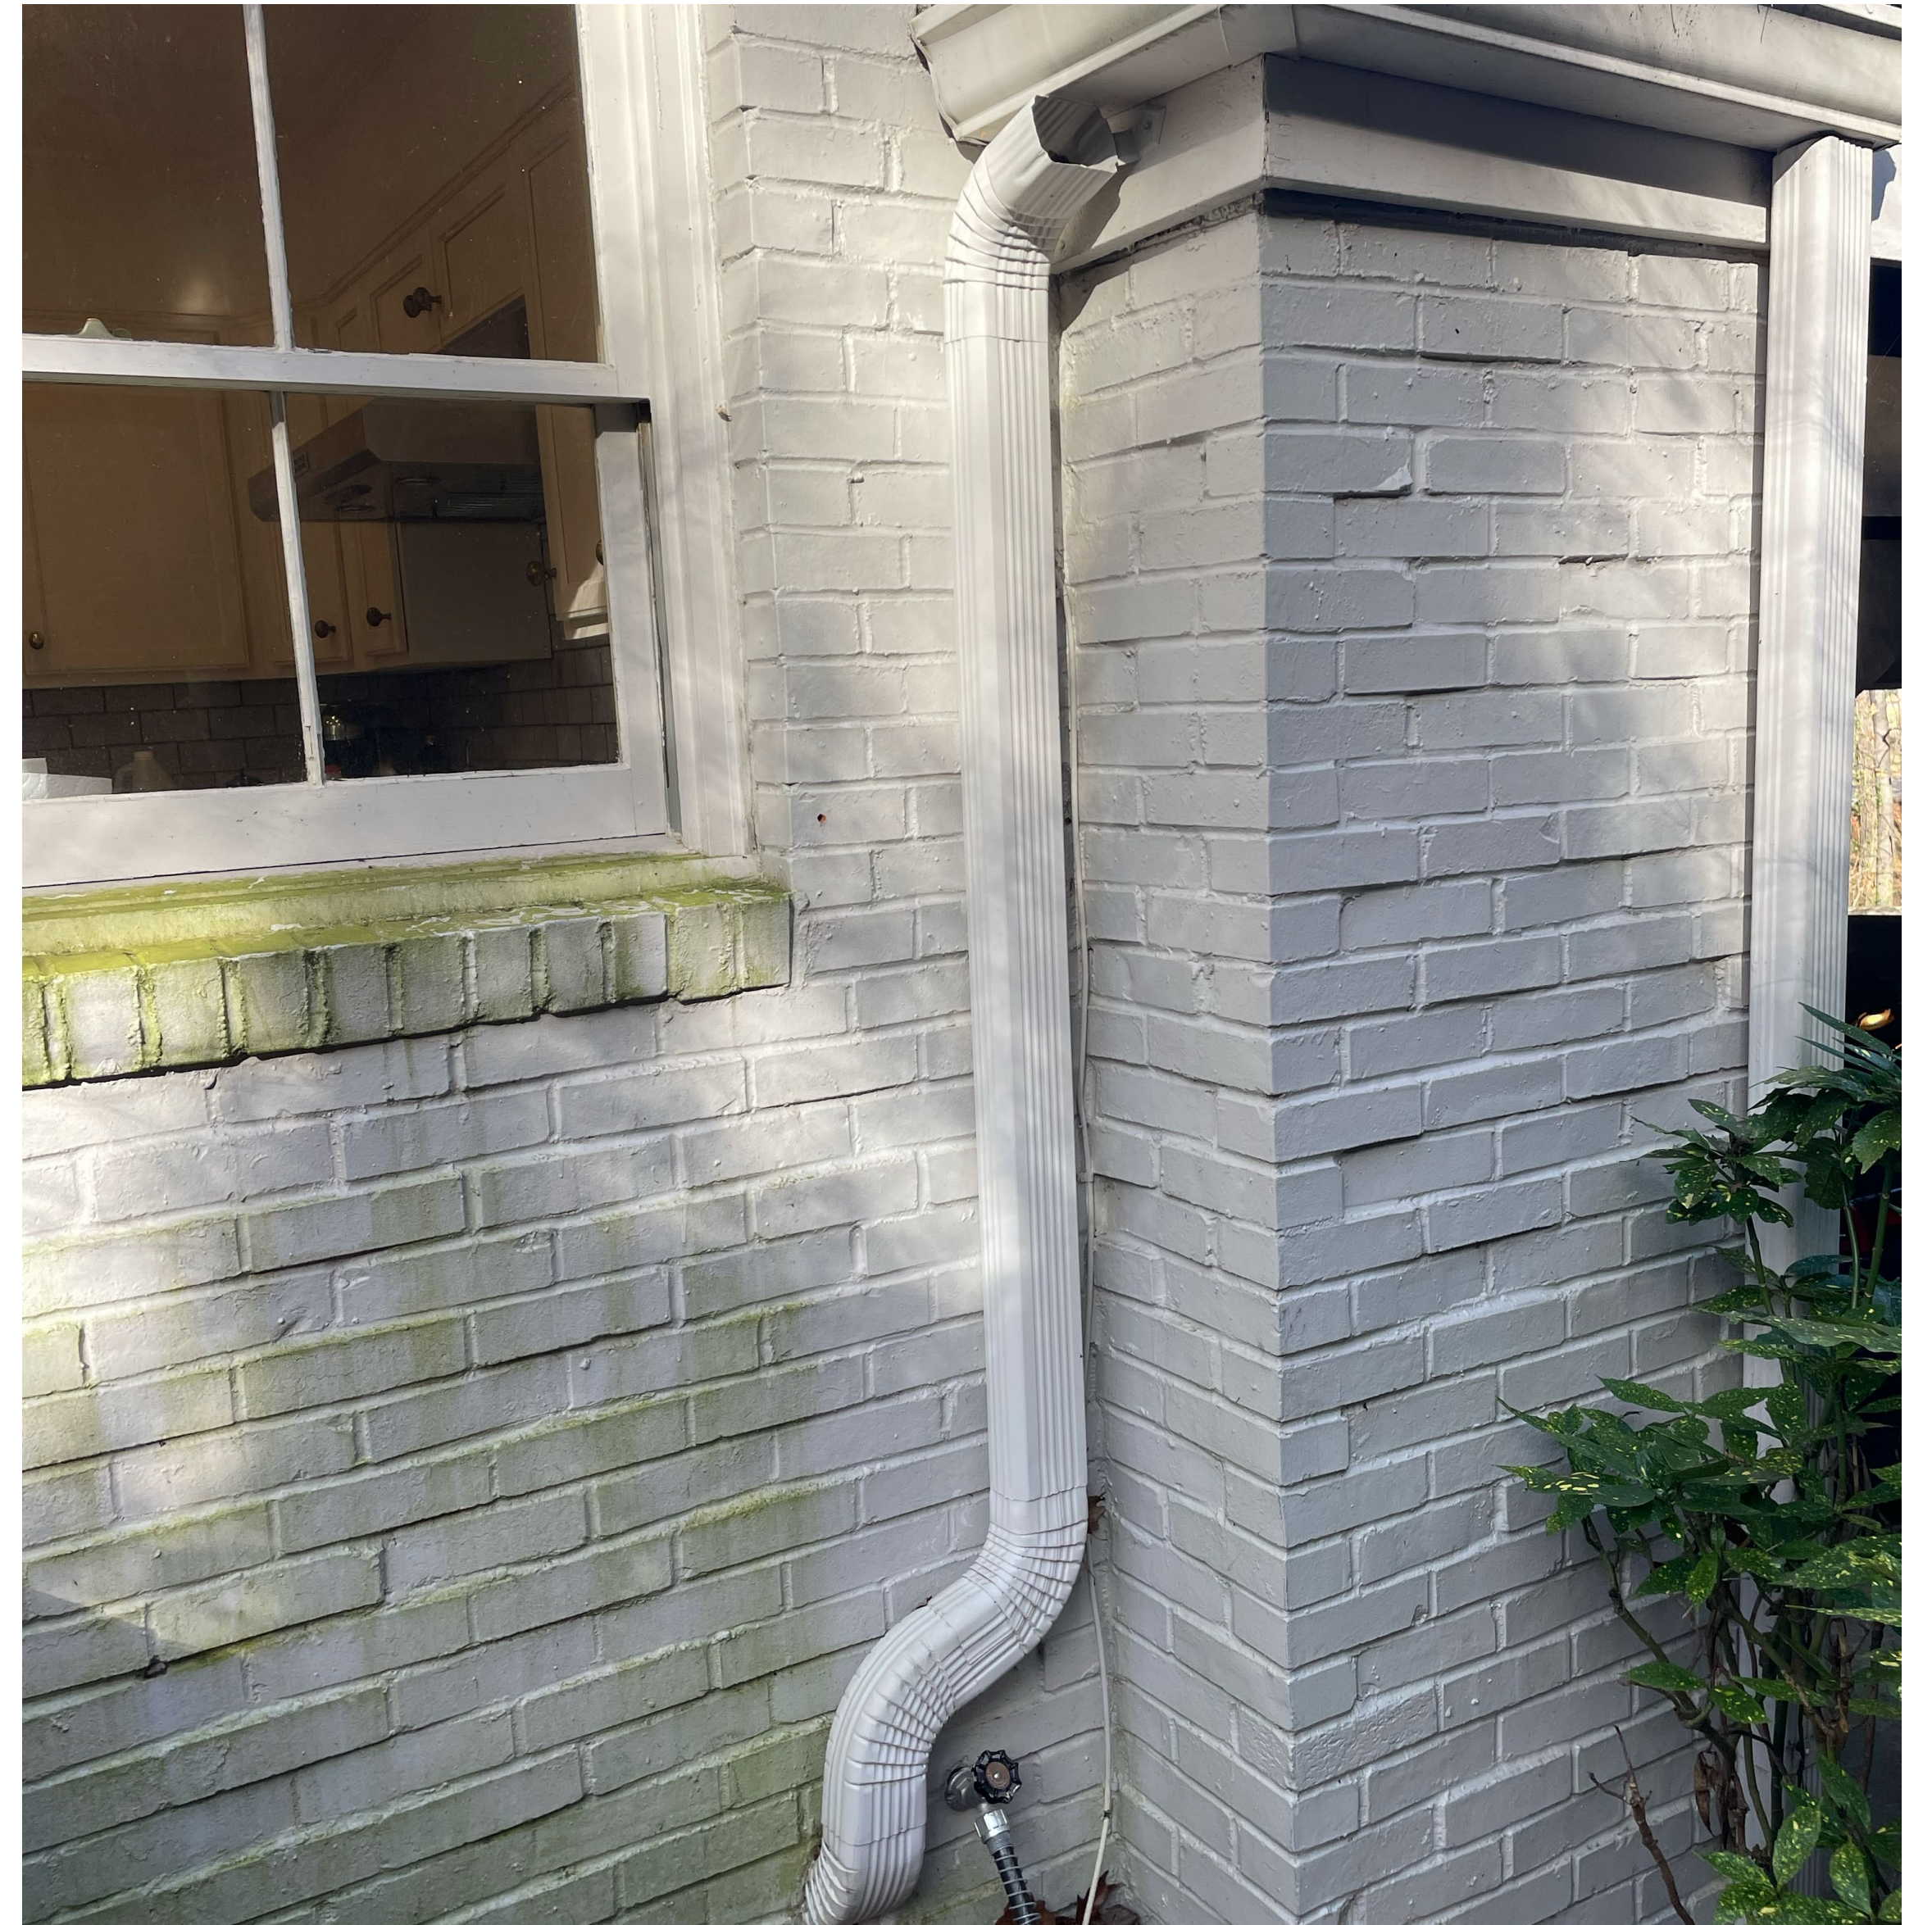
Proximity to window

- I know it is an old looking house, but these are operable windows
- The exhaust for this system is right next to the window
- Clearly the installers have not looked at the standard at any time.
