Health Care Facility Vapor Intrusion (VI) Assessment and Mitigation

By: Michael Devir, PE
KERAMIDA Inc.

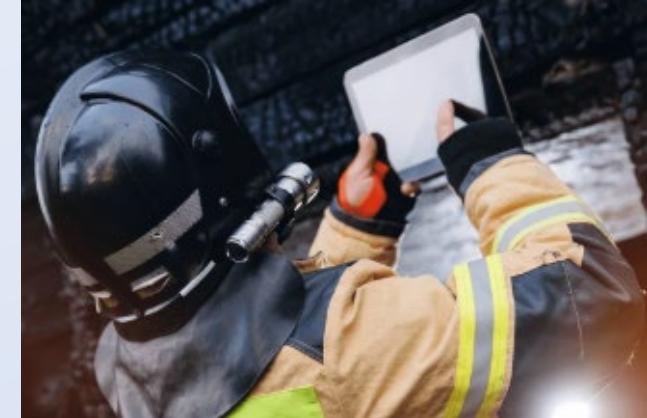
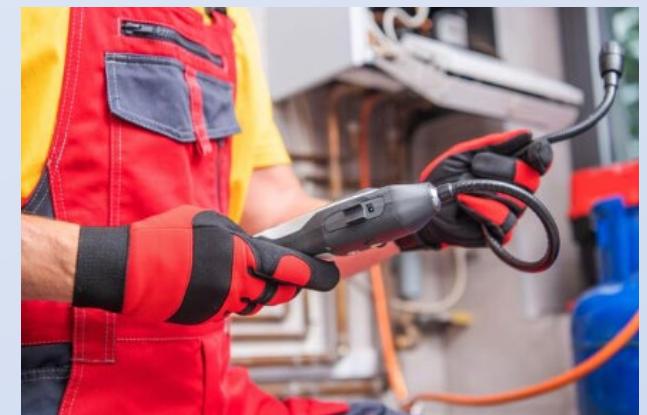
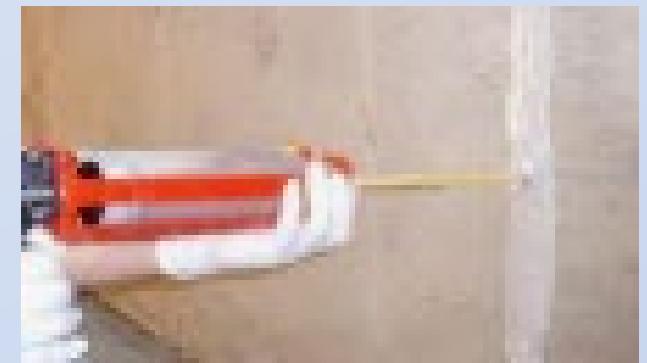
- Response by IDEM Emergency Response & Local Fire Marshal
 - Facility inspection (find elevated VOCs in basement)
 - Basement wall crack (Floor to Ceiling) w/highest VOCs reading
 - Recommend Facility Evacuation
- Client Concerns
 - OSHA citation and worker compensation claims
- Measures by Maintenance Personnel
 - Caulk/seal the large basement wall crack
- Monitoring Program Initiated by Clinic

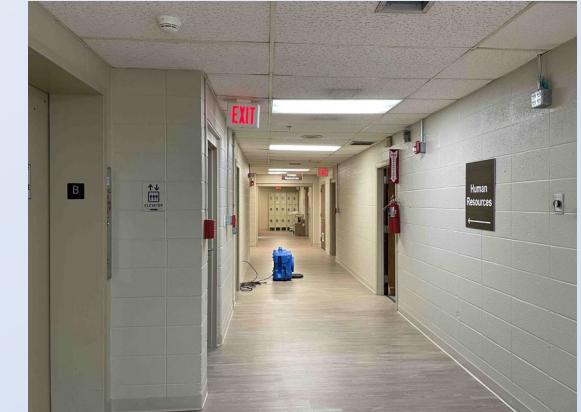
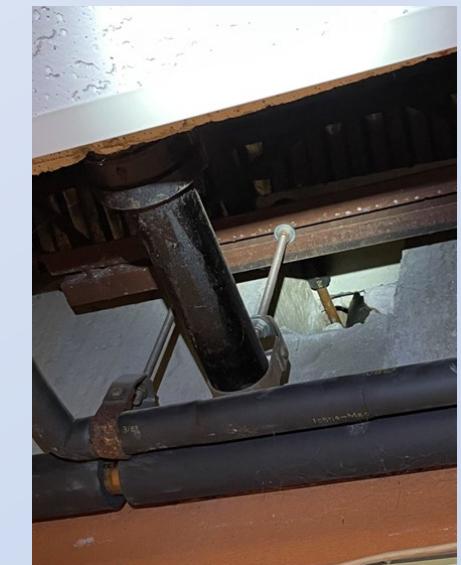
- Evening Following the 2nd Evacuation
- Visual Inspection of Facility (basement, walls, ceiling, HVAC, foundation penetrations, etc.)
- Screen Indoor Air Using VOC Detector and LEL meter
 - Low VOCs (4 ppm), no LEL response, and little or no odors
- Wall Penetrations Observed Above Ceiling Tiles
 - Some penetrations open to exterior soil
- Recommend Penetrations Sealed, as Feasible

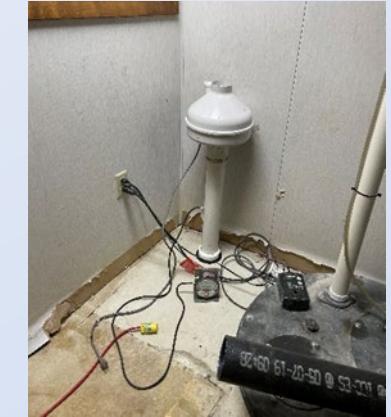
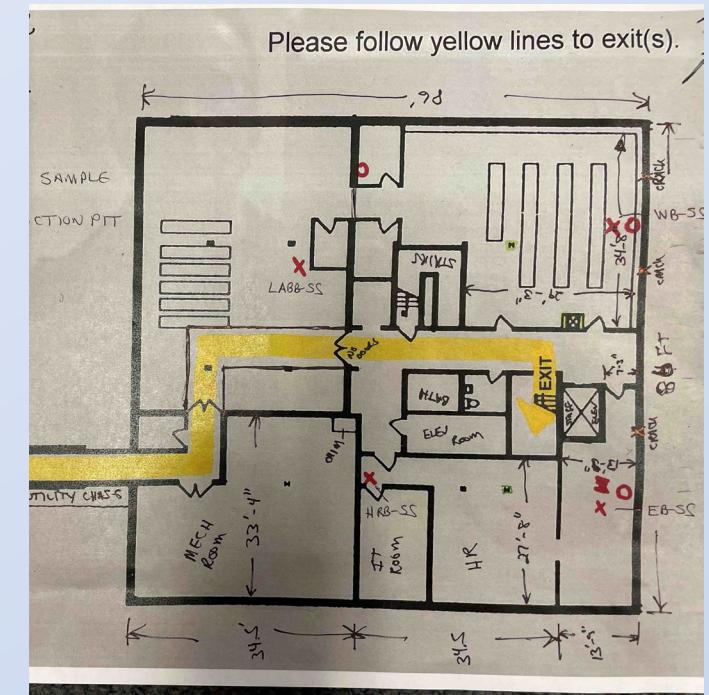
- Basement Testing – Cored Floor in target areas, installed vapor pins, conducted fan testing and measured pressure (PFE) across slab
- Installed 3 suction points & piped into east and west systems
- Utilized temporary fans (RP-145 & RP-265) for testing and preliminary VI control
- Goal of (- 0.004 in wc) not obtained across targeted VI Area (using available GX-3 & GX-4)

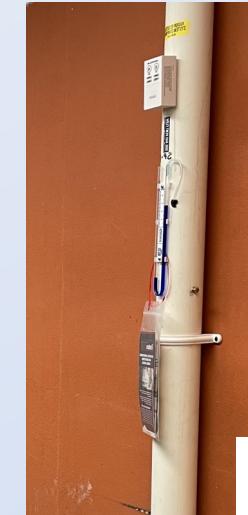
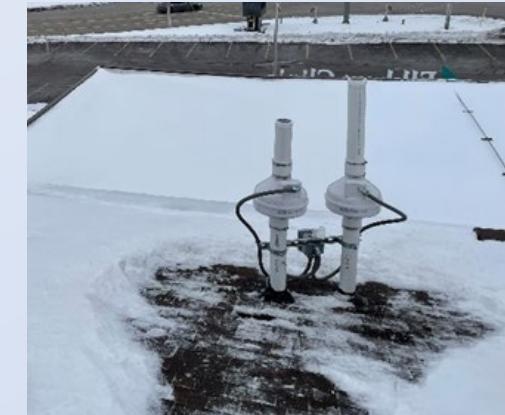
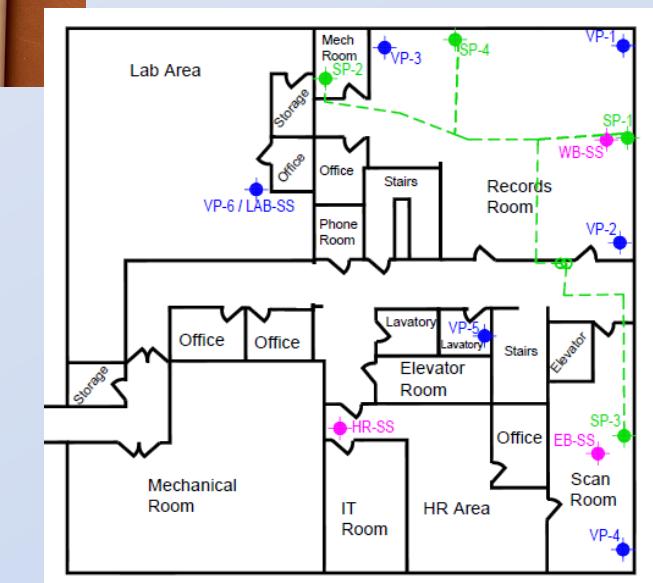
- GX-5 Fans (5.2 in wc) installed (snowy sloped roof)
- Operation evaluated with the stronger fans
 - PFE testing of all vapor pins
- Addition of suction point on east system
 - Flow balanced on east system
 - Goal of (-0.004 in wc) achieved across VI target area
 - Flow alarms and labels installed

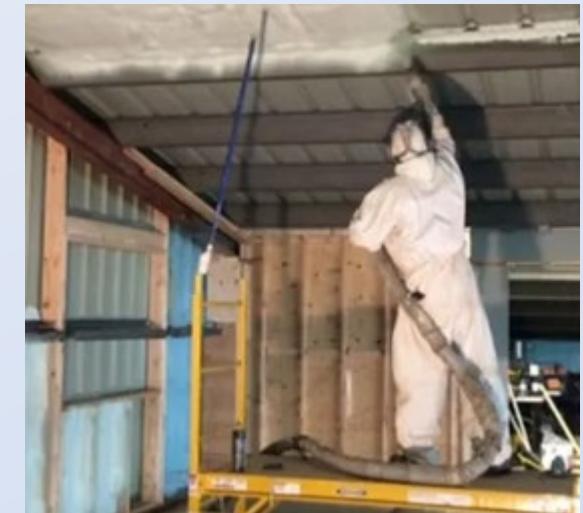
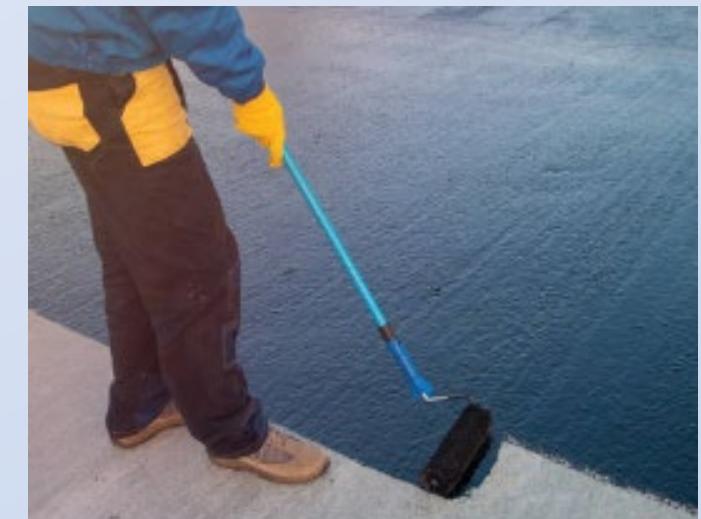
- Spray Foam Contractor – Client had upper basement walls and penetrations sealed
- Floor and Walls Sealed – Client had basement floor and walls prepped and sealed in 2 rooms w/ highest VOCs

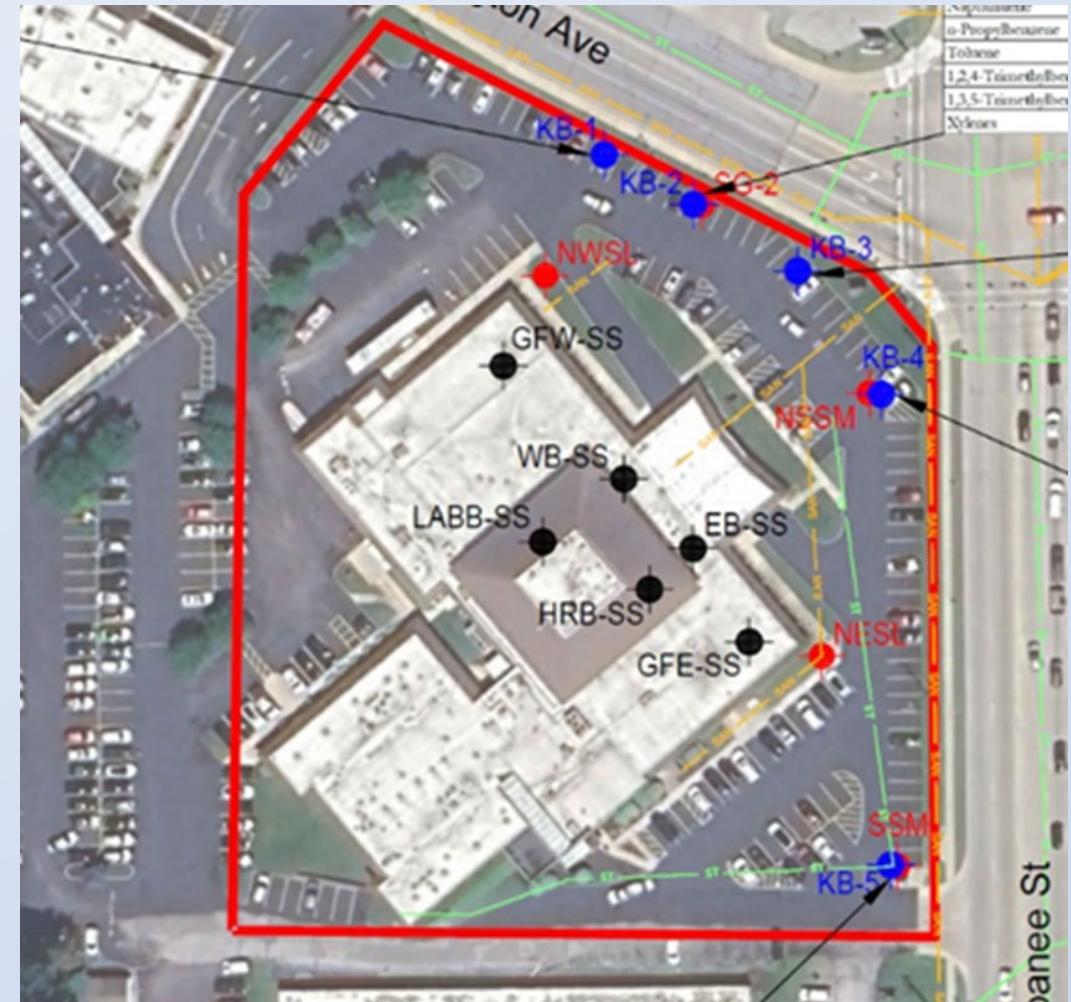
- Soil: Below IDEM R2 Resident PLs
- Groundwater: > IDEM R2 GW PLs
 - 4 northern boring report gasoline VOCs
 - Highest in northeast parking lot boring
- Soil Gas: < IDEM R2 Vapor PLs
 - Report detection of GRO and multi-VOCs
- Sub-Slab (in building): > R2 Comm. PLs
 - GRO compounds w/highest results in basement along north wall/upgradient
 - Concentrations 2-4 X decrease (N to S)
 - GW within 6 to 8 ft of basement slab
