Case Study: Difficult to Mitigate Home

Matt Koch

AVIP 2025 Conference

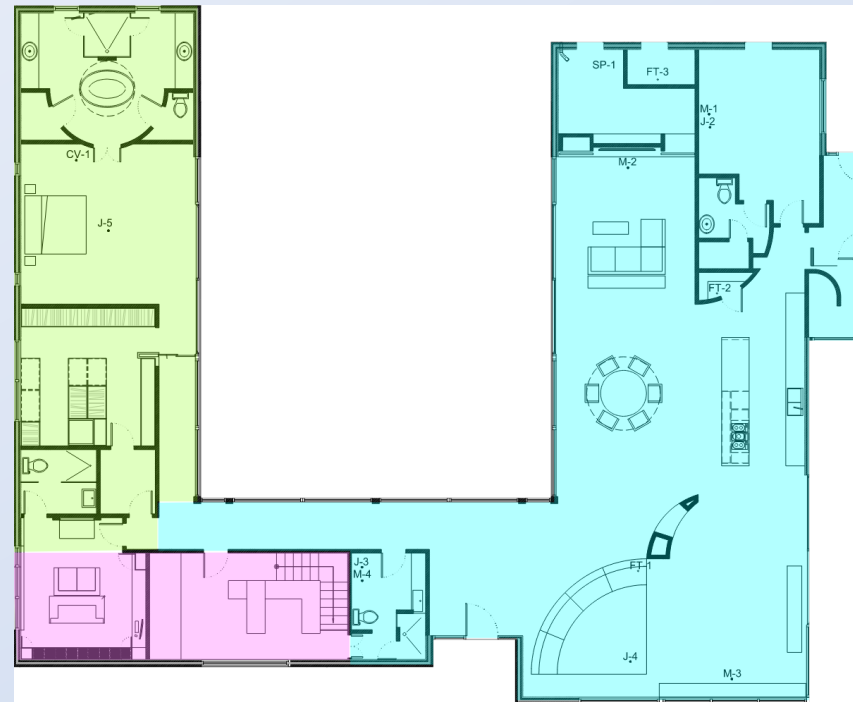
7.5 pCi/L
Master (first floor)

11.8 pCi/L
Crawlspace
(under master)

8.5 pCi/L
Basement

10.8 pCi/L
Main living area

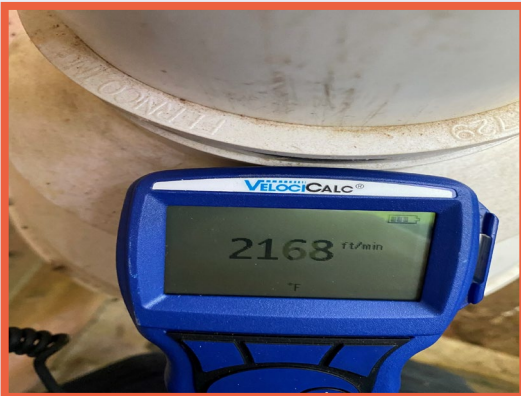
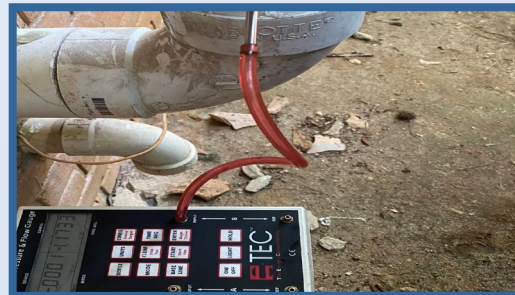
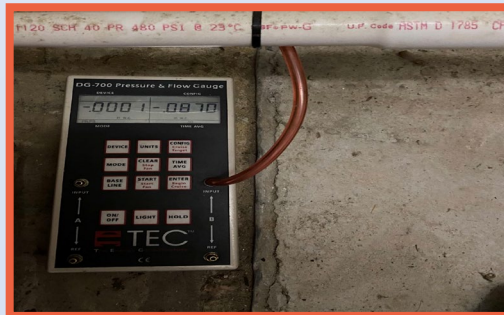
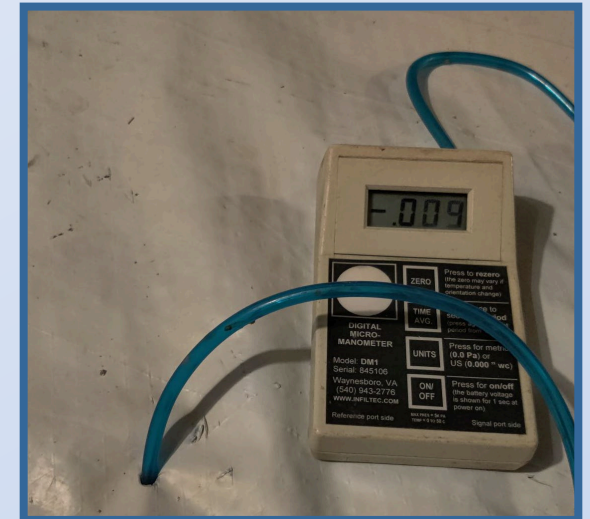
- Performance of each system measured
 - Air flow in exhaust vent
 - Air pressure across fan
 - Sub-slab PFE
 - Sub-membrane PFE

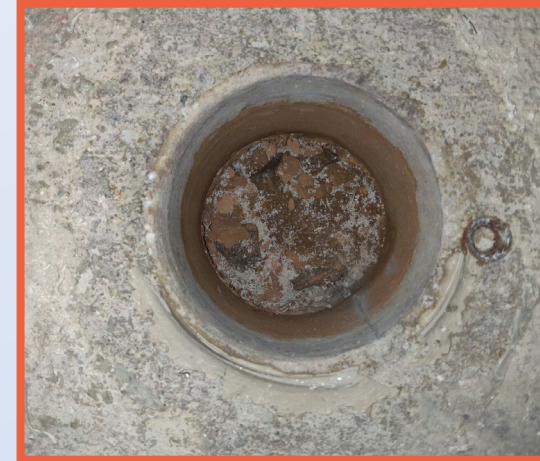
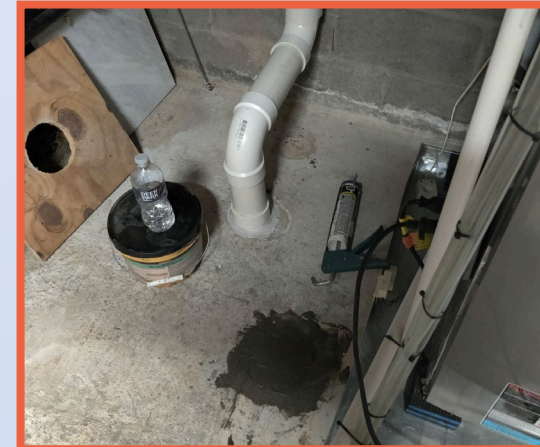
System 2

- Intrusive evaluation of system
 - Cut pipe – inspect pit
 - No pit dug
 - Hard Clay
- Dig larger pit
- Core hole in new concrete where trench for plumbing work was created to connect pit with loose soil under new concrete
- Replace fan with high pressure/high flow fan

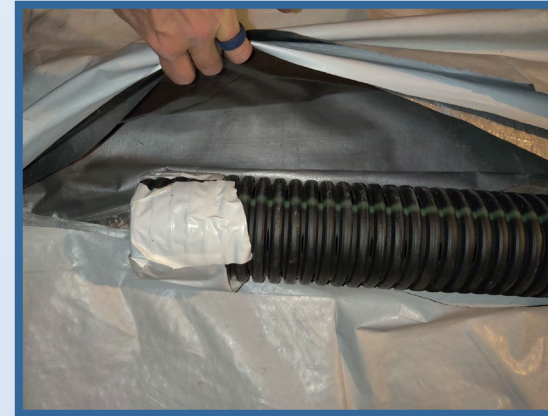
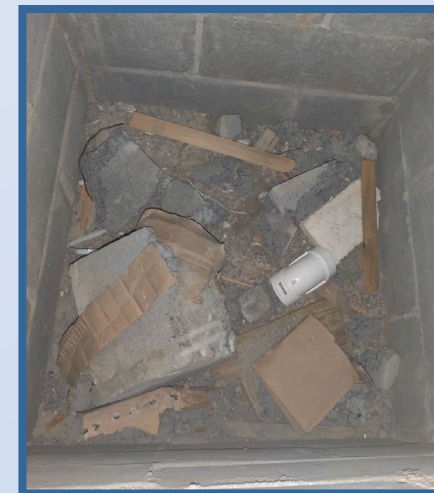
System 3

- Intrusive evaluation of system
 - Cut vapor barrier – inspect vapor collection system
 - Tarps installed over soil
 - Perforated pipe installed ON TOP of tarps
 - Previously installed pipes to other side of crawlspace were abandoned
 - Area in center of crawlspace with block wall with exposed soil in center

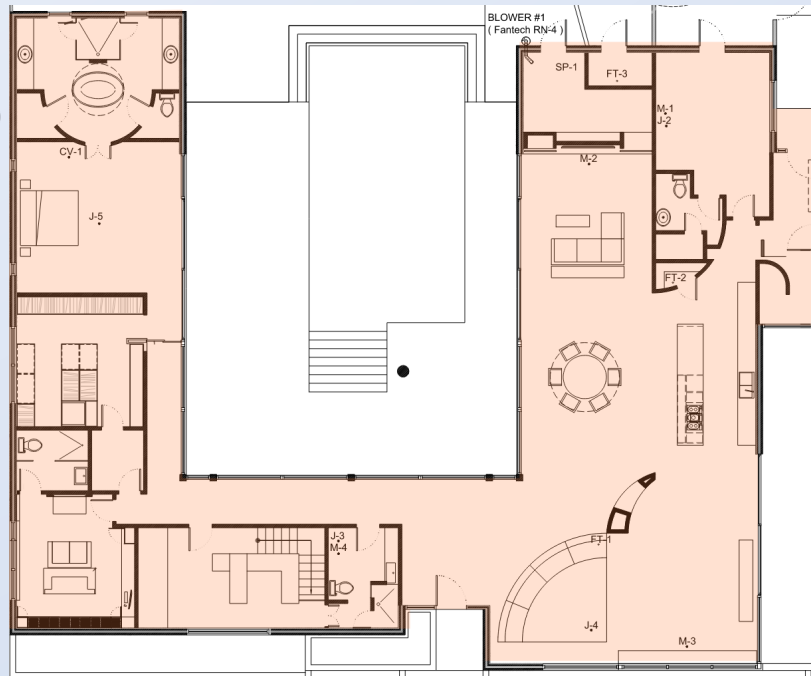
1.0 pCi/L
Master (first floor)
86% Reduction

0.9 pCi/L
Basement
84% Reduction

0.6 pCi/L
Main living area
94% Reduction
