5 Year Mitigation Licensing Recap

MN Licensing Program Overview

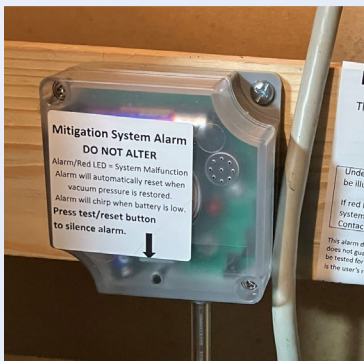
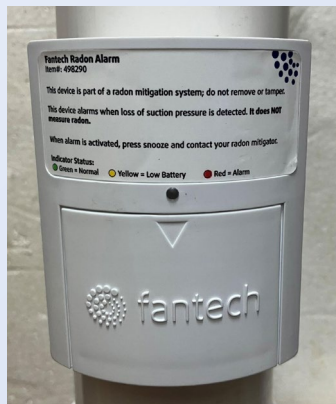
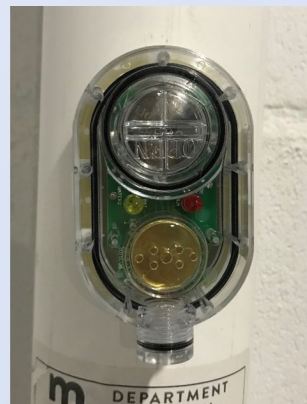
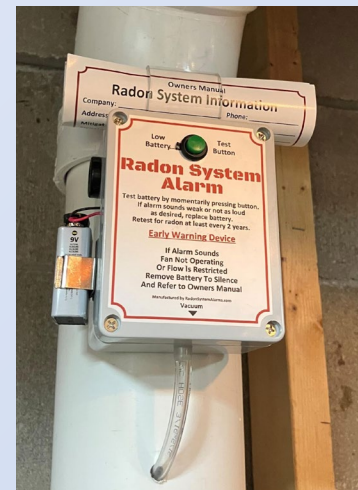
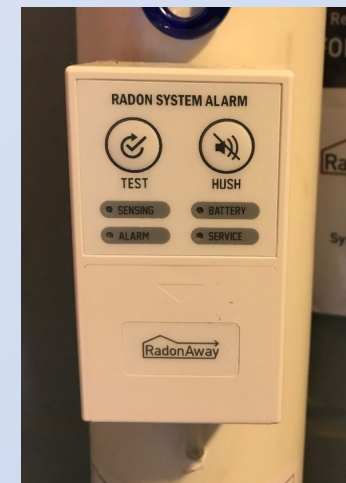
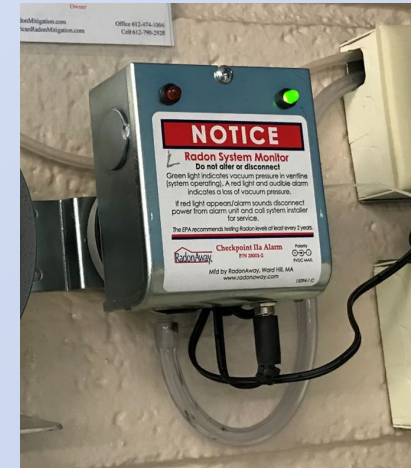
- 3% - no alarm in year 5 – down from 73% in year 1
- Still had another 4% that aren't activated but even that has improved in the last few years
- New concerns of proper installation, function, reliability, and homeowner understanding of how to operate it
- Some new options available

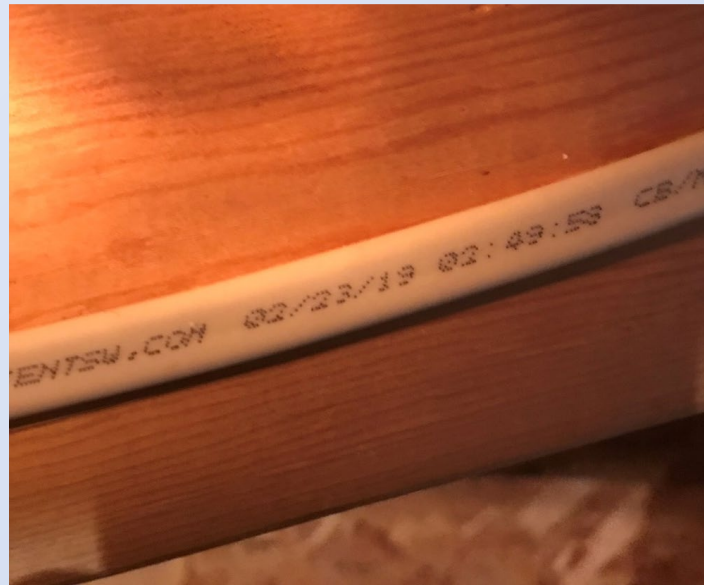
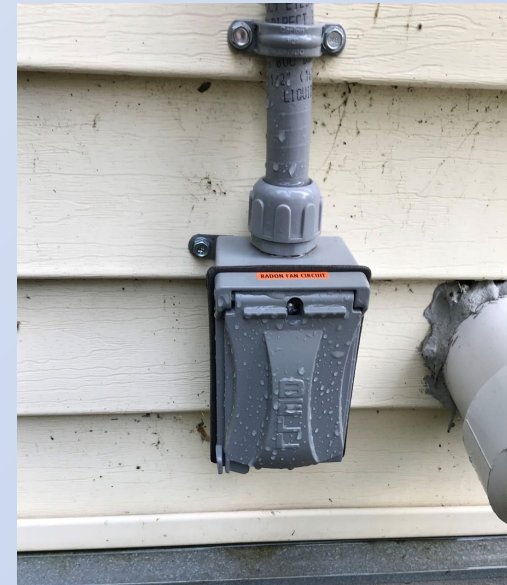
- 41% - Electrical permit not obtained or the permit was never finalized
 - Regulated by electrical inspector and not MDH - Noted on the checklist for the homeowner and contractor to follow up on
 - Down from 58% in year one but has consistently remains a very common issue each year

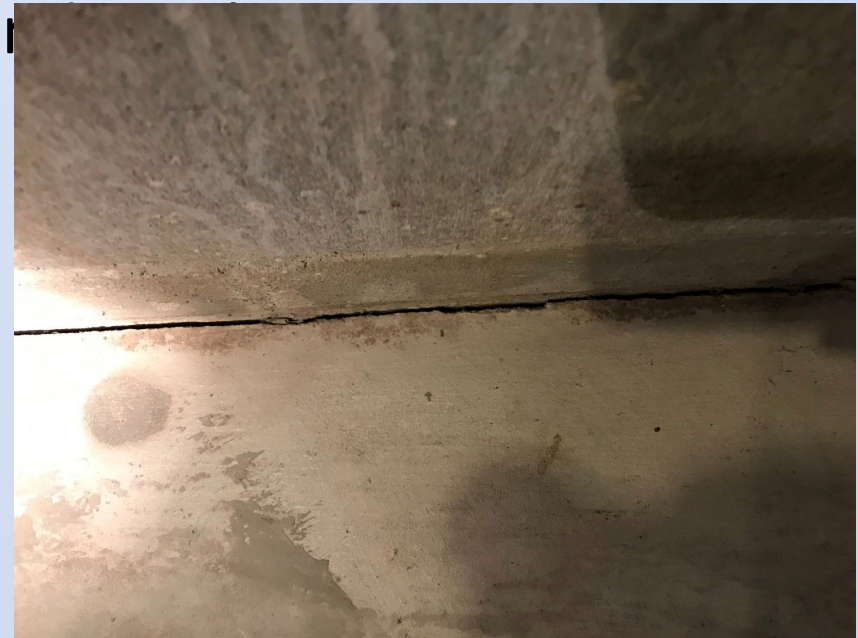
17% - Not sealing floor/wall joint, utility penetrations, or large openings

- Instances of not sealing some openings has improved
- Little improvement on sealing large openings u

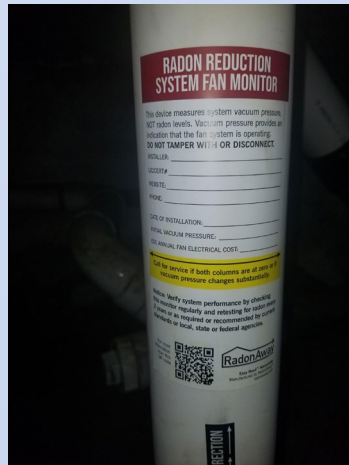
14% - Primary label missing information

- Includes most vital information for homeowner to know about maintaining the system.
- Huge improvements since year 1
- Most common item missing is not recording the initial manometer reading

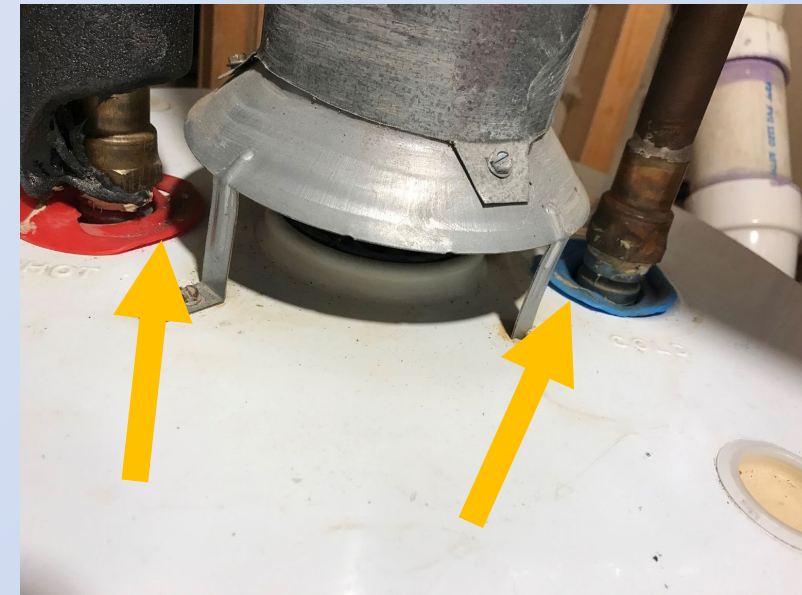
12% - Water heater shows signs of prior backdrafting – no improvement

- Not officially cited
- Added to the checklist to inform the homeowner and contractor

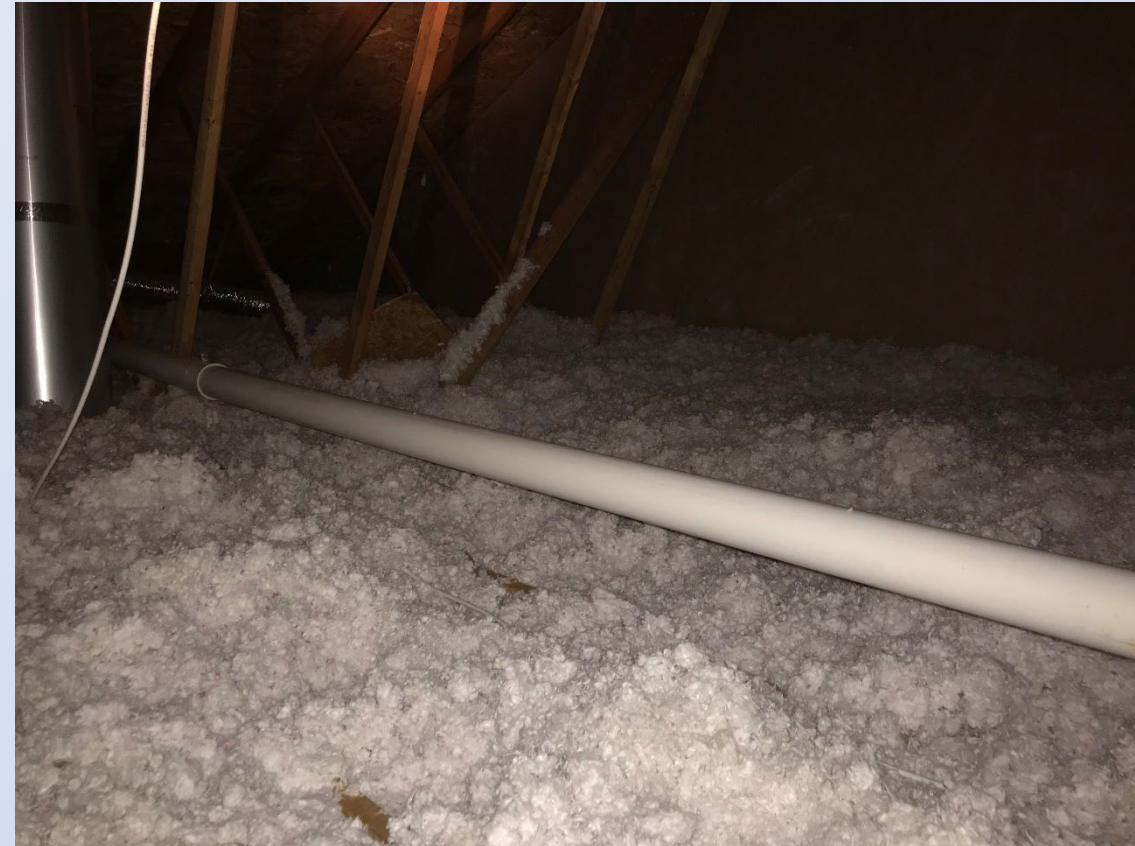
11% - Pipe support – down from 16% in year 1 but fairly common each year

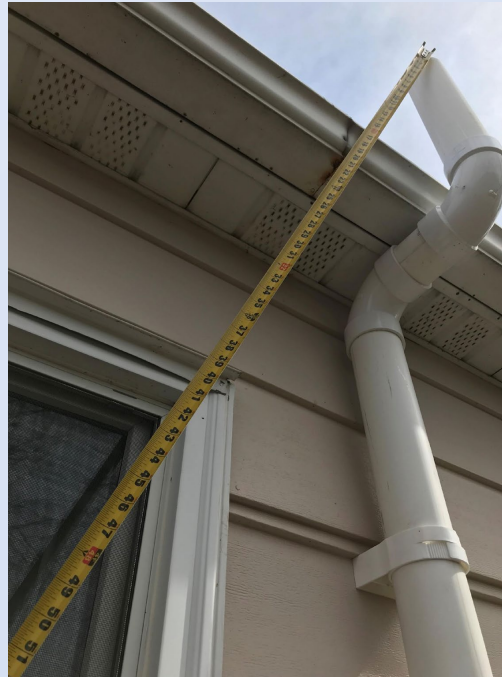
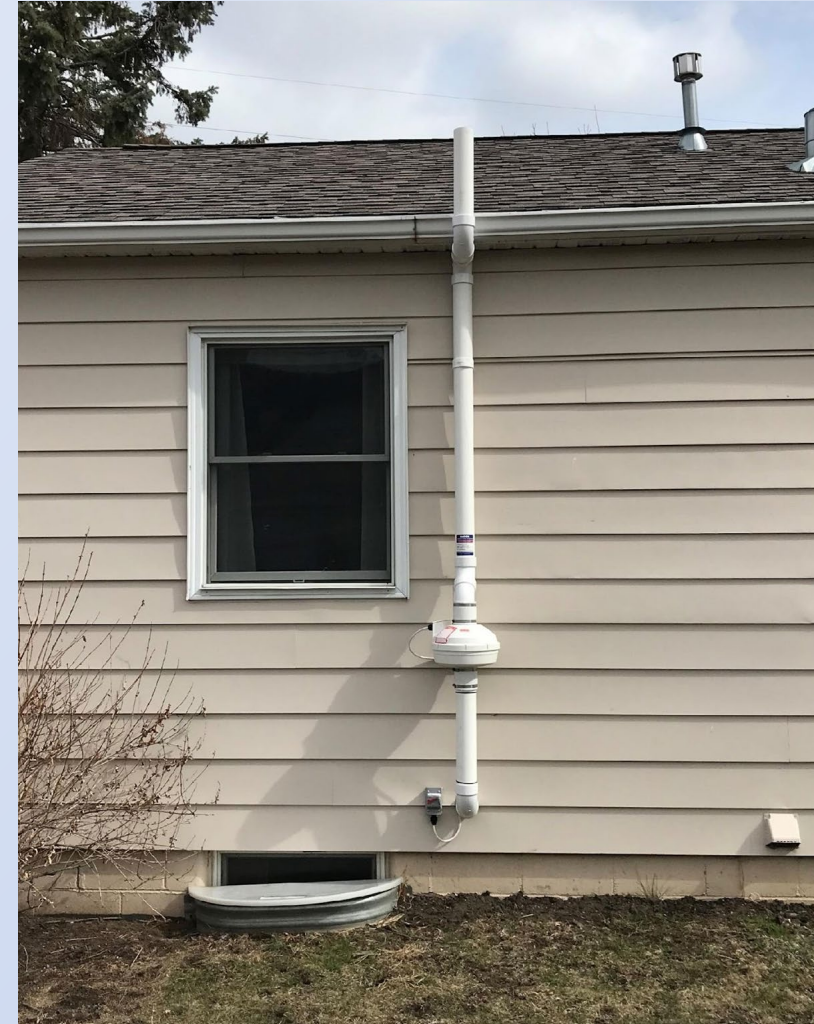
10% - Vent termination point issues

- Frequency was decreasing until additional and more detailed requirements came out in the last standard revisions.
- Is now trending back down again.

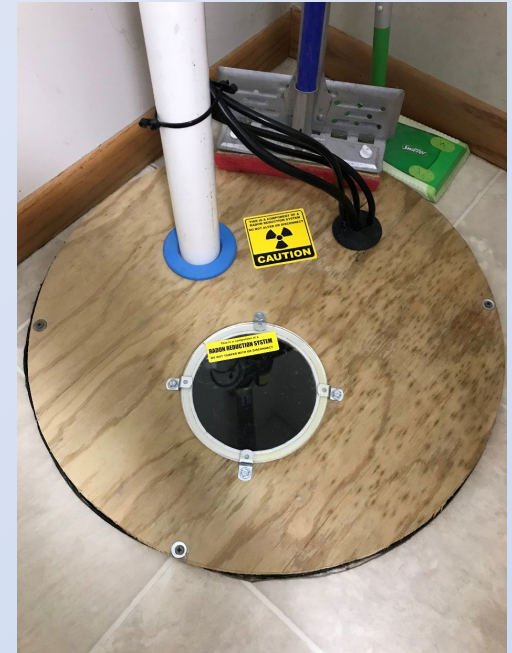
31% - had deficiencies with regards to dealing with sump baskets

- 10% - issues with sealing the sump cover
 - Not covered at all, cover that is not durable (tape), penetrations not sealed, etc...
 - Very little gains over the years – continues to be a common issue
- 10% - Sump access port missing / unapproved sealing method
 - Big improvement after 1st year but then has remained a consistent issue
- 8% - sump cover not labeled
 - Has had a general decline in prevalence over the years.

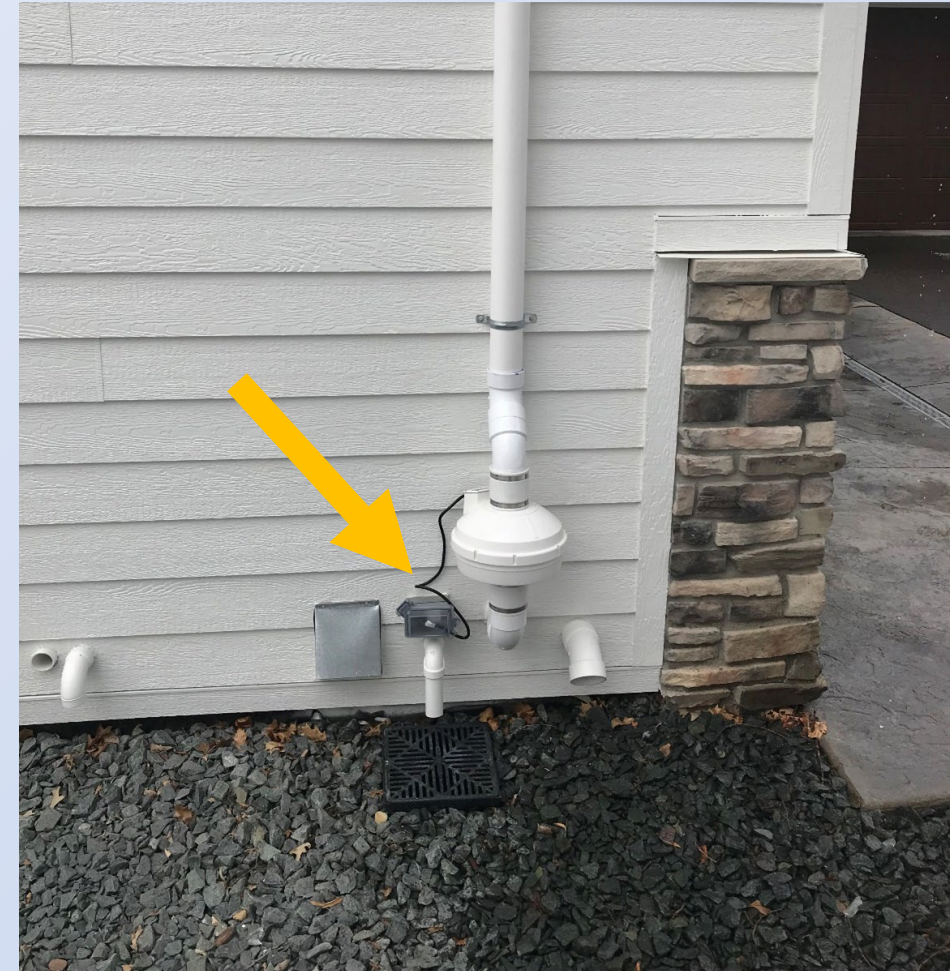
- 4% - Exterior fan with plugged disconnect
 - Down from 19% in year 1
