# Finally, A Solution For Sub-slab Ductwork!

Sealing Ductwork in Conjunction with Radon Mitigation

By: Jamie Dunn, Jourdan Dunn, and Jim Dunn  
Radon Technology/Dayton Duct Seal/Volcano Radon

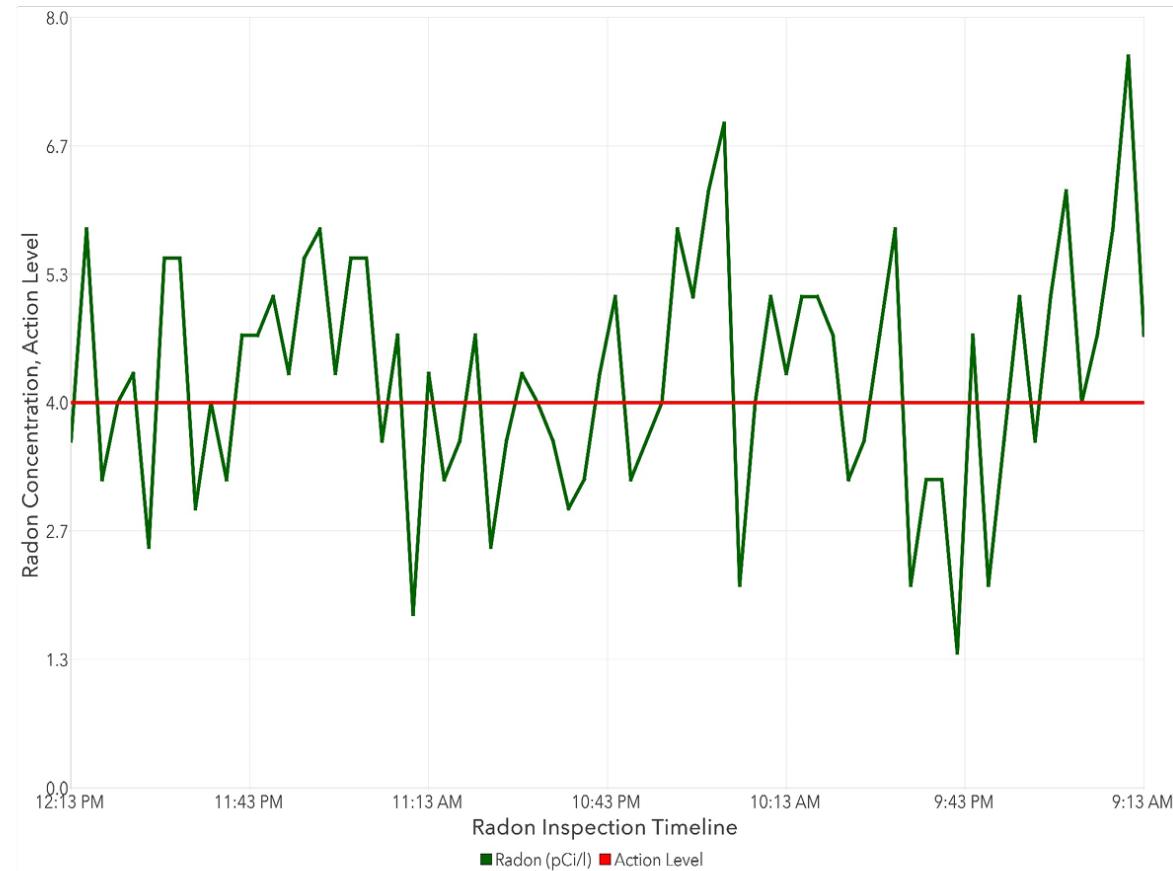
Radon Inspection Chart

**Lower Slab 4.3 pCi/L**

# Radon Test Results

## Mitigation With Sub-slab Ductwork

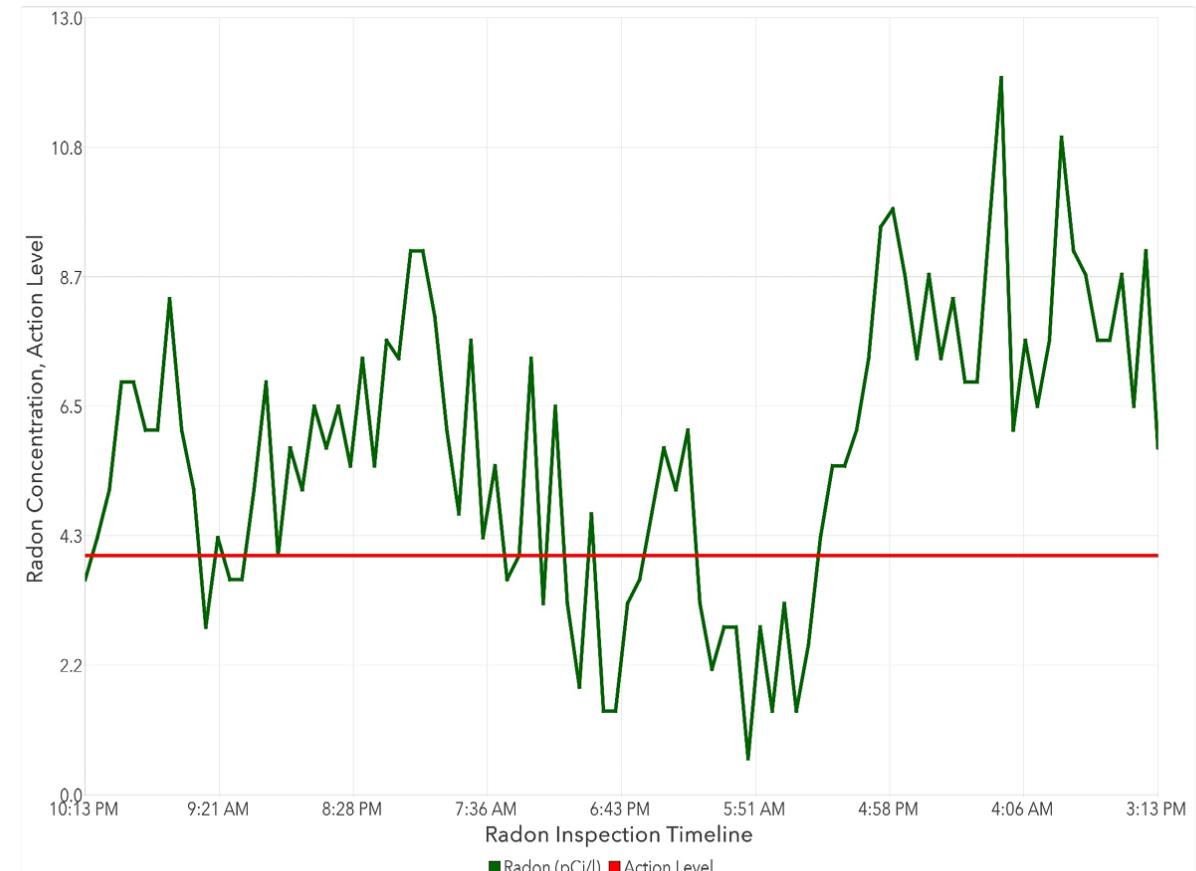
Radon Inspection Chart

**Upper Slab 5.8 pCi/L**

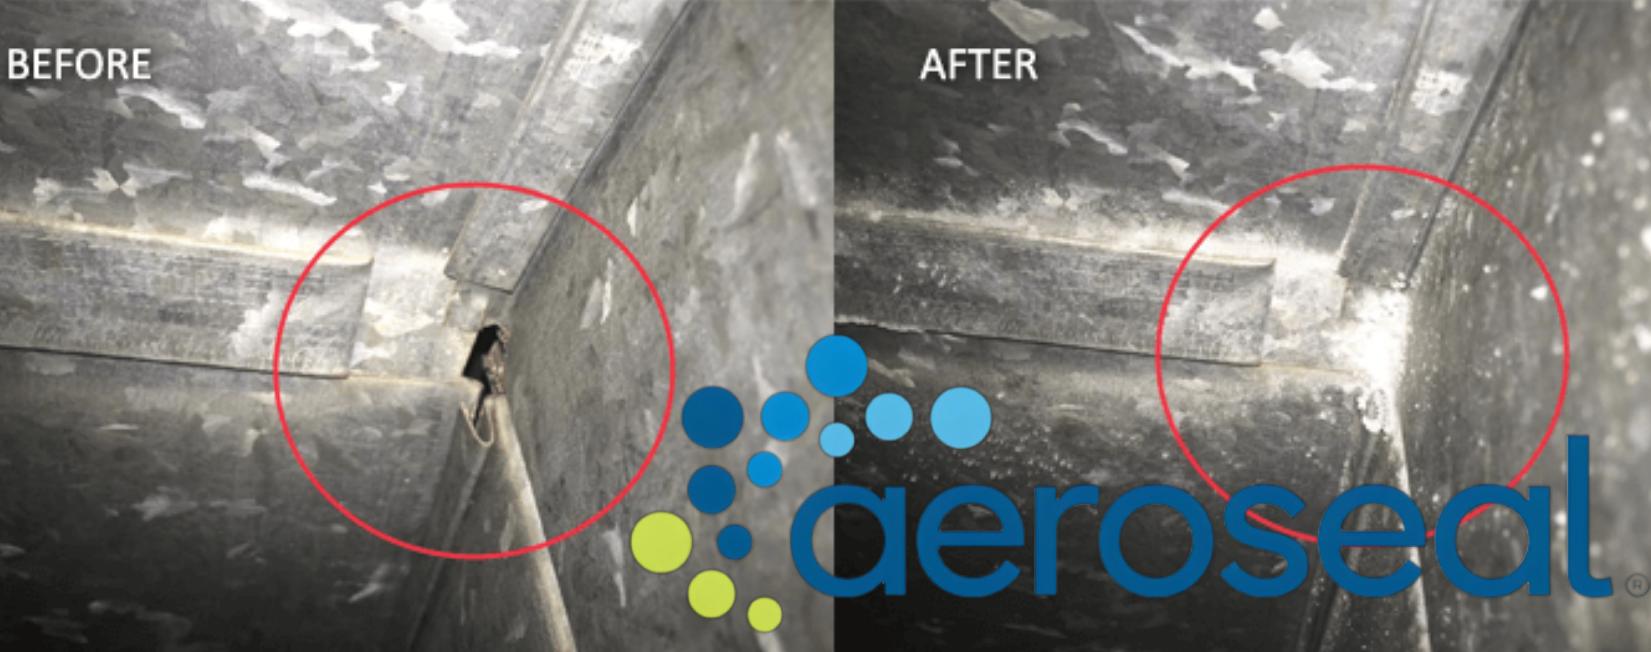
BEFORE

AFTER

- Aerosol sealant injected by pressurizing duct system
- Fills in gaps and holes
- Water soluble

Don't Abandon  
the Ductwork,  
Seal it From the  
Inside

**Aeroseal/DuctArmor**

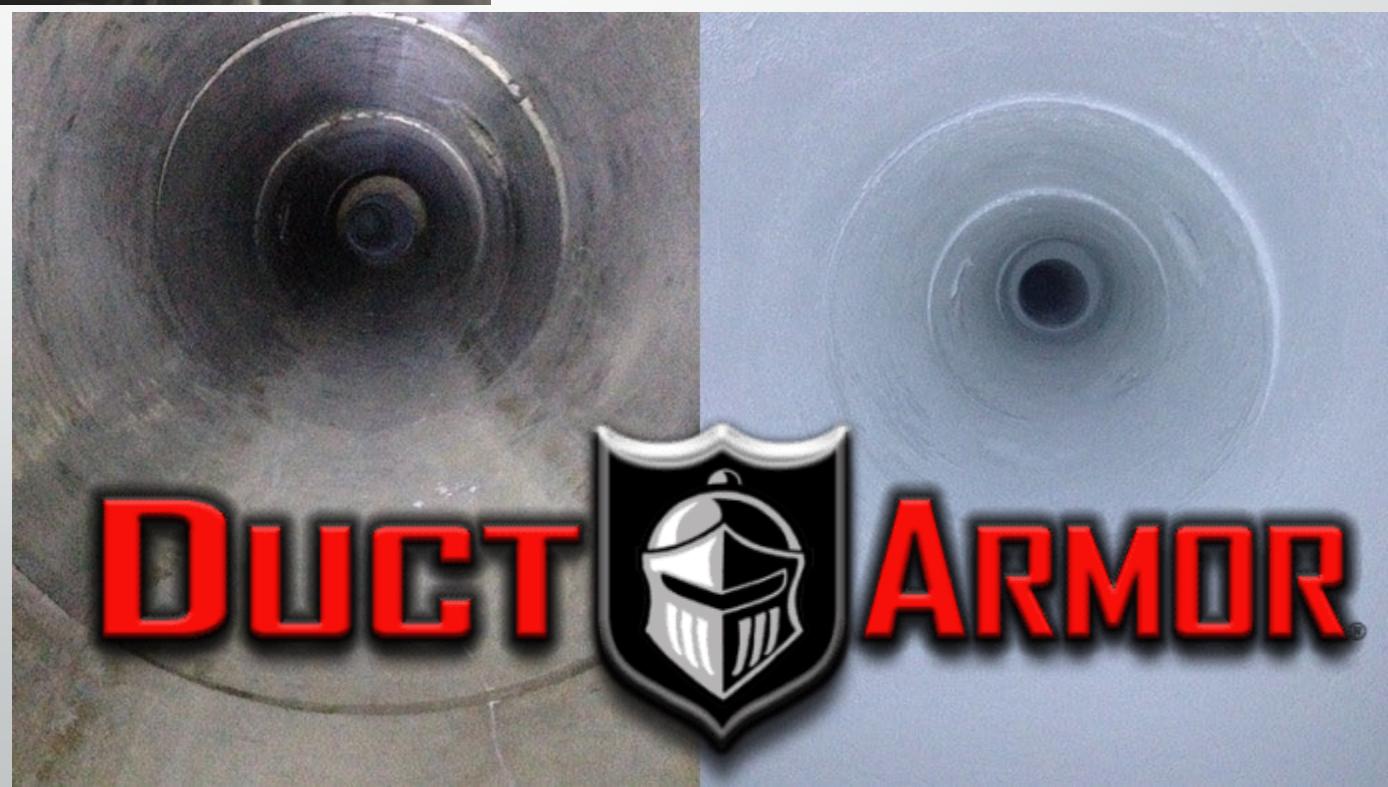
- Applied using a sprayer and hose
- Coats and encapsulates entire duct system
- Water resistant

**DUCT**

**ARMOR**

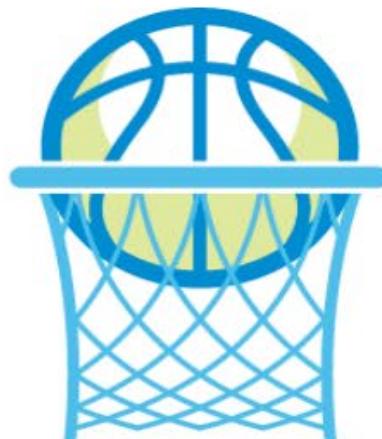
## Initial Leakage

**247.7 CFM@25Pa = 46.8 Sq.In**

Leakage - 20.6 %  
System Capacity - 79.4%

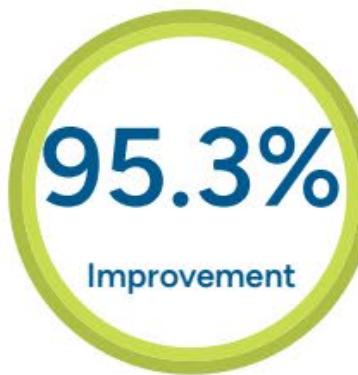
## Final Leakage

**11.7 CFM@25Pa = 2.2 Sq.In**

Leakage - 1.0 %  
System Capacity - 99.0%

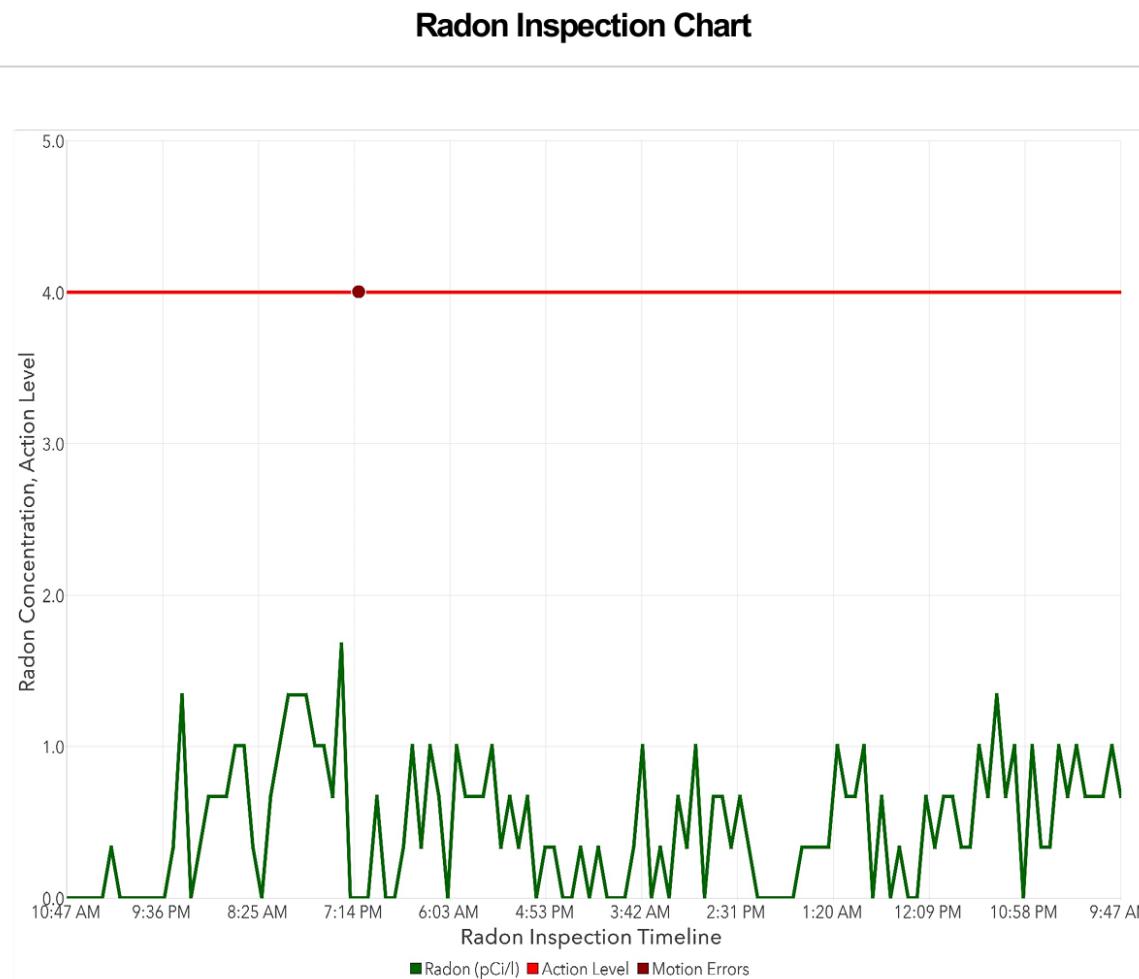
## Lower Slab 0.5 pCi/L

# Radon Test Results After Seal

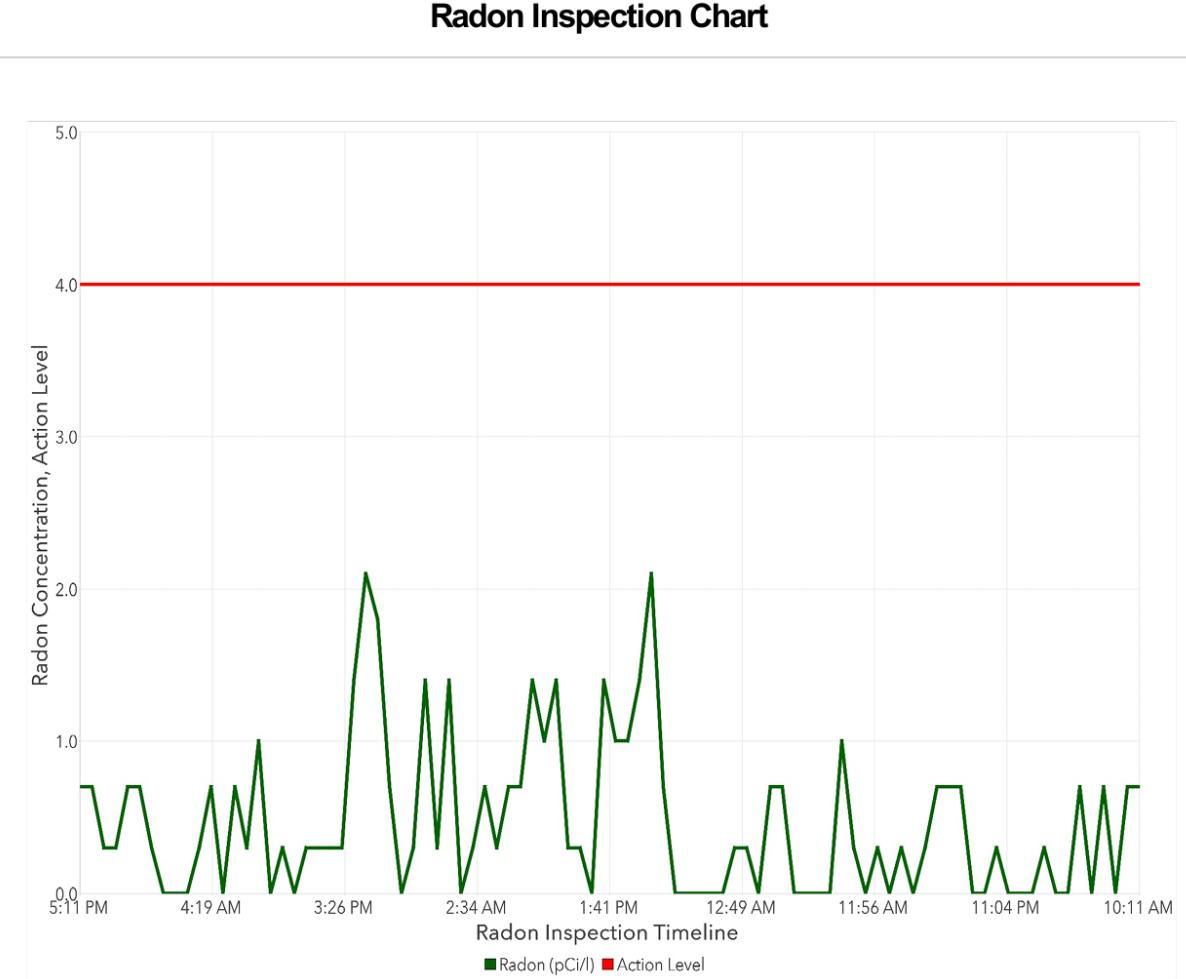
## Upper Slab 0.5 pCi/L
