COMPLEX RADON MITIGATION OF A LARGE BUILDING

David Wilson, Oak Ridge National Laboratory, Oak Ridge, Tennessee, USA

Stanley Ng, Pacific Division, Naval Facilities Engineering Command, Pearl Harbor, Hawaii, USA

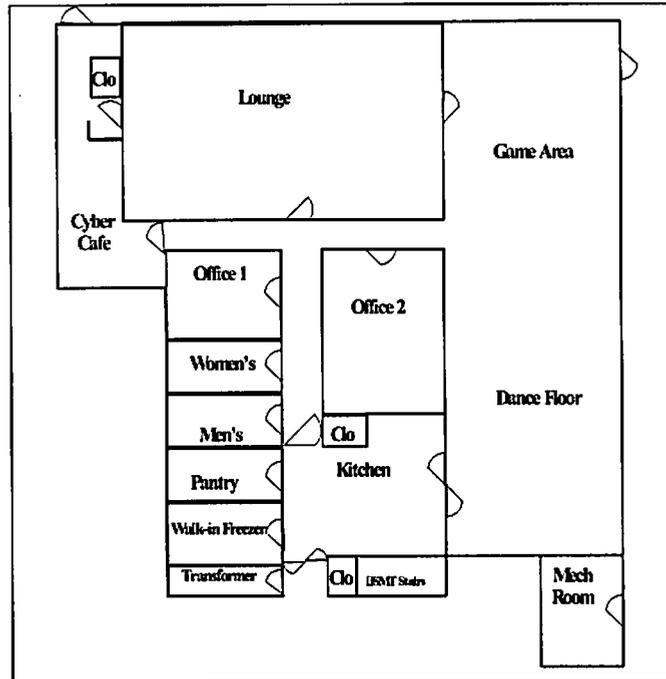
Figure 1. Home Plate floor plan

Relative to the outdoors and with all exhaust systems turned off, the game room (Figure 1) shell differential pressure (DP) was (-) 5 Pa and 0 Pa if both air conditioning mechanical systems were turned off as well. This 5-Pa loss of conditioned air was linked to leaks in the external ductwork of System 1 and the transition collar at the unit supply duct interface. Sealing around the transition collar was feasible. However because the supply duct was covered with a riveted, insulated metal wrap, finding the duct joints that were leaking would have required replacement of the entire duct. During normal mechanical operation, little variation in DP (± 2 Pa) was found in the lounge or in offices relative to the open areas of the building. This was an indication that the forced air systems were balanced. Overall, the ducting design for both air conditioning systems was found to be adequate, and both systems were found to be reasonably well balanced and maintained. The only problem noted was the absence in the design for any fresh-air makeup.

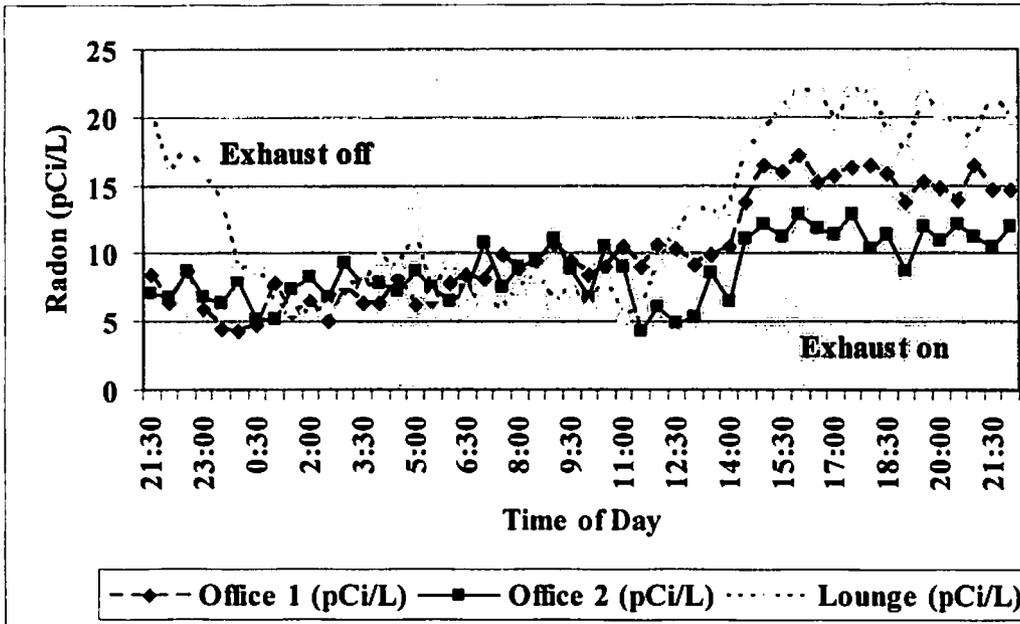
Figure 4. Continuous radon levels in three rooms as a function of exhaust

Assuming that the makeup air problem in the kitchen could be solved, diagnostics were then directed toward the two forced-air mechanical systems to determine if they could condition sufficient makeup air to equalize the pressure imbalance, pressurize the shell, or increase the building’s air change significantly. To determine if vacuum reduction was an option, continuous radon measurements (CRM) using a FemtoTech Model 210F radon detector were performed in three rooms with all mechanical exhaust systems turned off. Although the radon levels were significantly lower at (-) 5 Pa, all three rooms were still >4 pCi/L (Figure 4). Shorter duration tests with the mechanical exhaust turned off, as well as with the two forced-air mechanical systems turned on (0 Pa), did not show any additional decrease in radon levels.

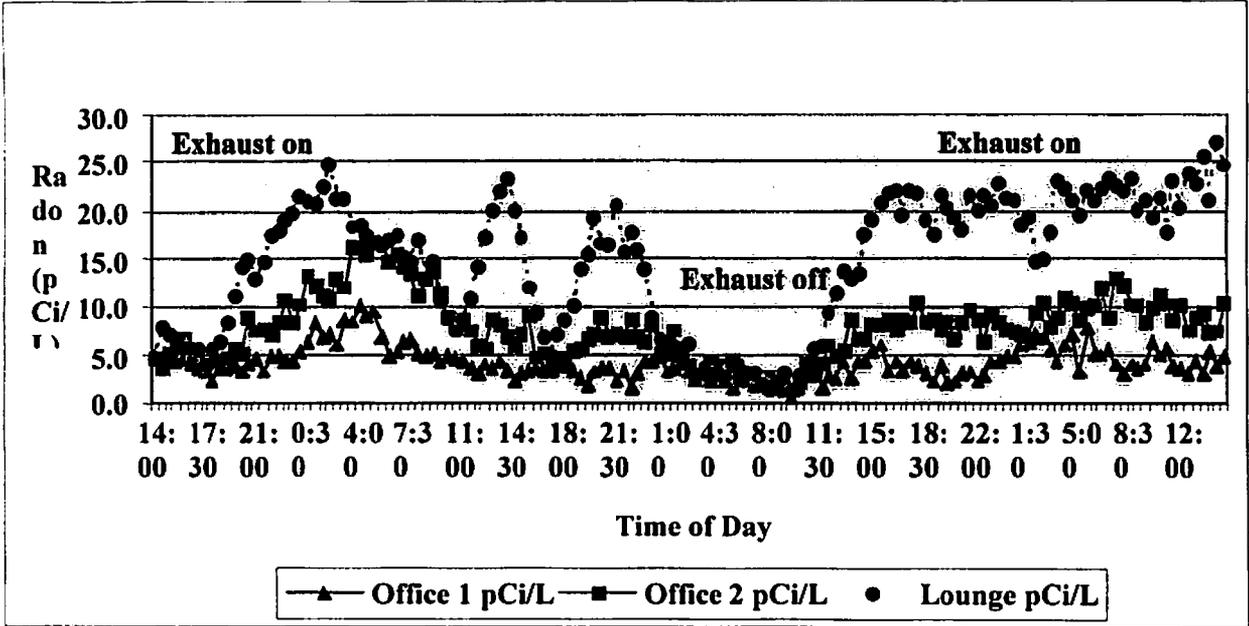
Figure 10. Radon levels in three rooms before supplemental air

The three-fan (GP 501), four-suction-point ASD system was installed as originally proposed (Figure 6). As predicted by the subslab diagnostics, at (-) 14 Pa, with all exhausts turned on except for the grill, only 60% of the subslabs were covered. Postmitigation testing found that only conditions in the Cyber Café were mitigated. CRM measurements performed in three rooms identified as having elevated radon levels showed that room conditions were mitigated if the exhaust systems were turned off (Figure 10). Additional subslab diagnostics determined that mitigation could be achieved if the shell pressure could be reduced to (-) 8 Pa or less. After consulting the blower door curves generated during earlier diagnostics, it was estimated that only 800 CFM of additional fresh air would be needed to achieve this pressure.

the estimated 800 CFM of fresh air needed, concern was expressed whether a 3-ton unit would have sufficient reserve capacity to condition additional air if the original projections were optimistic. Mindful of the fact that the building needed an additional cooling, a 5-ton compressor was selected. This choice provided additional cooling and a reasonable “cushion” if estimates were wrong. The system design included auto sensors that would shut the system down if a fire occurred or if the supply air stream exceeded 78°F or 50% humidity. Because of comfort factors, the location of the discharge point for the 2000 CFM of air (total system capacity for 5 tons) became an issue. Long, complex duct runs that would evenly distribute the conditioned air throughout the building would degrade system performance. Therefore, the shortest duct run possible to the point of highest load would be ideal. Examination of the building’s activities identified the dance floor as the most likely location to meet these criteria. The location required only 20 ft of supply duct and was the place of highest physical activity in the building. Installation and activation of the 5-ton system (Figure 11 and 12) reduced the negative pressure within the building to (-) 7 Pa, which was within the desired range.
