PRESENTATION OBJECTIVES

BVQ LOFTS CLEVELAND OHIO

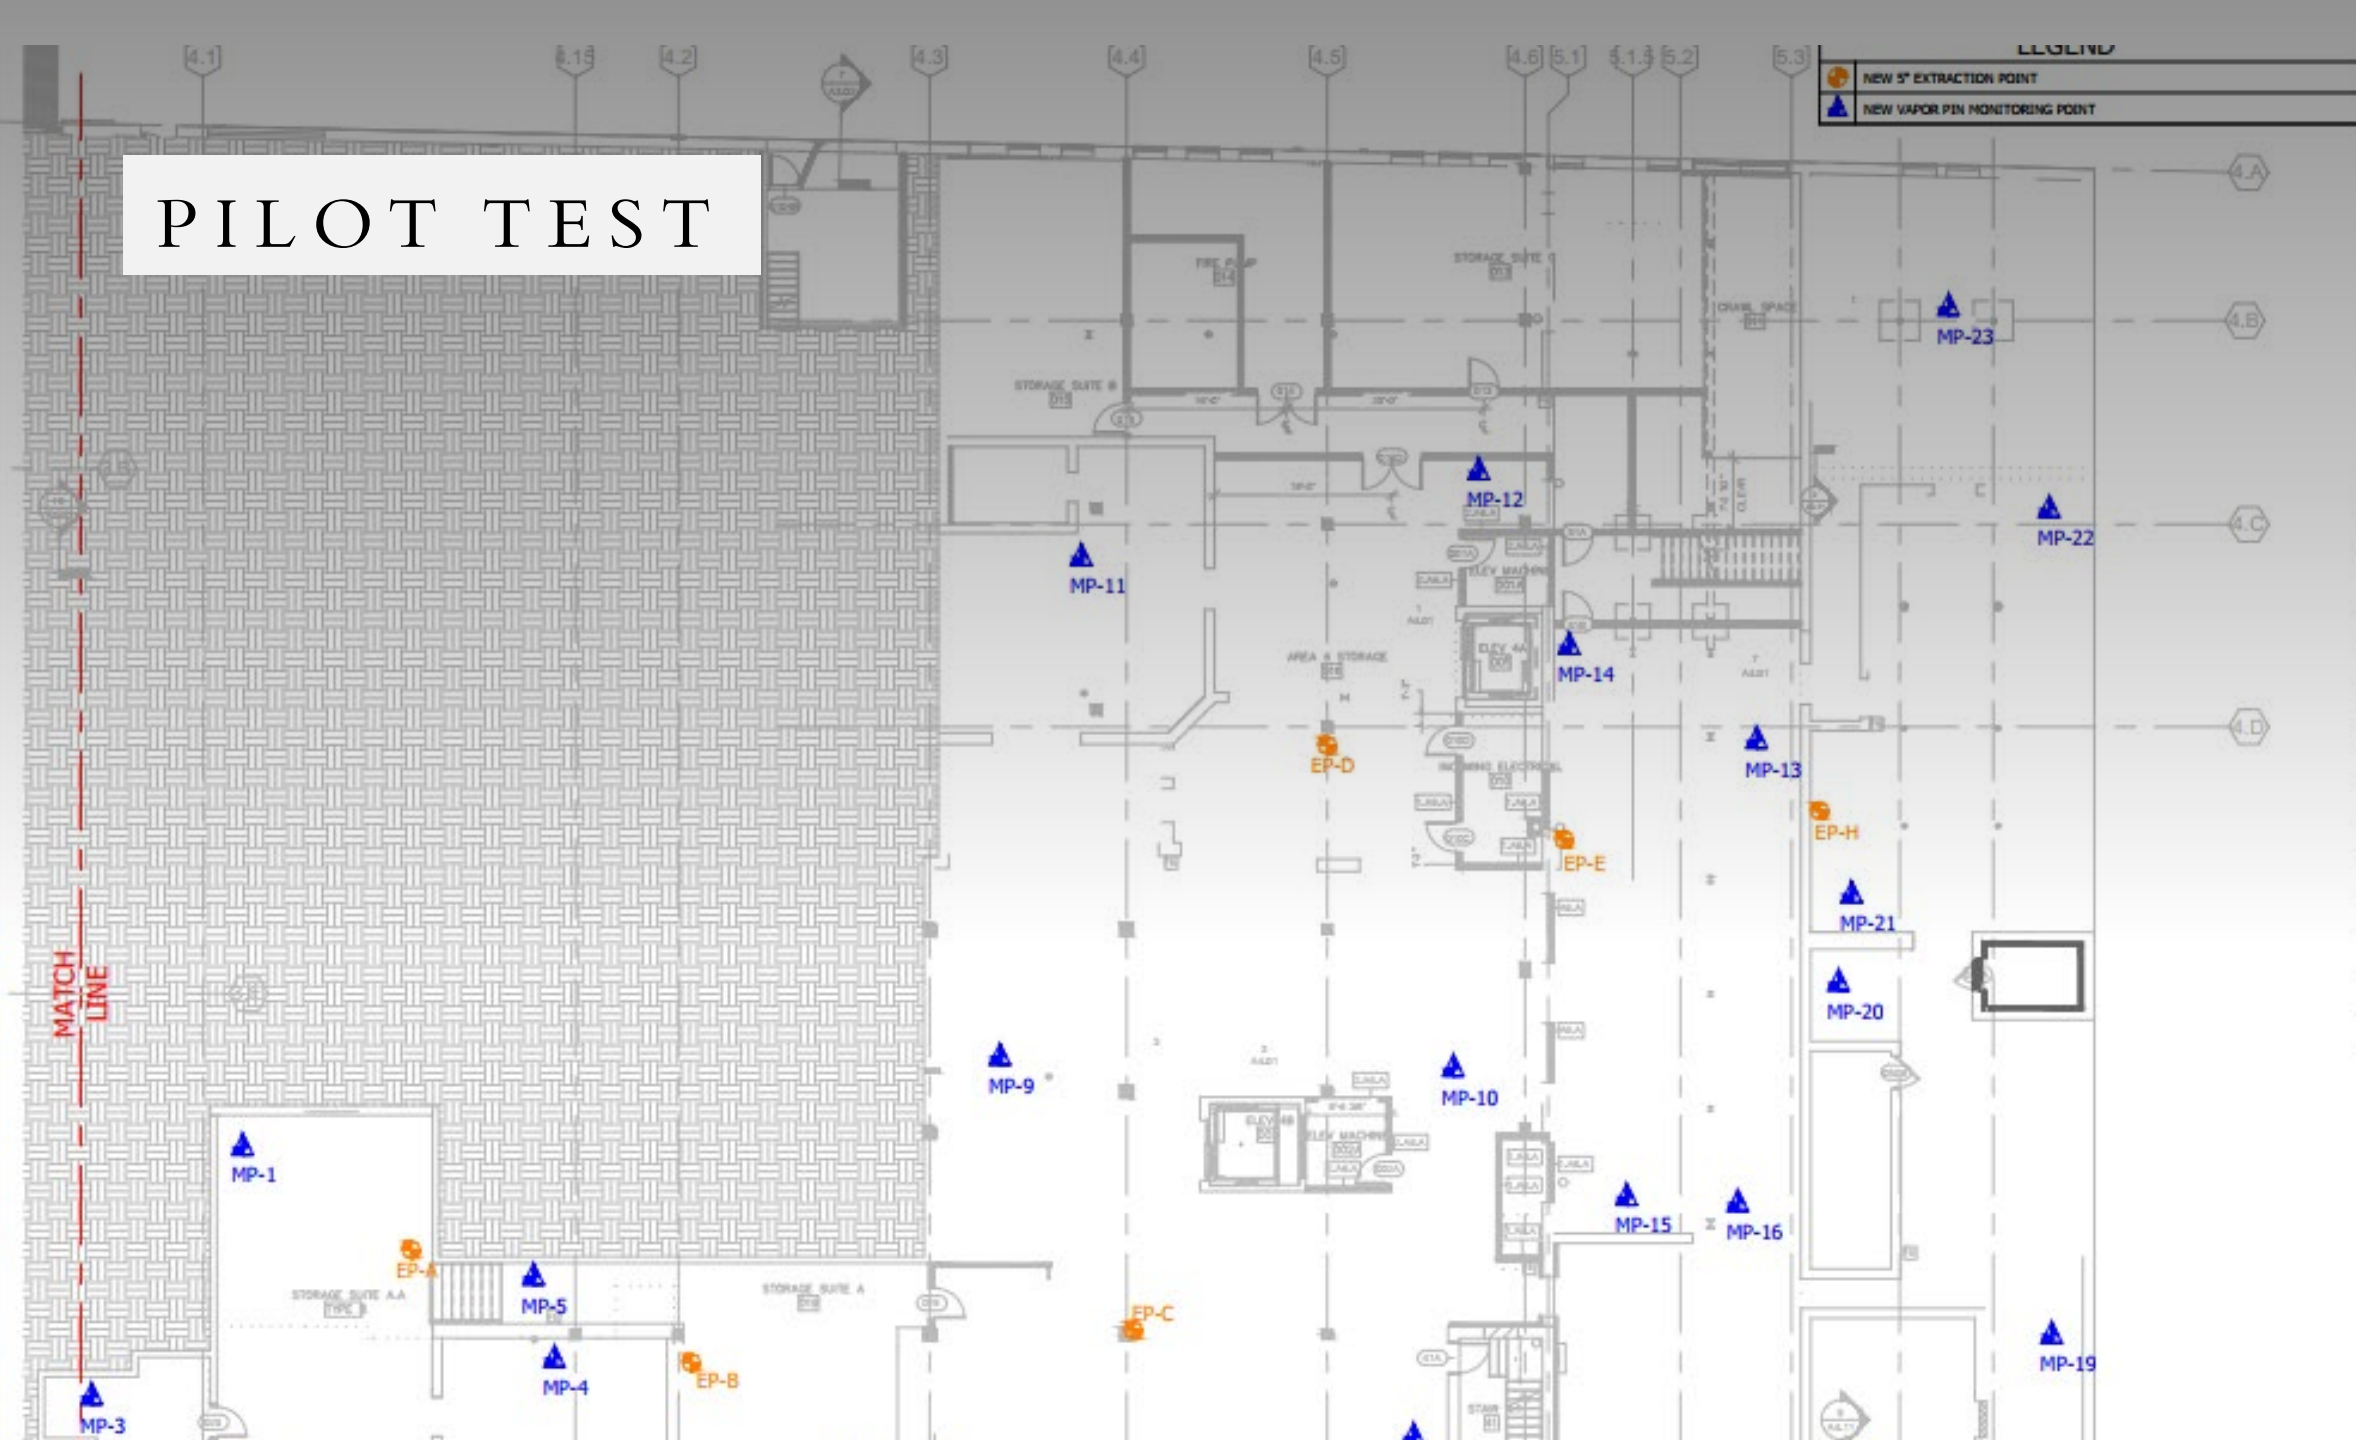
PILOT TEST

- A Pilot Test was conducted to determine PFE and under slab airflow.
- PT results showed decent PFE in the sub-basement and most of the upper basement.
- Large cracks and holes in the floor were causing air flow gaps in the slab.
- Visible cracks were caulked and sealed.
- Floor was very dirty and cluttered so all cracks could not be identified.
- Original System was installed which included 11 Extraction points and one 3 phase 208V 3HP HP4A Cincinnati Fan Motor controlled by a VFD. Moving 450 CFMs at -11.0".
- Clearance assessment results showed the sub-basement as well as the far east wing of the upper basement still had radon levels above the EPA Action Level.
- CRMS were placed in the building – results showed spiking of levels at certain times of day.

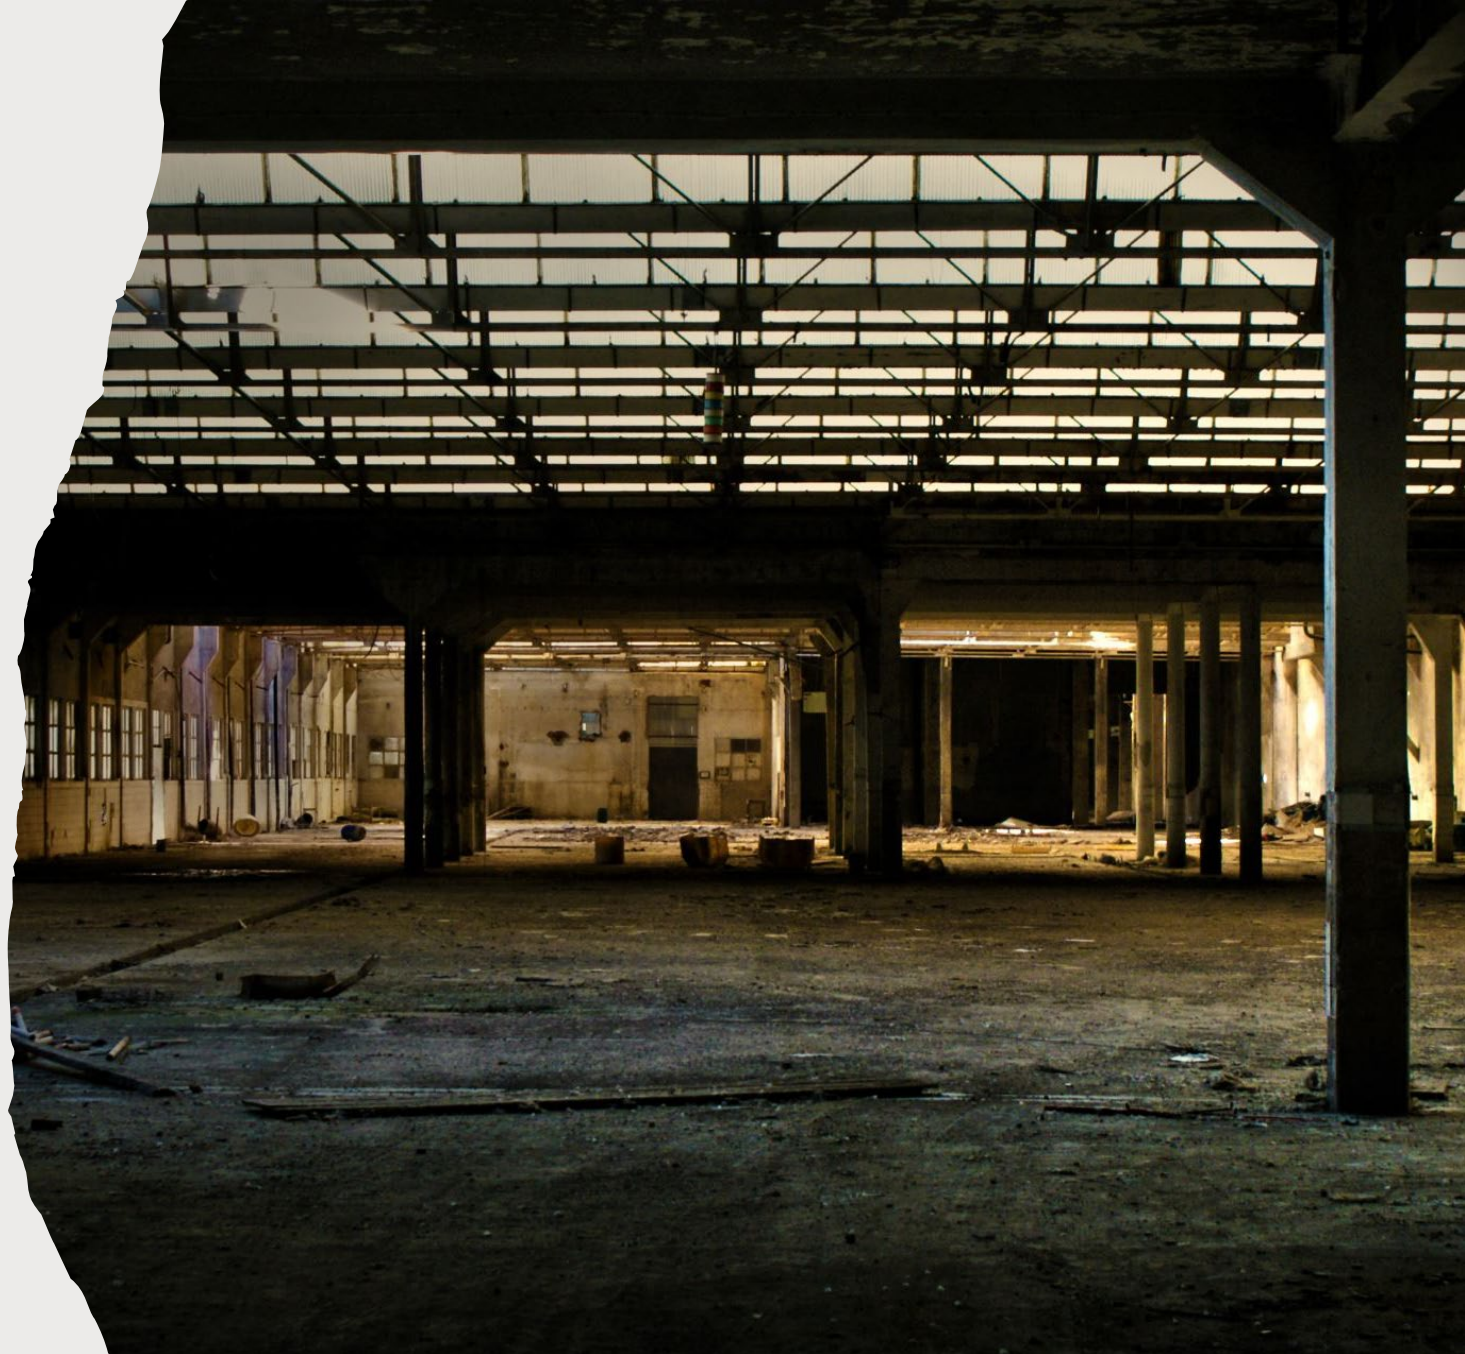
FINAL CLEARANCE ASSESSMENT

- All areas of the sub-basement and upper basement were below the EPA Action Level.
- Highest level reported was 3.1 pCi/L.
- All residential units located on floors 1 through 4 were at < 0.3 pCi/L.
