Health Care Facility Vapor Intrusion (VI) Assessment and Mitigation

By: Michael Devir, PE
KERAMIDA Inc.

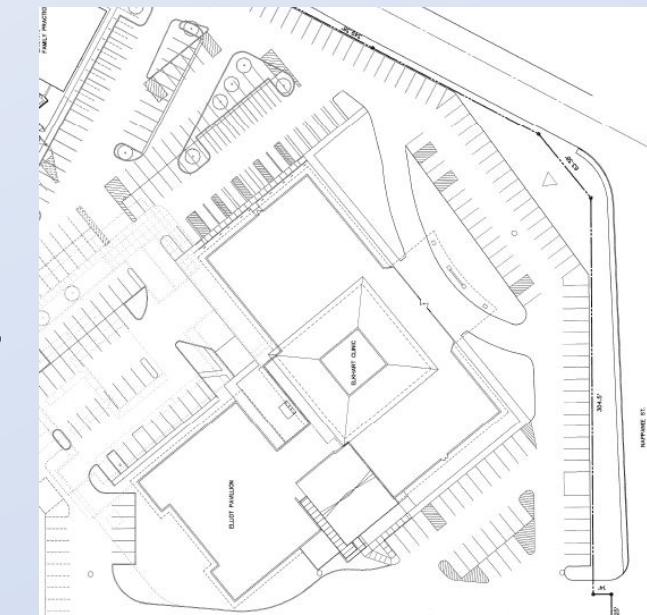
- Location of Cracks:

- Basement exterior foundation wall (north wall)
- Crack mitigation measures & photographs (pre- & post-)
- Floor condition - unknown (covered in carpet or floor tiles)

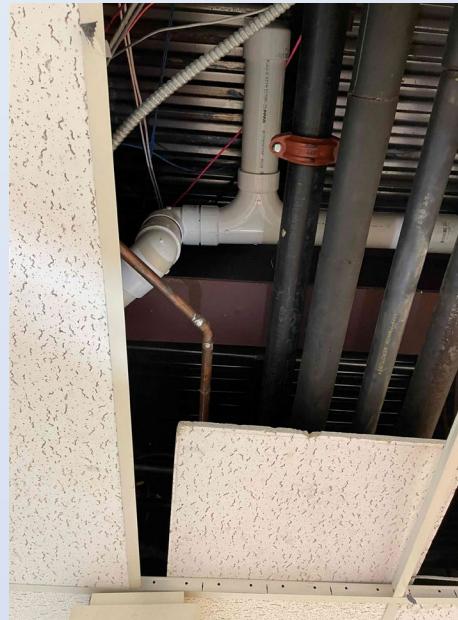
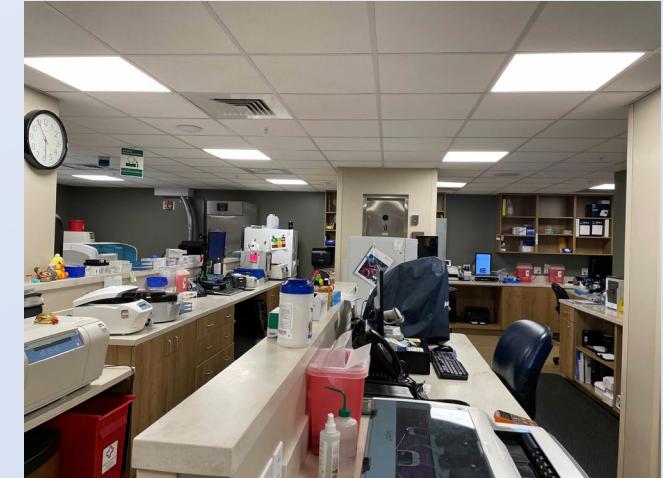
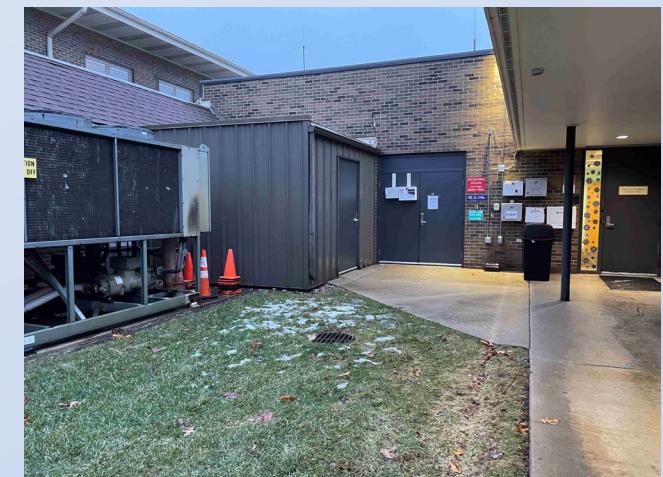
Facility Challenges:

- No exterior access due to centrally located basement and much larger upper floor
- Basement below 'open' reception/ waiting area
- Basement ceiling space with mechanical, electrical, and fire suppression equipment
- Clinical laboratory located in a portion of the basement

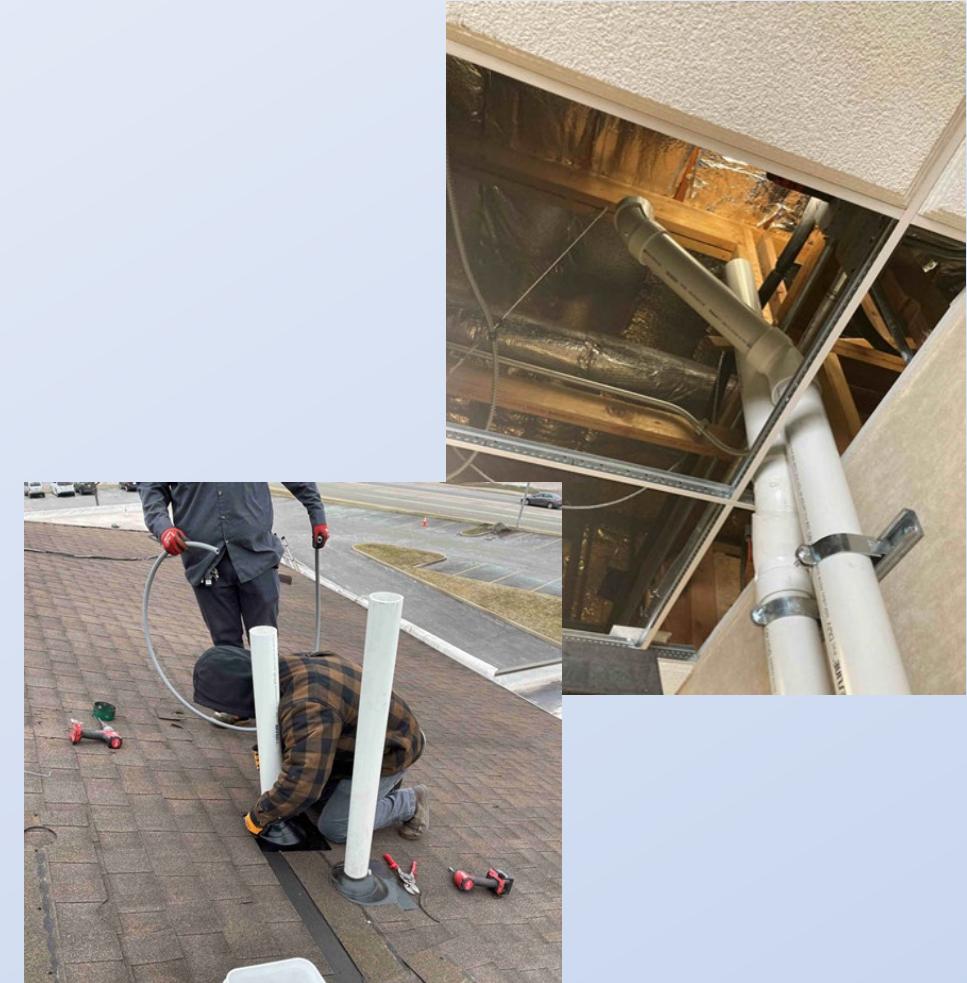
- Knowledge of facility equipment & operations
- Trained to conduct work wearing a respirator
- Mechanical – Identify stack pipe location, core 2 floor levels from basement to roof
- Roofing – Roof penetrations and sealing of stack pipes and electrical
- Electrical – Install of power to roof penetration / fan location / breaker labeling
 - Wired temporary fans for removal of vapors during basement testing

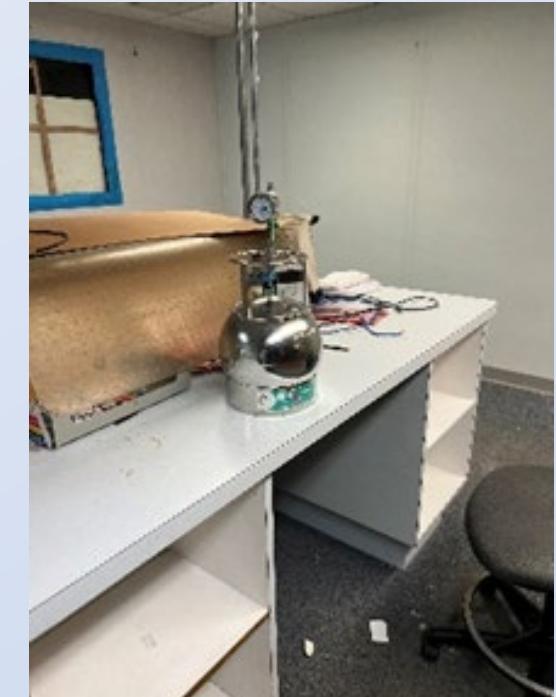
- Paired Indoor Air Sampling Conducted
- Approximately 2 Weeks Following VI Mitigation System (VIMS) Start-Up
- 6 Samples by Method TO-15 with 8-hr Duration
 - 4 samples in basement, 1 on main floor above, & 1 ambient sample
- All Results Below IDEM R2 Indoor Air Commercial Published Levels (PLs)
- Management Able to Resume Clinic Operations

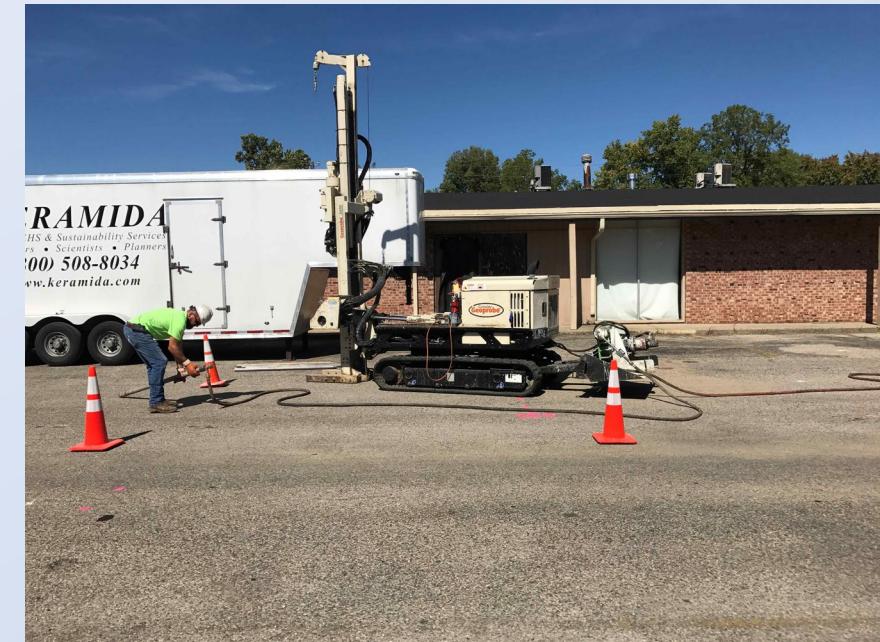
- Limited Site Investigation (Field):
 - 5 Soil borings and collection of soil, soil gas and groundwater samples
 - Borings focused on up-gradient side of facility (north and east)
 - Soil Gas samples along utility corridors
 - 6 paired VI samples in facility (indoor air, sub-slab vapor, exterior air)
