Case Study: Difficult to Mitigate Home

Matt Koch

AVIP 2025 Conference

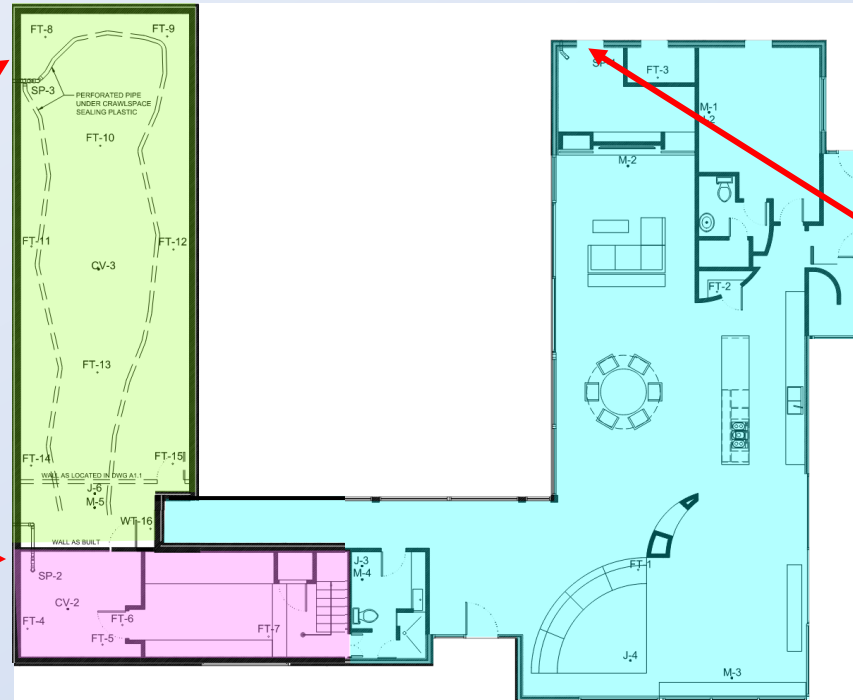
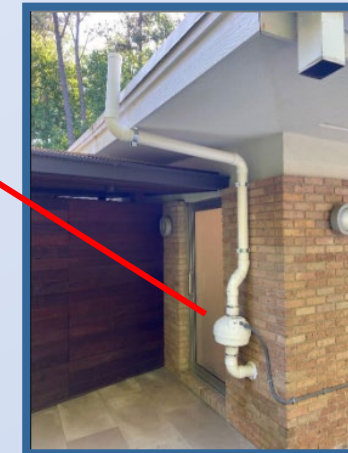
- Mid-Century Modern House in Georgia
 - Person living in the house has lung cancer
 - There are three active mitigation systems in the home!
 - What was missed?

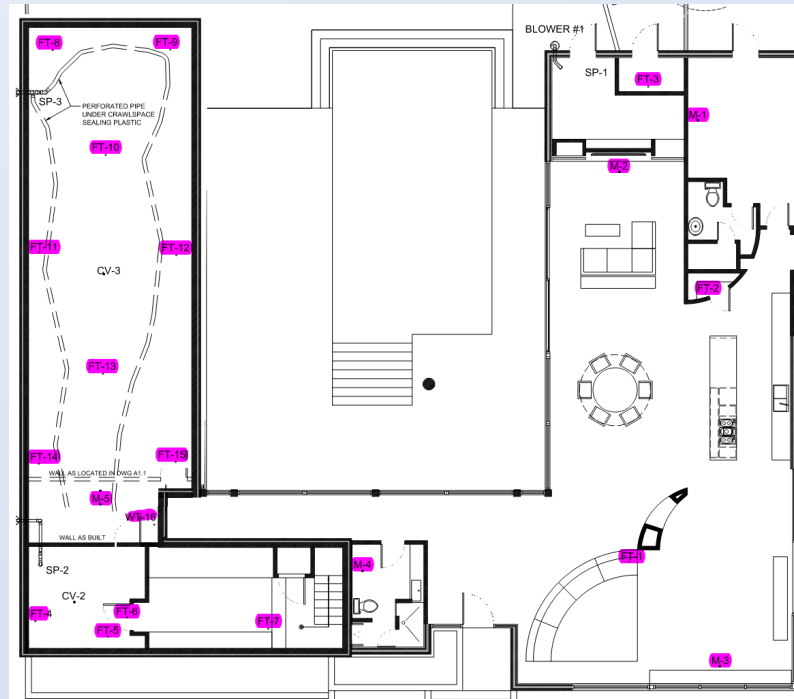
- Clean Vapor called in to investigate
- Diagnostic testing performed

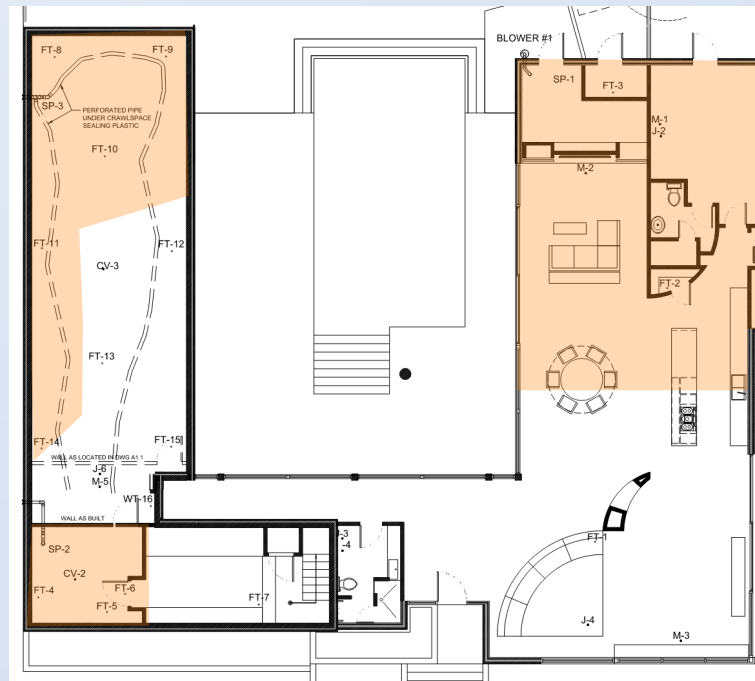
- Information evaluated
- Where are we not getting sufficient PFE?
- Plan for further work developed

- System 1: Slab on grade
 - Replace fan with high flow fan
 - Replace 3" pipe with 4" pipe
- System 2: Basement
 - Additional suction point
 - Higher pressure fan
- System 3: Crawlspace
 - Modify configuration to get better air flow across the space
- System 4: Crawlspace
 - Add another system at other end of crawlspace to get better PFE
