THE UK MINISTRY OF DEFENCE RADON SAFETY PROGRAMME

Dee Emerson, Health Physicist & Dean Williams, Radiation Protection Advisor
Radiation Protection Group
Defence Science and Technology Laboratory (DSTL)
United Kingdom
Email: dmemerson@dstl.gov.uk

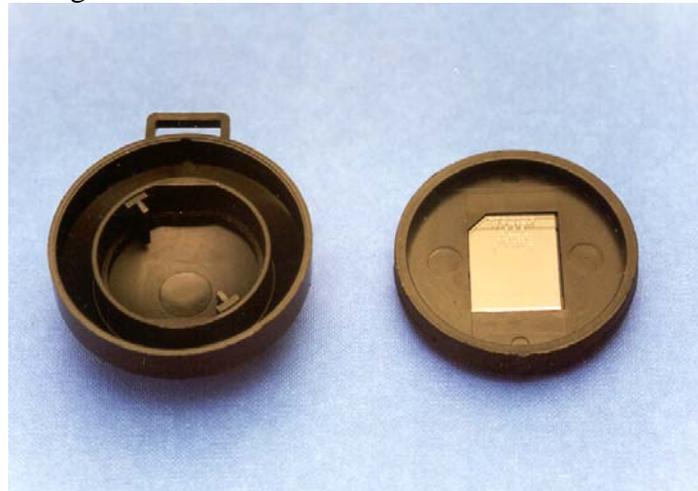
Figure 1: Dstl radon detector

Monitoring is carried out using passive radon detectors. The detector consists of a TASTRAK™ etched-track detection element housed inside a NRPB/SSI holder (*Langridge et al 2010*). The radon-daughter decay alpha particles leave tracks of damage on the surface of the TASTRAK™ element that are enlarged by a chemical etch process and then counted using a TASL reader within the Dstl radiation detection laboratories.
