NATIONWIDE SURVEY OF RCP LISTED MITIGATION CONTRACTORS

Bill Brodhead
WPB Enterprises, Inc.
Riegelsville, PA

ABSTRACT

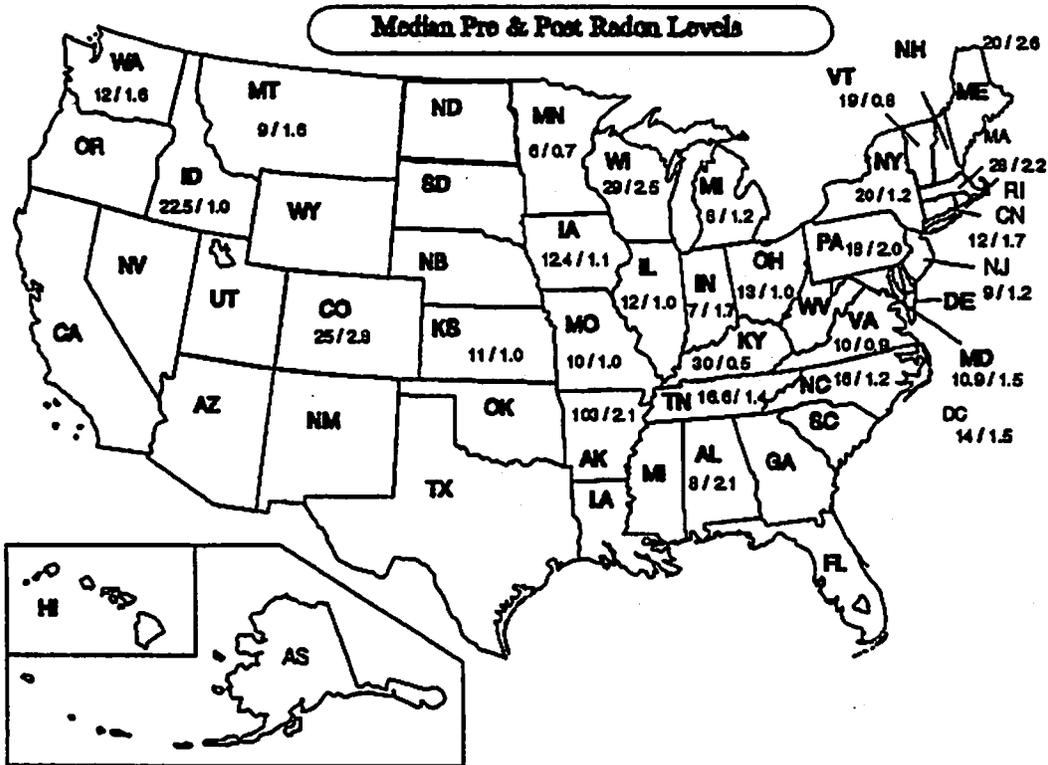
between the house age and the initial radon results. The second United States maps lists the median system price in each state from the survey houses. There were at least three survey houses in each of the listed states except North Carolina and Wyoming which had only one Survey house.
